Qualitative Assessment on the Effects of Damaged Connectors and Optical Interfaces in Fiber Optic Measurements

White Paper

Presented by Peter Linowitz
Agilent Technologies
National Conference of Standards Laboratories (NCSL)

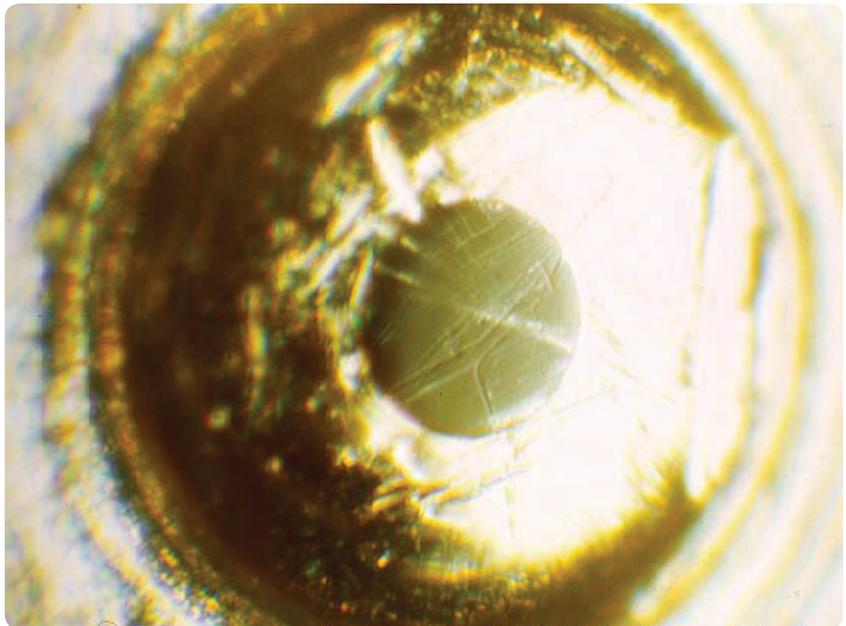
Feel of Dimensions ... (6)

- 125 μm fiber and scratches;
- elbow scratch approx. 3 μm wide

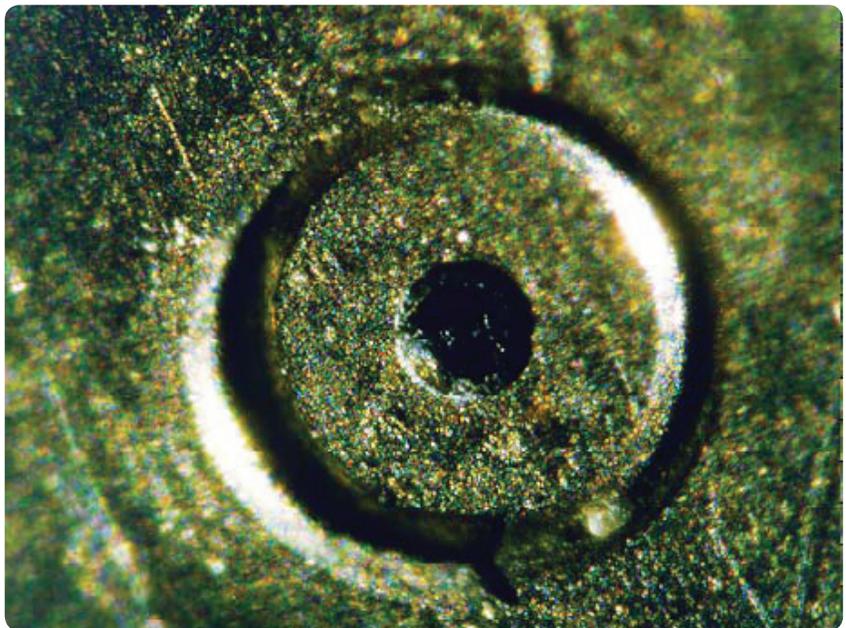
Extreme fiber damage on connector.

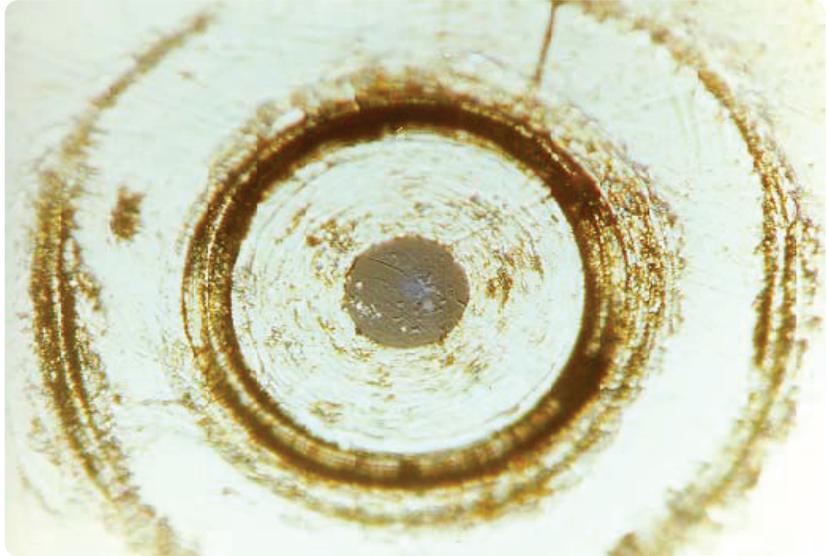
HMS-10

General example of damage:

- Scratches
- White objects are metallic particles embedded in fiber
- Pits are where metallic particles have fallen out

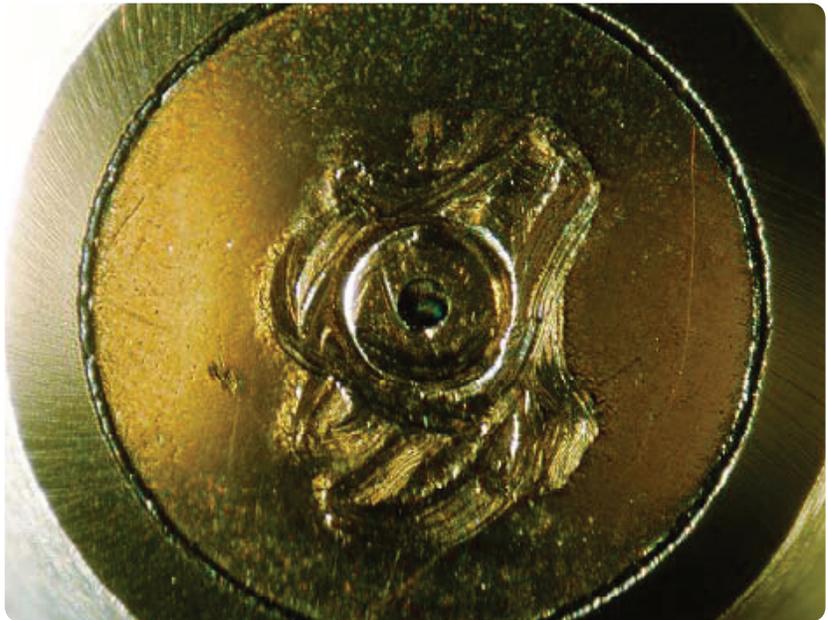
2.5 mm Ferrule

Assume that ferrule end was 'cleaned' by probing with pin.

Nickel/silver insert within Tungsten carbide ferrule easily scratched with pin. Insertion loss was approx. 8 dB.

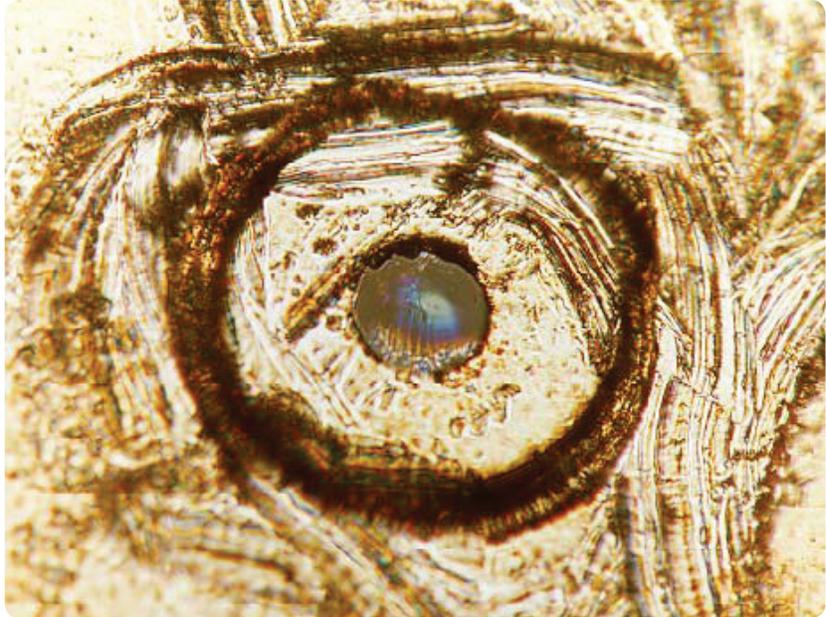
Fiber within 2.5 mm Ferrule

Previous slide magnified.

- Note where scratch leads to broken fiber edge
- Crescent mark across bottom of fiber is where metallic disposition has taken place when pin was drawn across surface of fiber

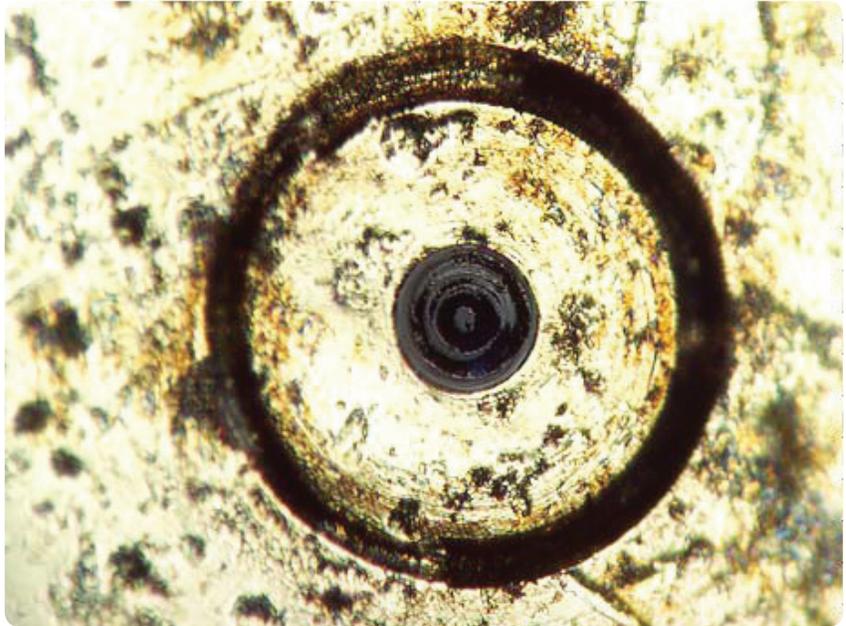
Fiber within 2.5 mm Ferrule

OTDR front panel connector/ferrule

Recessed ring effect either due to incorrect fiber inserted and rotated or missing key on correct connector. This caused extreme multiple reflections between this and the fiber .

See page 13 for effects on OTDR measurement.

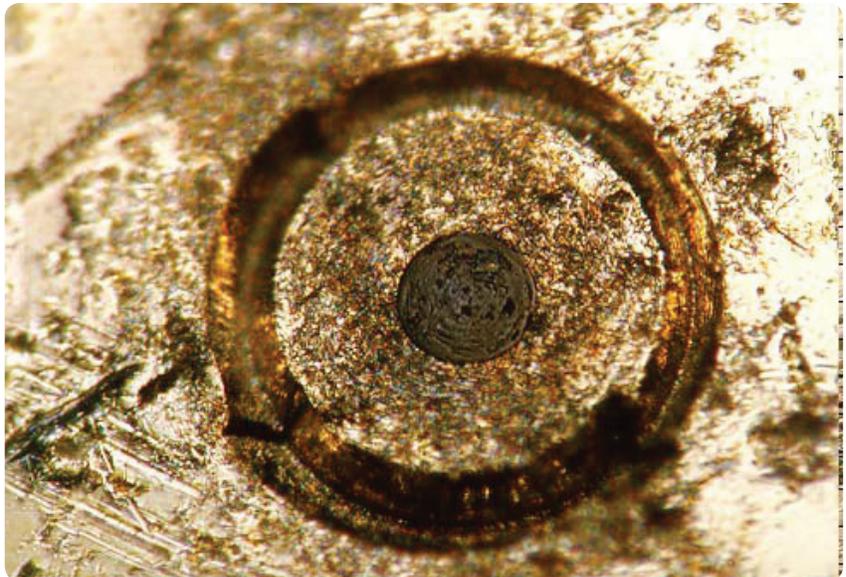
Fiber within 2.5 mm Ferrule

- After seeing this unit over a period of 1 year, the connector finally gave up.
- See page 13 for effects on OTDR measurement.

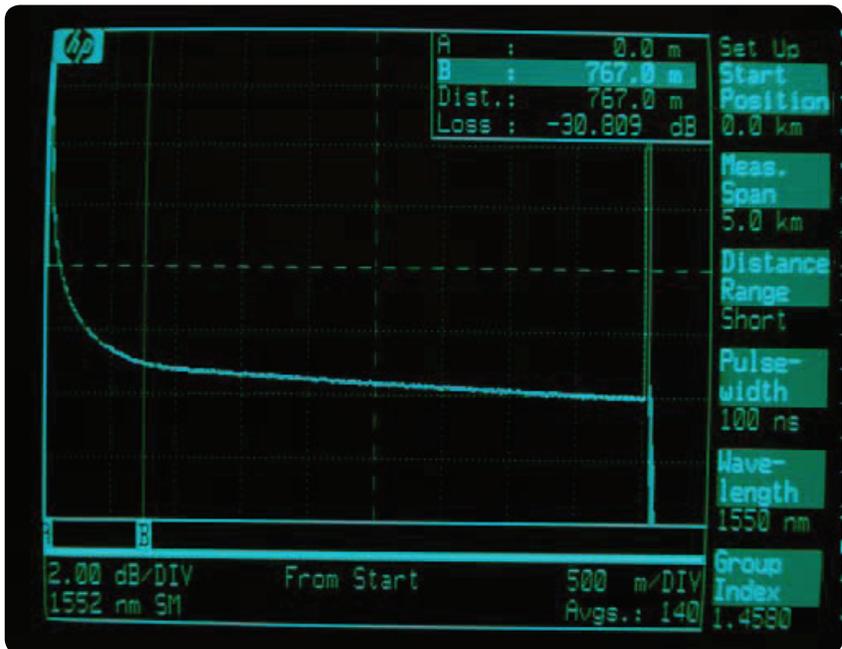
OTDR Trace

Typical result of damaged front panel connector

Note! Extreme back reflection at pulse launch and loss of 0.75 km before useable measurements can be made.

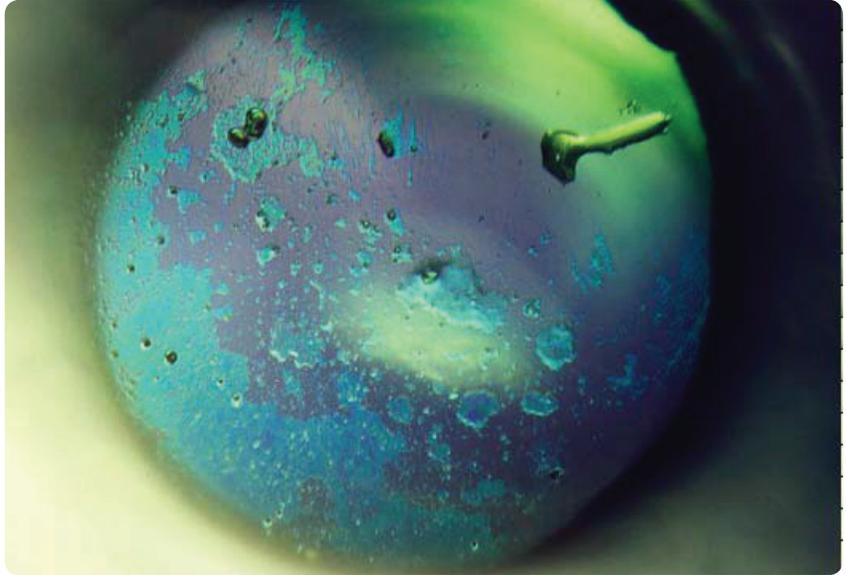
Optical Attenuator

Picture through front panel connector of collimating lens.

- Lens coated with Refractive Index matching (RI) liquid which has collected particles of dust and grit
- This unit showed approx. 10 dB insertion loss.

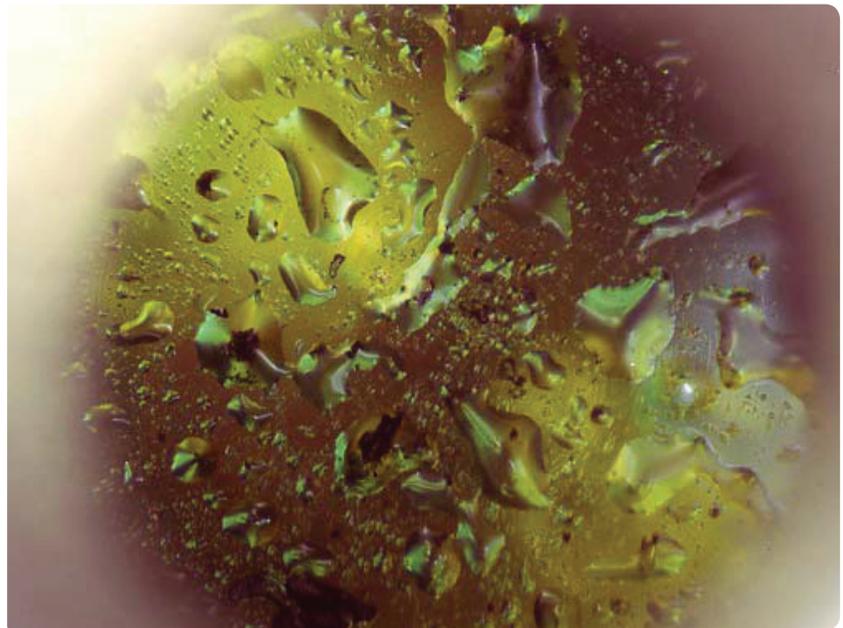
Picture through front panel connector of collimating lens.

User has attempted to remove RI liquid with solvent.

- Typical globular RI liquid pattern results when solvent has evaporated.
- This unit showed approx. 20 dB insertion loss.

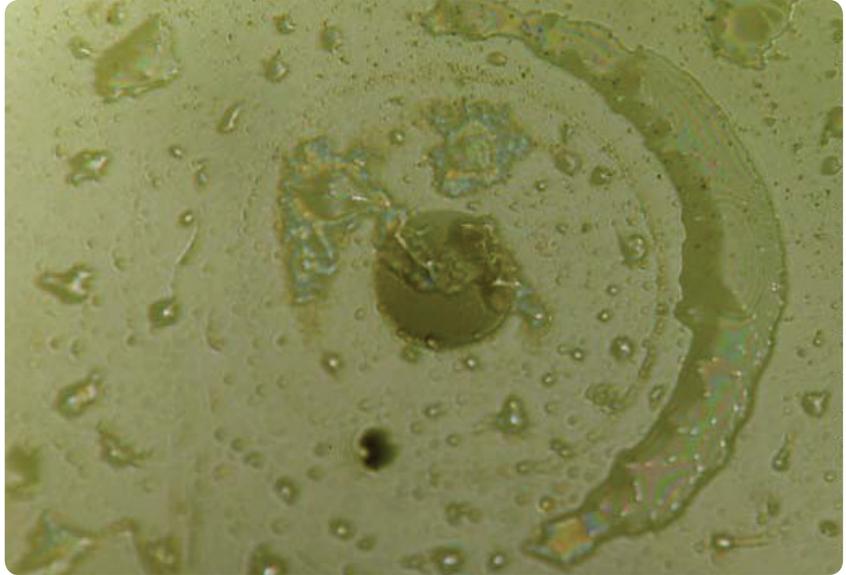
FC/PC Connector

Ceramic ferrule showing RI liquid contamination

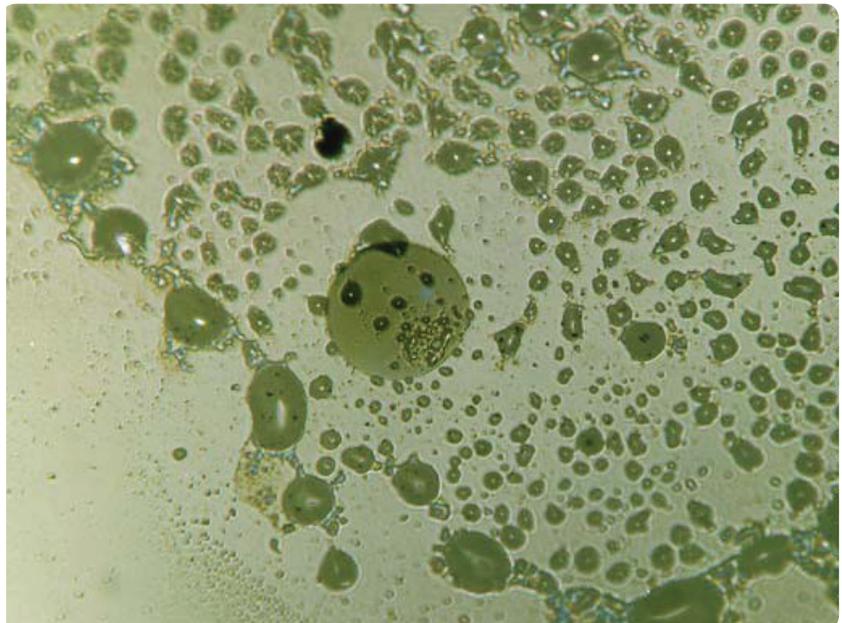
Isopropyl alcohol (IPA) applied with cotton bud and cleaned, waved in air to evaporate IPA.

Result: RI liquid reforms into globules.

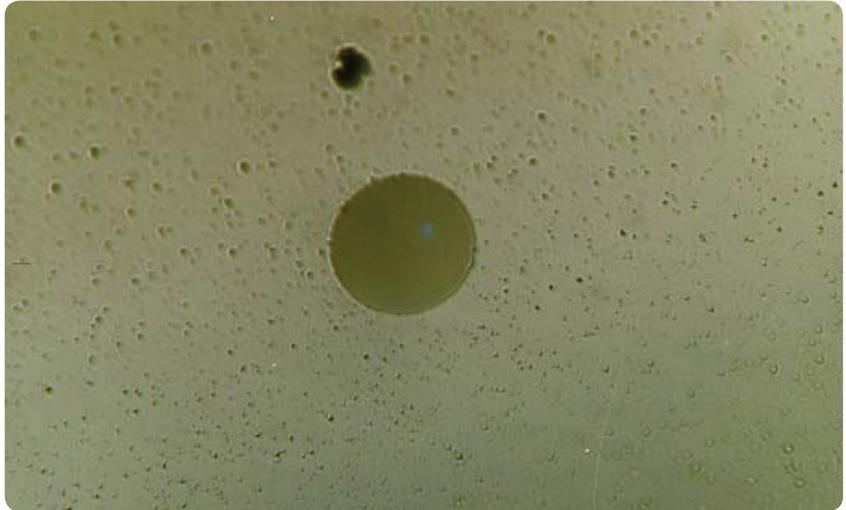
FC/PC Connector

Again cleaned with isopropyl alcohol in some way but compressed air blown over ferrule end.

Result: clean connector/ferrule. Marks on ferrule end are part of the ceramic material.

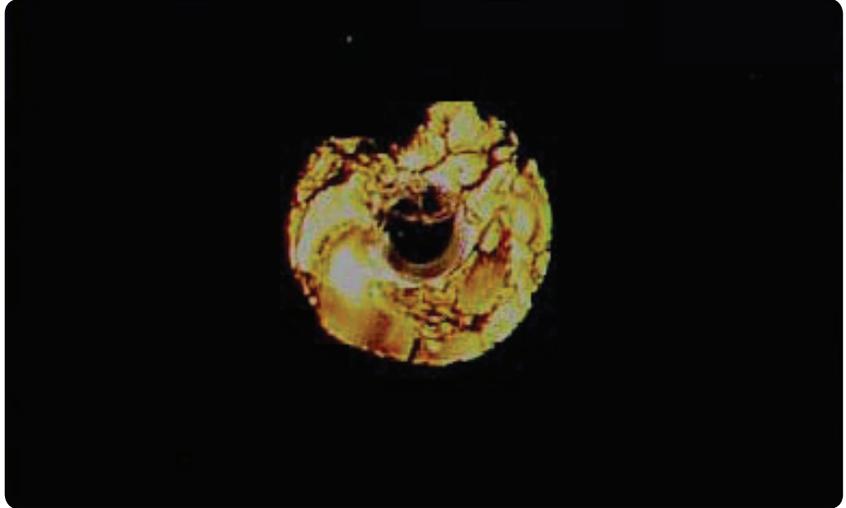
OSA Input Connector

Multimode fiber from previous slide, back illuminated now.

Light is traveling through the cladding, where the center of the core is nearly without any light.

Note the scratches on the core and chipped effect across the entire surface of the fiber end face.

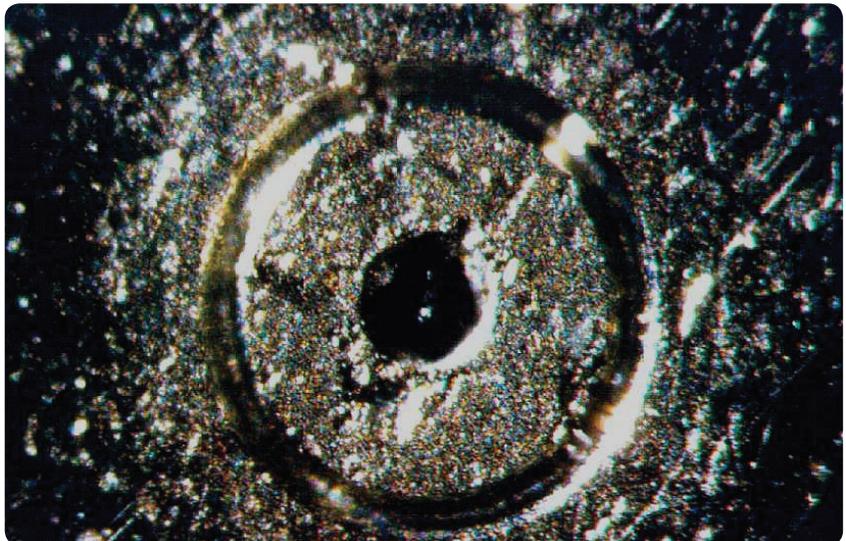
OSA Input Connector

Multimode fiber

Front illumination.

Scratches on the core or cladding and chipped fiber end face are hard to see.

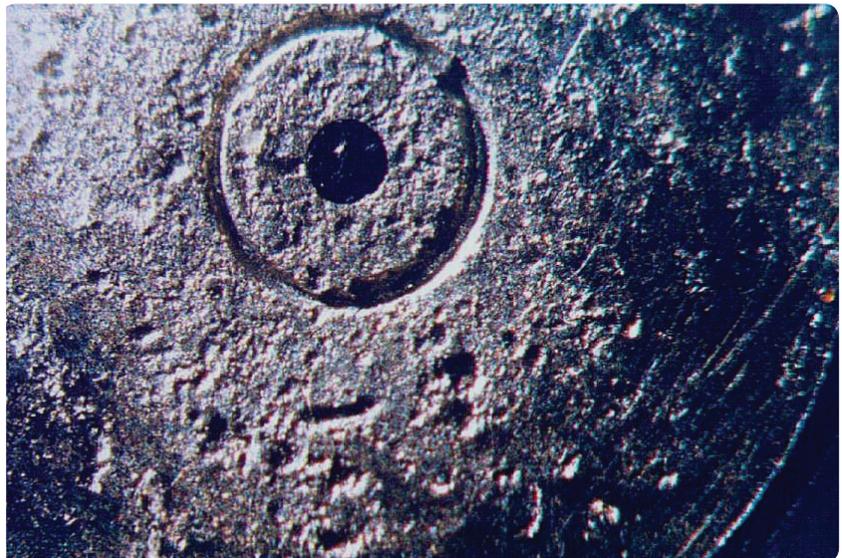
OTDR Input Connector

Singlemode fiber with even distributed dirt and dust.

- Note the fine scratches at the edge of the ferrule.
- They are generated by scrubbing the connector with other tools than lint-free cotton swaps or lens papers.

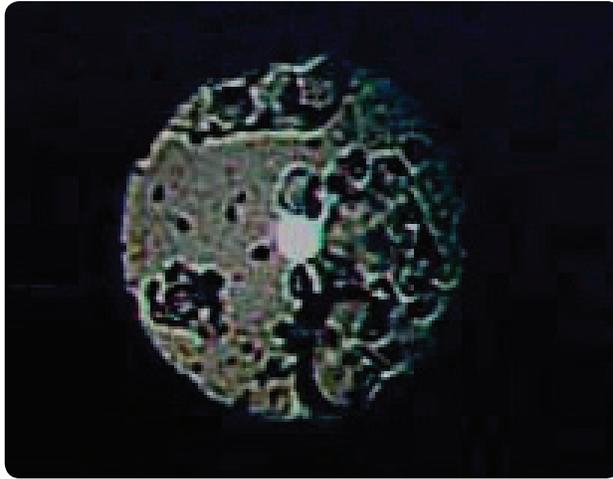
OTDR Input Connector

Singlemode fiber cladding and core of the previous slide (black) are now both visible (back illuminated).

- The core guides the most light.
- Damage is primarily on the cladding, but also on the edge of the core.

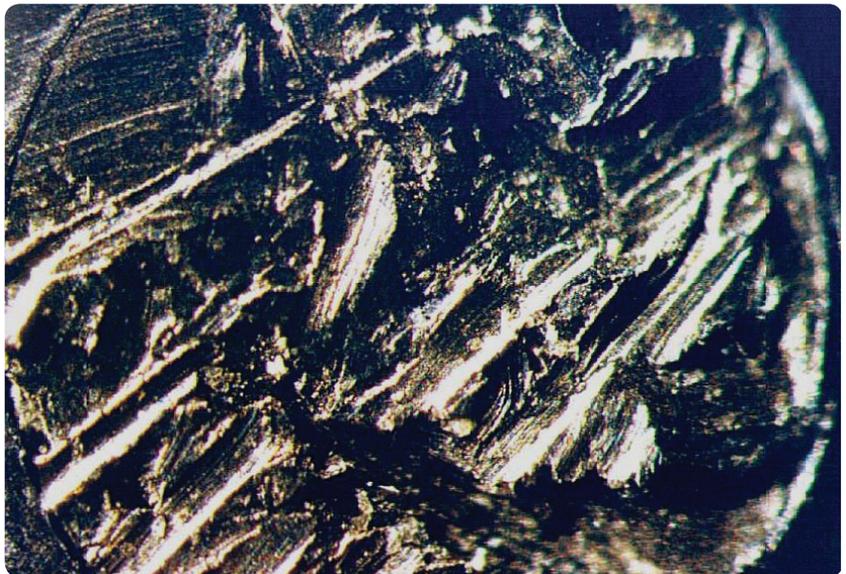
A completely damaged connector...
