1130A-01A

# S E R V I C E N O T E

## 1130A Infiniimax Probe Amplifier 1.5GHz

**Possible fractured solder joint on input pin**

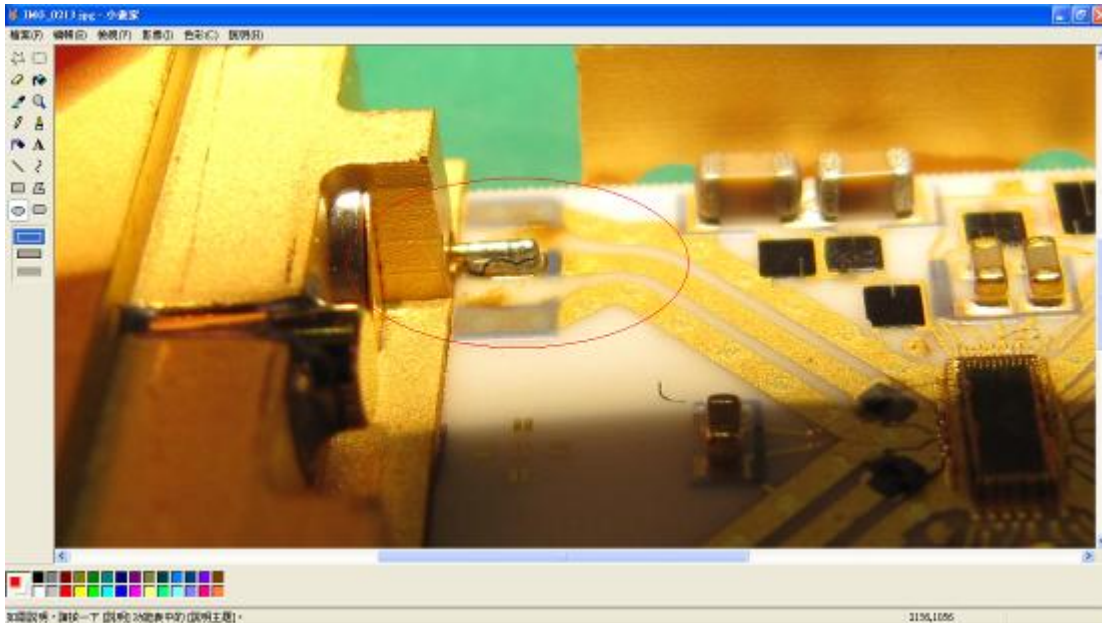
The above picture shows a fractured solder joint.

5. If you determine that the solder joint is fractured, bent, broken, or probe head parts stuck to a probe pin, replace with a new 01130-68701 probe amplifier. Charge the replacement cost to factory warranty.

If you find the above mechanical defects, replace with a new 01130-68701 probe amplifier.

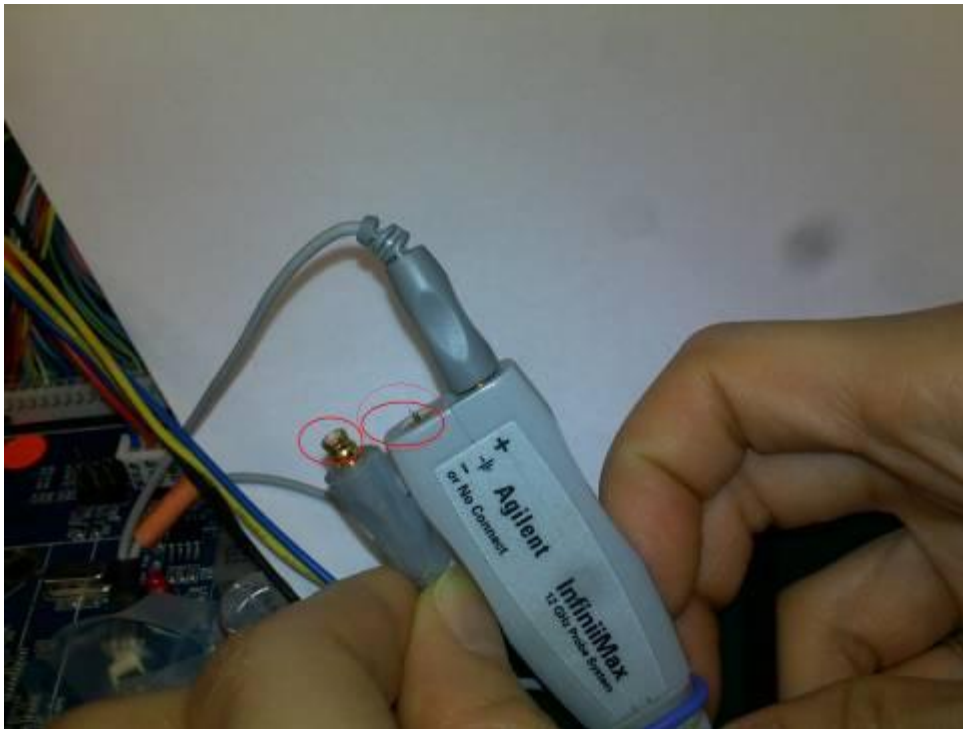
The above picture shows where the long pin of the probe amplifier actually got stuck in the female connector of the probe head. When the probe head was removed from the probe amp, part of the probe head female connector stuck to the probe amplifier pin and was pulled out.

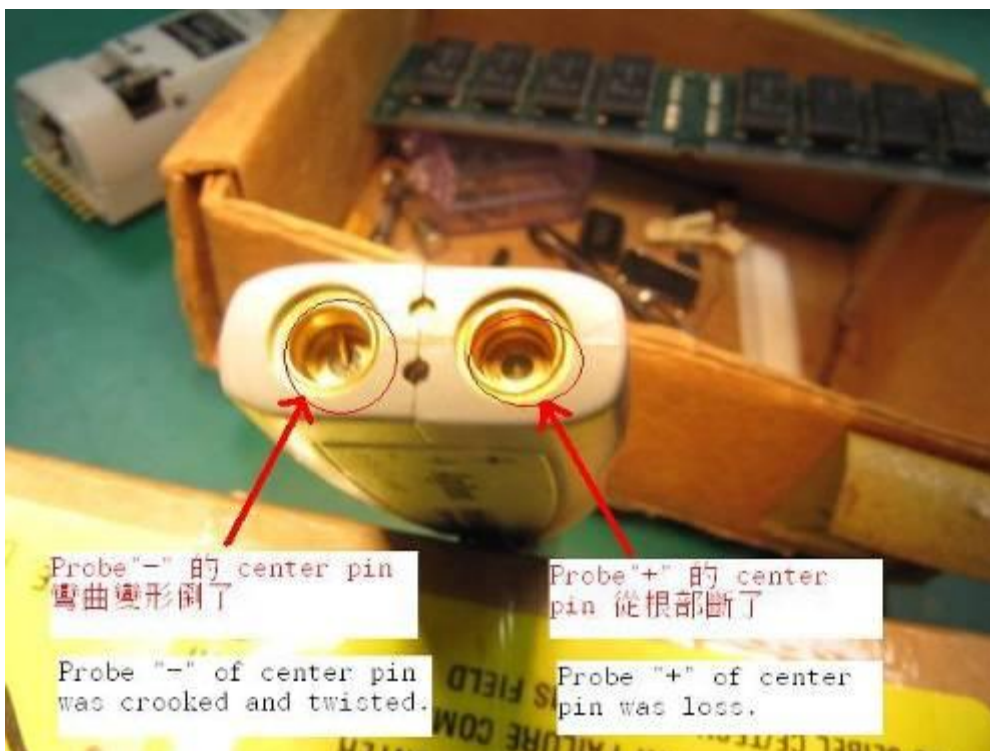
The above picture shows a bent male pin and a broken male pin. The longer male pin could cause the pin to bend or eventually break when connected to a probe head.
