1130A-01B

**S E R V I C E N O T E**Supersedes:  
1130A-01A

## 1130A Infiniimax Probe Amplifier 1.5GHz

Possible fractured solder joint on input pin

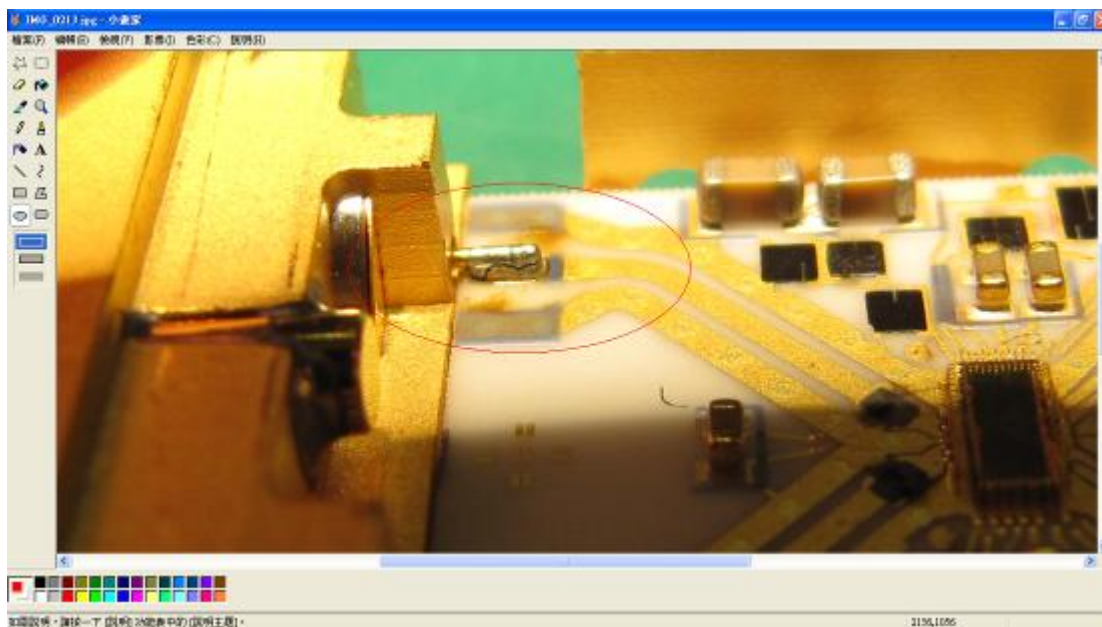
The above picture shows a fractured solder joint.

5. If you determine that the solder joint is fractured, bent, broken, or probe head parts stuck to a probe pin, replace with a new 01130-68701 probe amplifier. Charge the replacement cost to factory warranty.

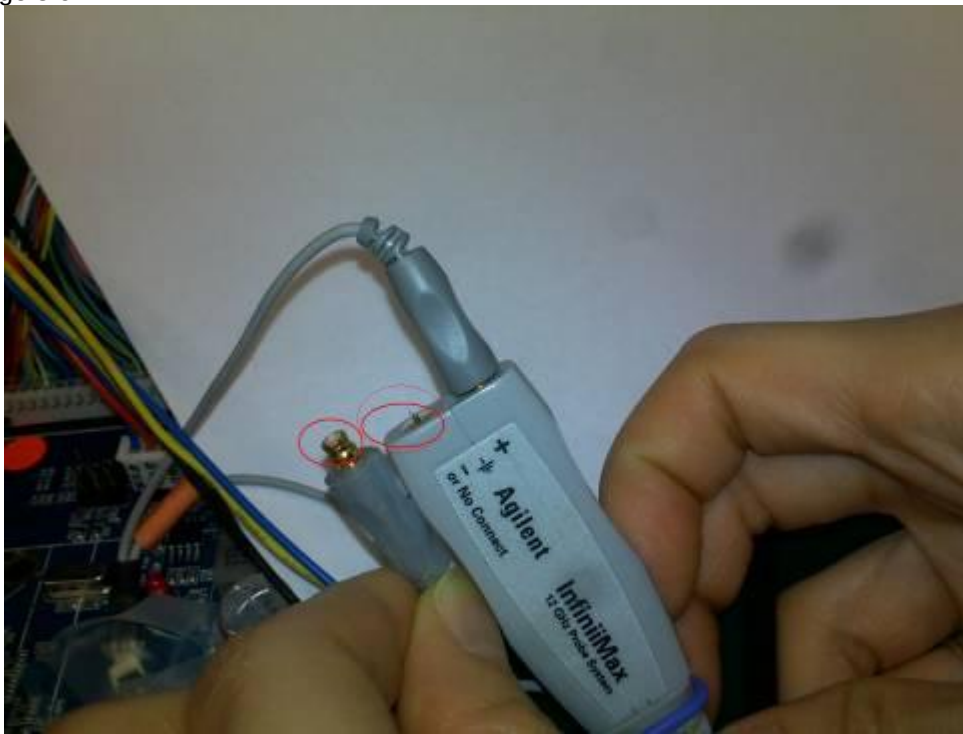
The above picture shows where the long pin of the probe amplifier actually got stuck in the female connector of the probe head. When the probe head was removed from the probe amp, part of the probe head female connector stuck to the probe amplifier pin and was pulled out.

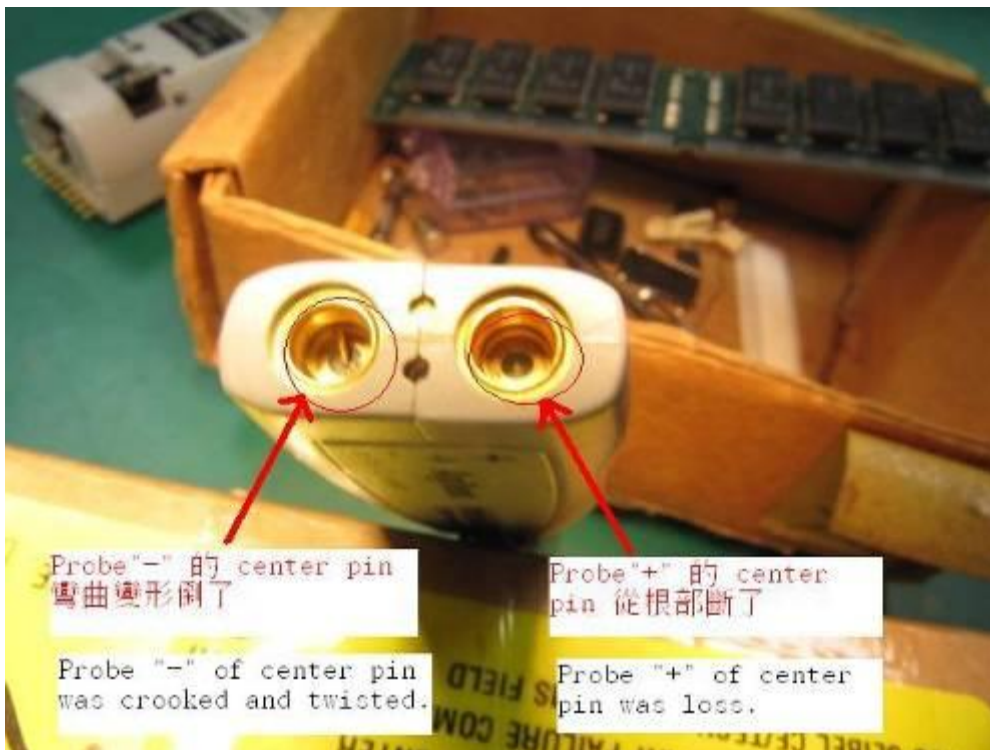
The above picture shows a bent male pin and a broken male pin. The longer male pin could cause the pin to bend or eventually break when connected to a probe head.
