1131A-01B

# S E R V I C E N O T E

## 1131A Infiniimax Probe Amplifier 3.5GHz

**Possible fractured solder joint on input pin**

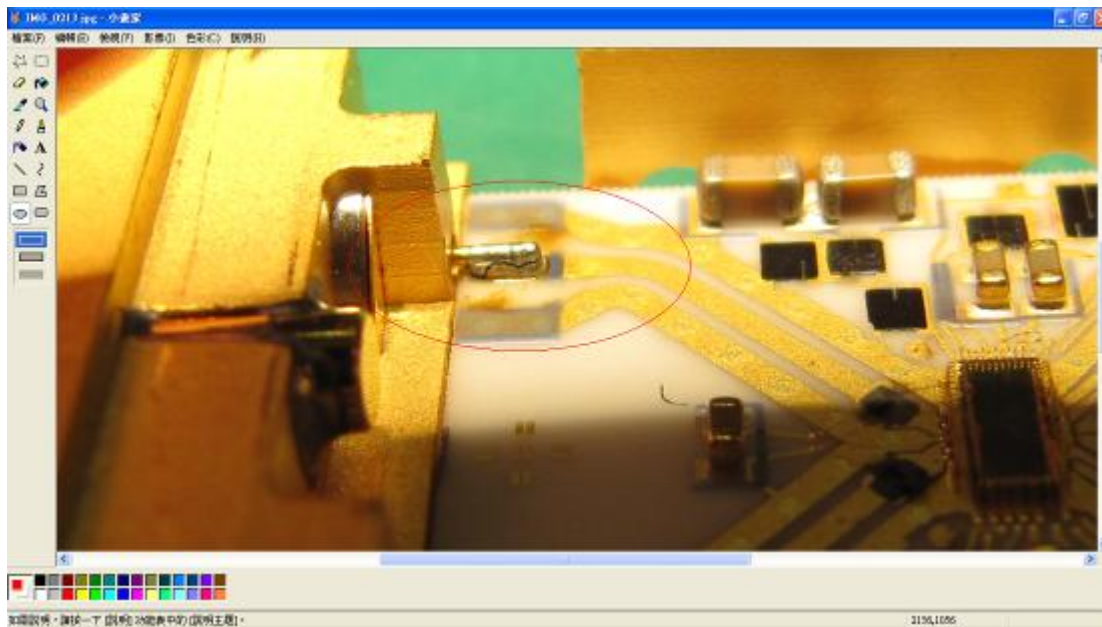
The above picture shows a fractured solder joint.

5. If you determine that the solder joint is fractured, bent, broken, or probe head parts stuck to a probe pin, replace with a new 01131-68701 probe amplifier. Charge the replacement cost to factory warranty.
