1132A-01B

## 1132A Infiniimax Probe Amplifier 5GHz

Serial Numbers: US00000000 up to and including US49410100

**Possible fractured solder joint on input pin**

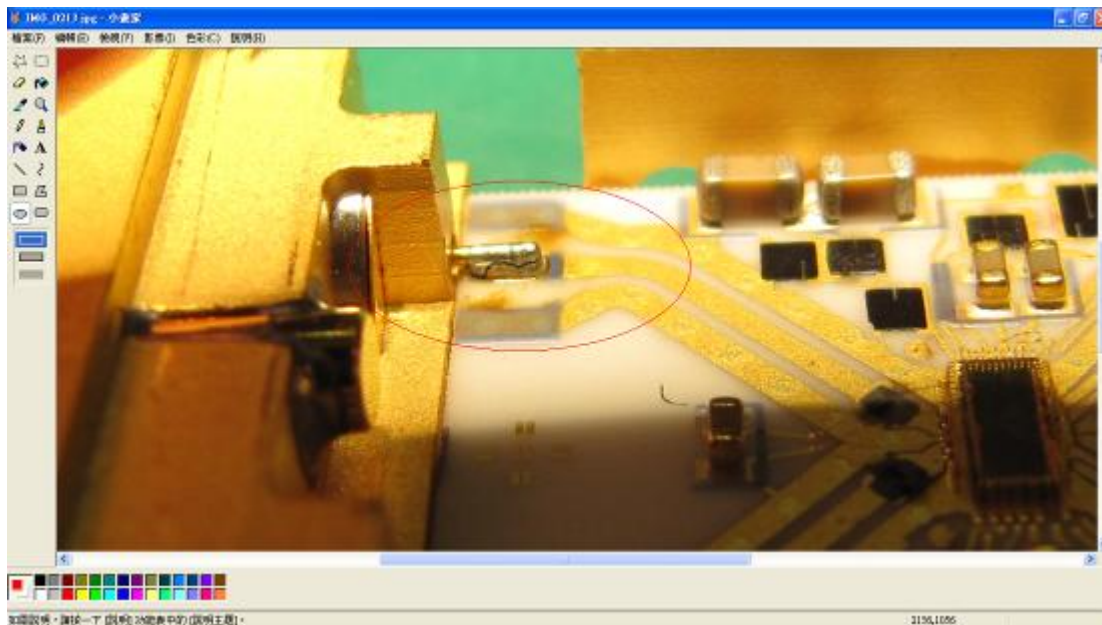
The above picture shows a fractured solder joint.

5. If you determine that the solder joint is fractured, bent, broken, or probe head parts stuck to a probe pin, replace with a new 01132-68701 probe amplifier. Charge the replacement cost to factory warranty.

If you find the above mechanical defects, replace with a new 01132-68701 probe amplifier.

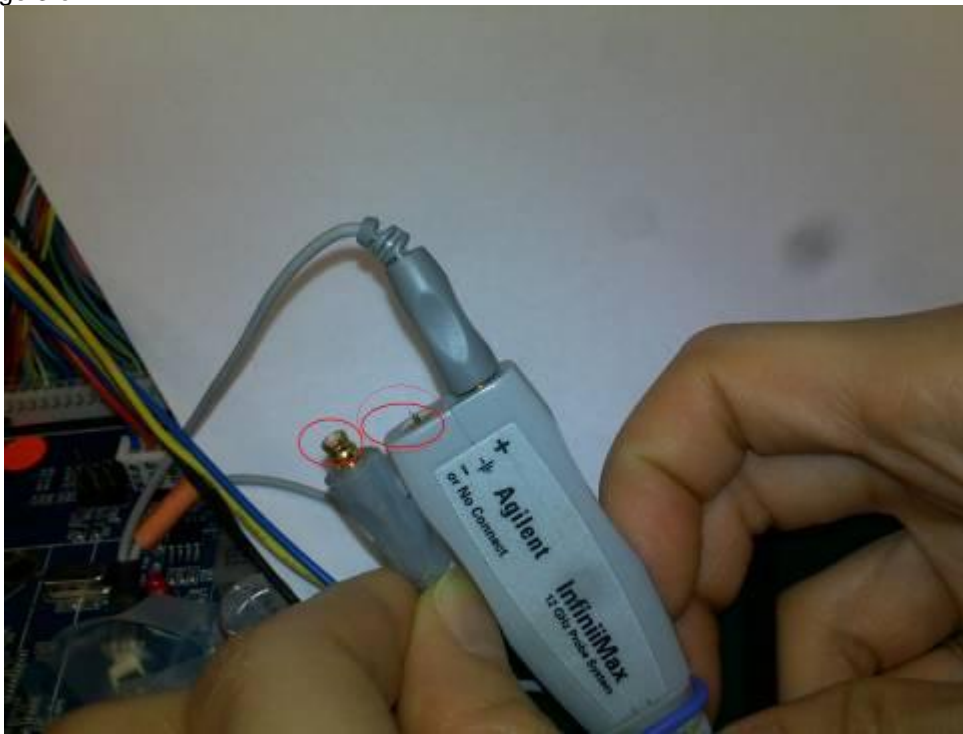
The above picture shows where the long pin of the probe amplifier actually got stuck in the female connector of the probe head. When the probe head was removed from the probe amp, part of the probe head female connector stuck to the probe amplifier pin and was pulled out.

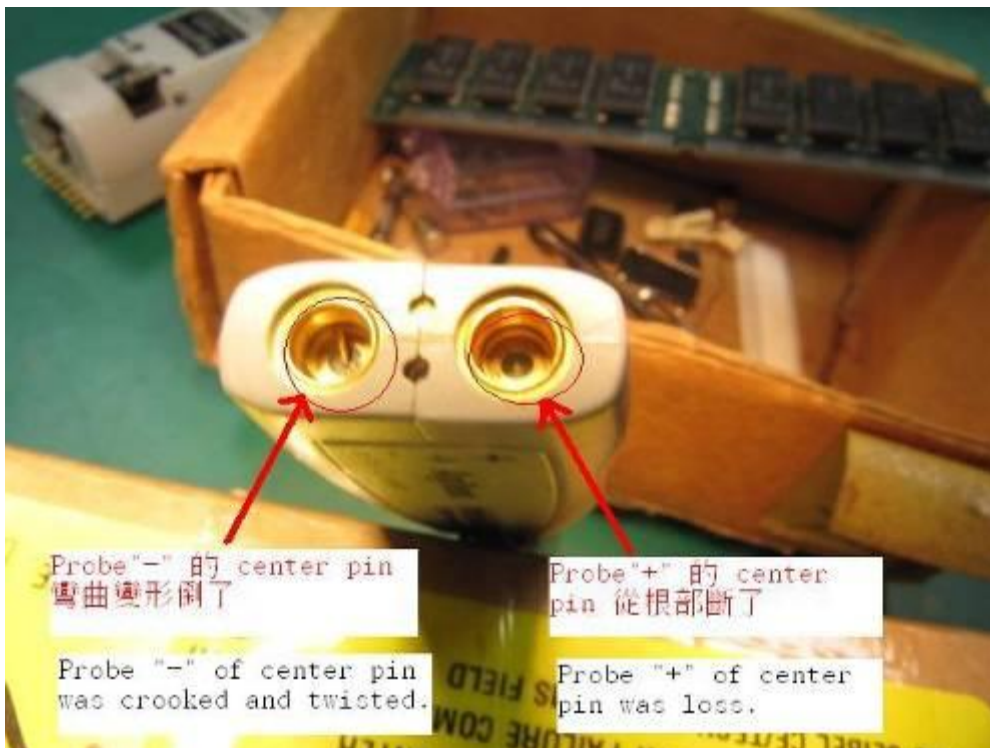
The above picture shows a bent male pin and a broken male pin. The longer male pin could cause the pin to bend or eventually break when connected to a probe head.
