1134A-01A

# S E R V I C E                      N O T E

## 1134A Infiniimax Probe Amplifier 7GHz

**Possible fractured solder joint on input pin**

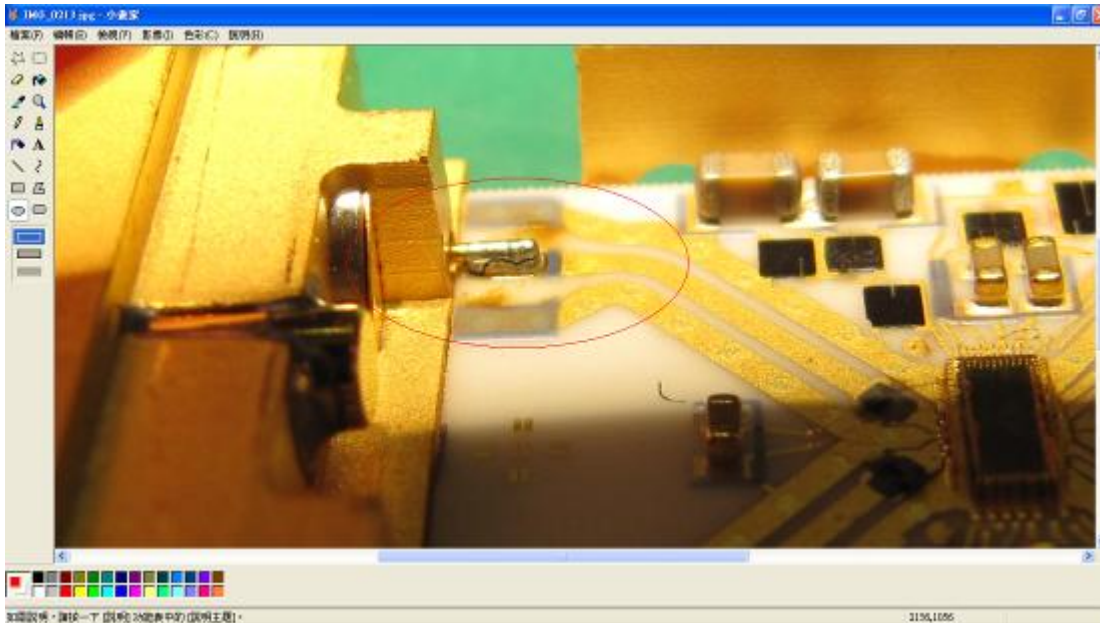
There is a possibility that the input pin solder joint may be fractured. You may also find the input pin bent, broken off, or stuck into the female connector of a probe head.

The above picture shows a fractured solder joint.

5. If you determine that the solder joint is fractured, bent, broken, or probe head parts stuck to a probe pin, replace with a new 01134-68701 probe amplifier. Charge the replacement cost to factory warranty.
