**1168A-01B**

# **S E R V I C E N O T E**

## 1168A Infiniimax Probe Amplifier 10GHz

**Possible fractured solder joint on input pin**

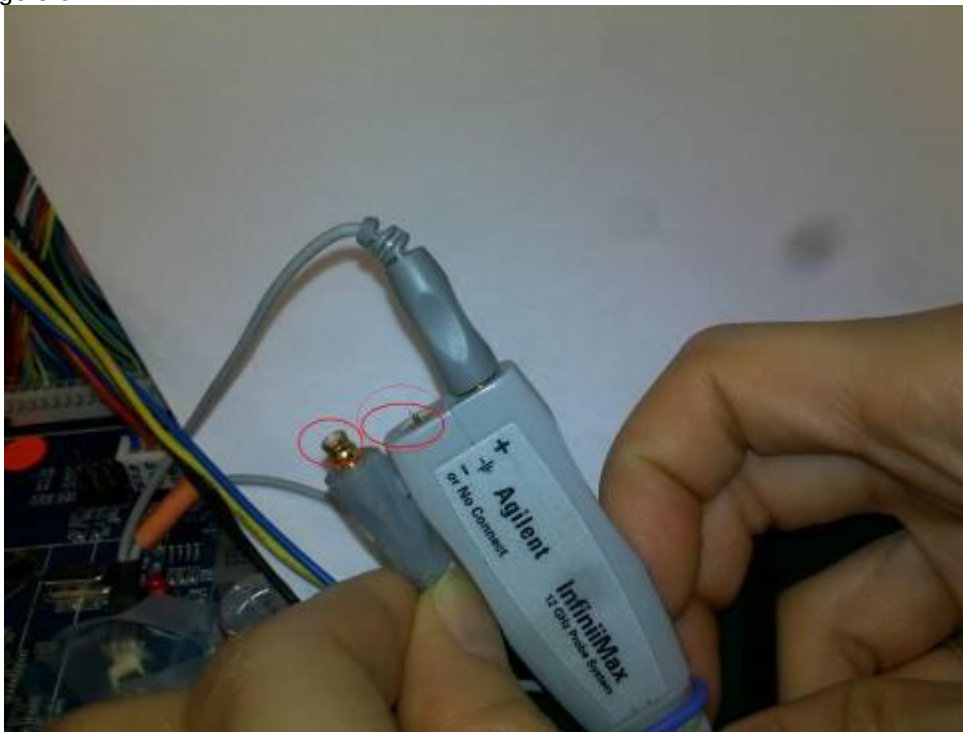
The above picture shows where the long pin of the probe amplifier actually got stuck in the female connector of the probe head. When the probe head was removed from the probe amp, part of the probe head female connector stuck to the probe amplifier pin and was pulled out.

5. If you determine that the solder joint is fractured, bent, broken, or probe head parts stuck to a probe pin, replace with a new 01168-68701 probe amplifier. Charge the replacement cost to factory warranty.

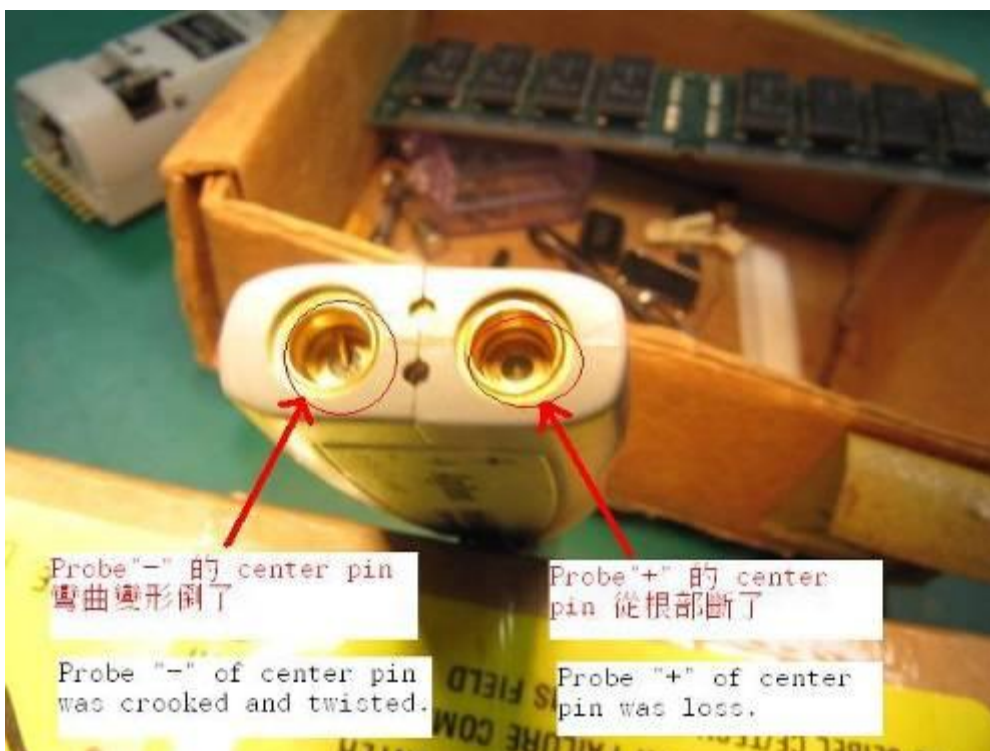
The above picture shows a bent male pin and a broken male pin. The longer male pin could cause the pin to bend or eventually break when connected to a probe head.
