# Modification Recommended Service Note

Supersedes:  
11713E-01

## 11713E Attenuator / Switch Driver

Serial Numbers: MY60050108 to MY61410384

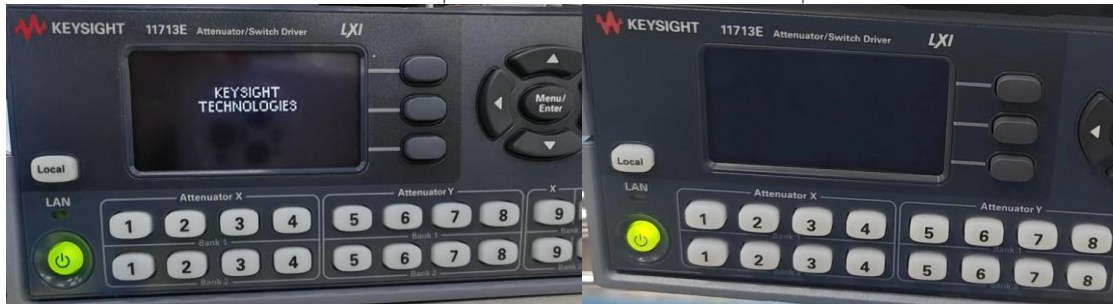
The instrument is unable to boot up and is stuck on the boot-up screen as follows. It is not functioning.

Replace PPMC board P0600-63004 with Programmed PPMC board serial number P06006300423**2413**000007 onwards where 13 is the work week and 24 is the year.

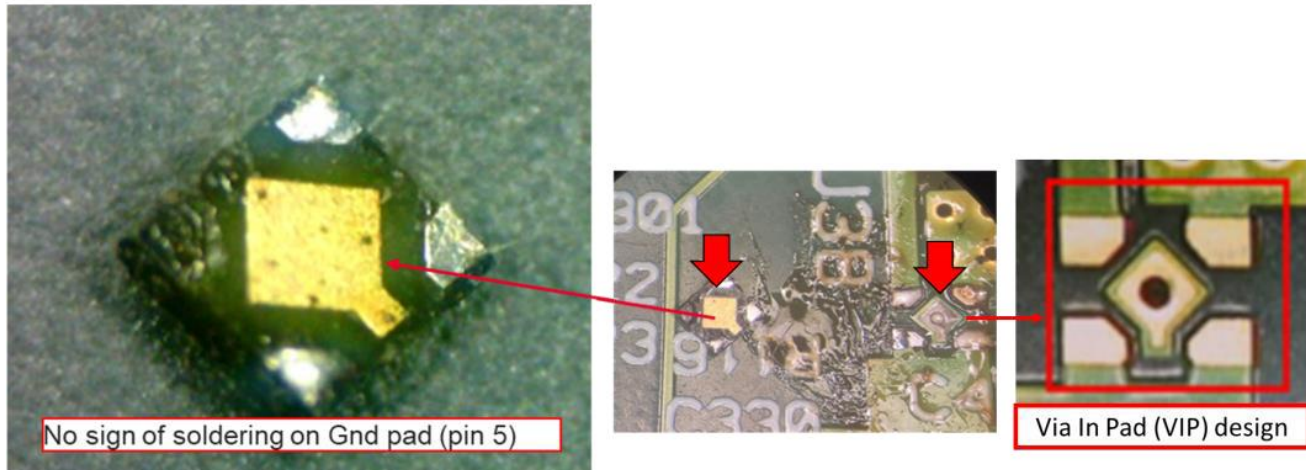
Failure analysis had indicated defective on P0600-63004 board where insufficient solder was observed at 2 locations. The insufficient solder was due to Via in Pad (VIP) where the melted solder had flown to the secondary side of the PCB.

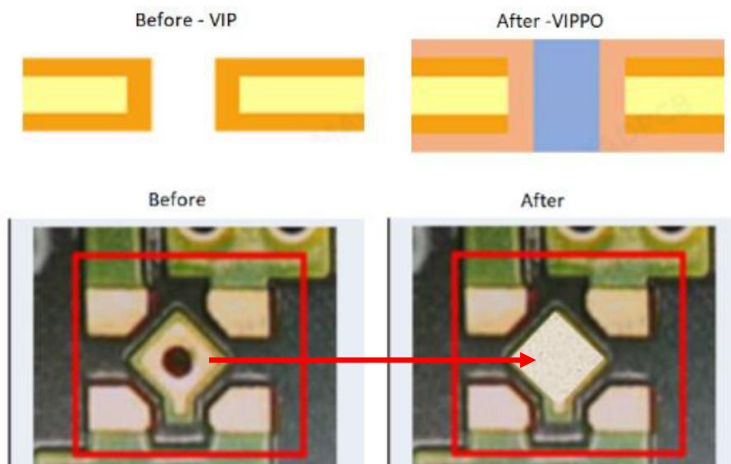
The improvements were made from Via in Pad (VIP) to Via in Pad Plated Over (VIPPO) as per below.

The improved PPMC board have Serial number P06006300423**2413**000007 onwards.
