3070-70-S

S E R V I C E N O T E

Agilent Technologies 3070 and 79000 Board Test Systems

POSSIBLE FIRE HAZARD

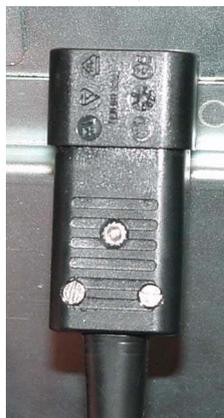
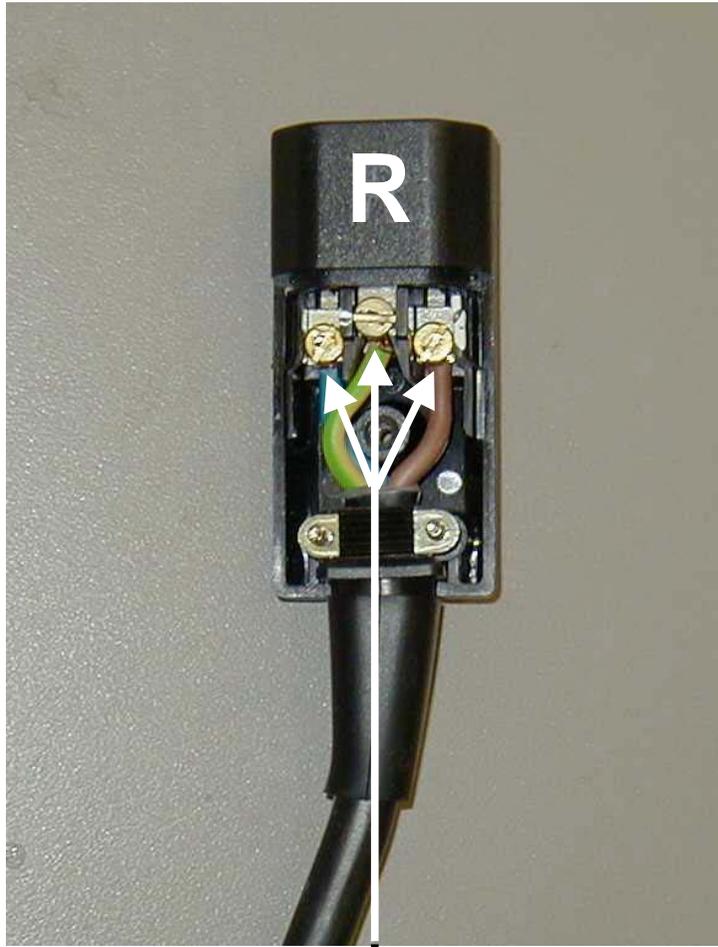
The 3070 system has a number of internal connections to power the MPU's and the Module Blowers that utilize an IEC-320 connector. The male plug has three flat blades in parallel with the ground blade off set from the line/neutral blades.

Note:
Screws torqued by the vendor, have an "R" stamped on the plug.

It has been discovered that some of the hard-wired plugs were not correctly installed on the power cord. The three internal wire attachment screws may not have been tightened correctly, which can result in intermittent connections and/or heat generation or arcing within the body of the plug.

Each Agilent 3070 system should be inspected for use of the hard-wired style connectors. Inspect the MPU power plugs and the Blower power cords.

If these are found, disassemble the plugs and check the wire attachment screws to assure that they are tight enough to clamp the wire to the terminal within the plug. The wire attachment screw's torque specification is 3.5 inch pounds (0.4 Newton-meters).

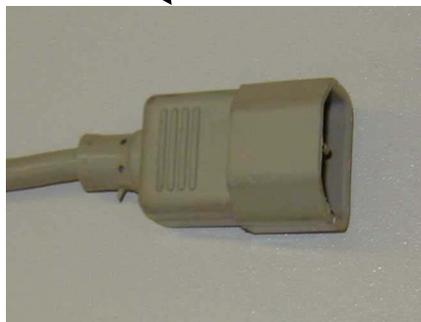
Note: Some 3070's shipped with molded connectors. These molded connectors have no known problems and need no action.
