3070-89

S E R V I C E N O T E

Agilent Medalist i3070 and i3070 Series 5 In-Circuit Test System

New Bootp file to solve the intermittent boot error with “Control XTPA” (N1807-66801) on Windows ® 7, software version 08.30pb.

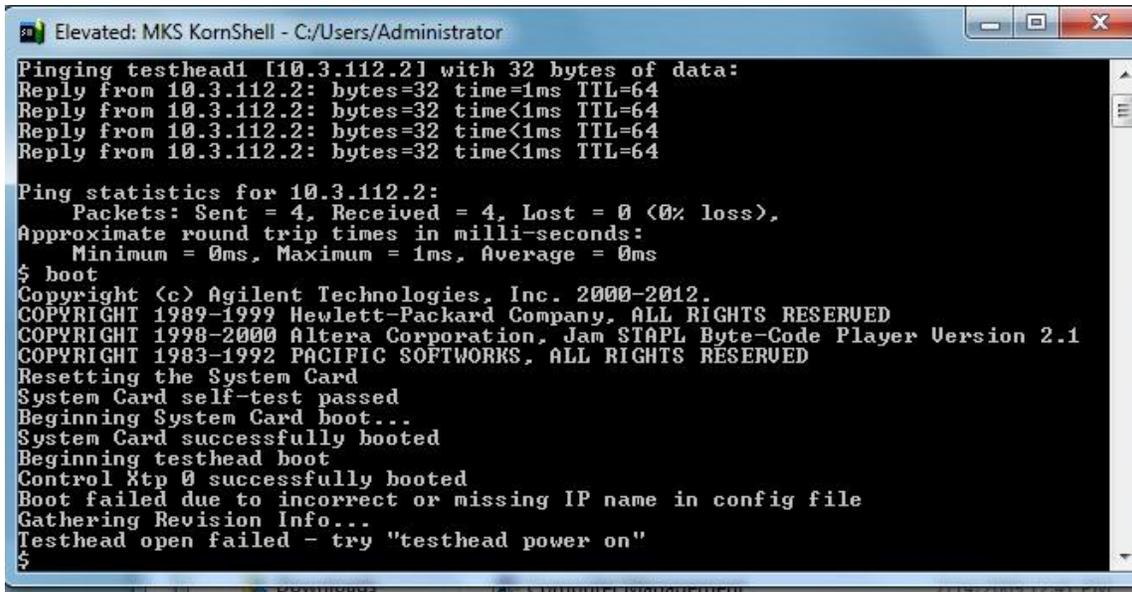
The intermittent boot error might occur with the Control XTPA card on Win 7 systems running software version 08.30pb.

If boot service is being restarted, some systems may intermittently encounter boot problem with a failure message attached.

This problem usually goes away with subsequent re-boots.

Installing a newer version of BOOTP software could resolve the issue.

1. Download the "bootpt.exe" from www.agilent.com/find/i3070patches.
2. Back up the bootptab file at c:\Windows\system32\drivers\etc.
3. Go to control panel -> Programs and Features & Remove BOOTP Turbo software
4. To install the new version, double click on "bootpt.exe"
5. Follow the instruction to complete the installation.
6. Rename bootptab.org to bootptab in c:\Windows\system32\drivers\etc
7. Restart the PC.
