# Modification Recommended Service Note

## Keysight i3070 Series 5 In-Circuit Test System

**The Problem** – The i3070 Series 5 In-Circuit Test System that testhead rotation motor may not grounded properly to the testhead frame/chassis.

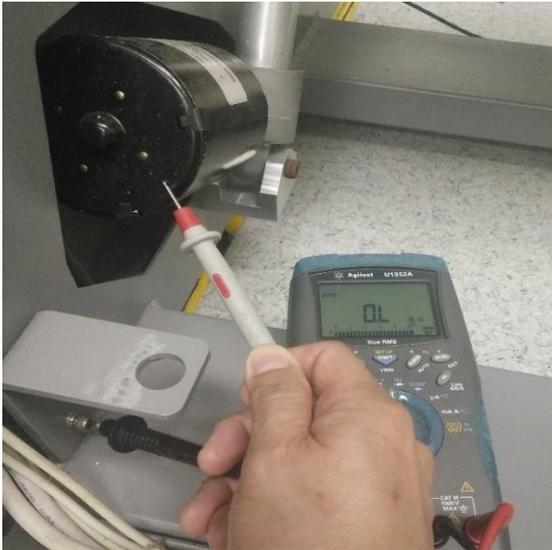
The i3070 Series 5 In-circuit system controller that the testhead rotation motor may not grounded properly to the testhead frame/chassis.

Figure 1: Measure between motor body (alum metal) and chassis screw

It is recommended that user to perform grounding check between motor screw and chassis screw as shown in the pictures below. If the reading found to be “OL” (open circuit), it is recommended to perform the Action described below.

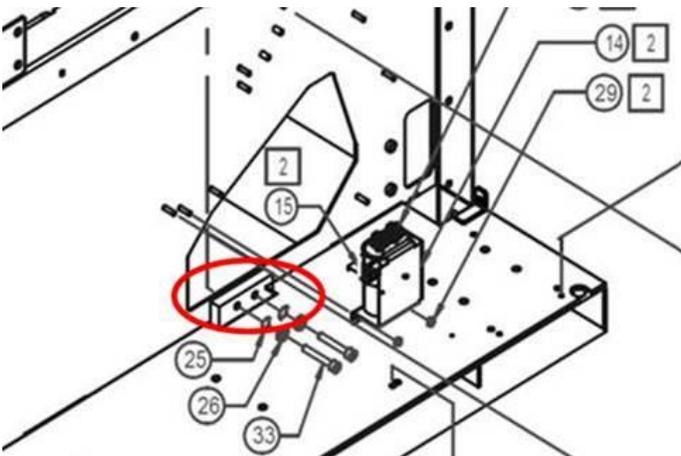
The root cause could be the hole (red circle areas) may be covered by the paint and causing measurement to be “OL”. After the paint was removed from the hole and measurement reading is 0.5 ~ 0.8.

Figure 2: Screws and screw hole location

1. Remove the cover near the PDU to access to the screw hole.
2. Remove motor bracket mounting calves.
3. Remove the two screws.
4. Use "File" as tools to remove the paint from the both screw track.
5. Then tighten back both screws.
6. Use multi-meter to ensure connectivity within 0.5 ~ 0.8.
7. Place back the motor bracket mounting calves
