33220A-02C

S E R V I C E N O T E

33220A 20 MHz Function/Arbitrary Waveform Generator

Encoder May Be Subject to Early Failure

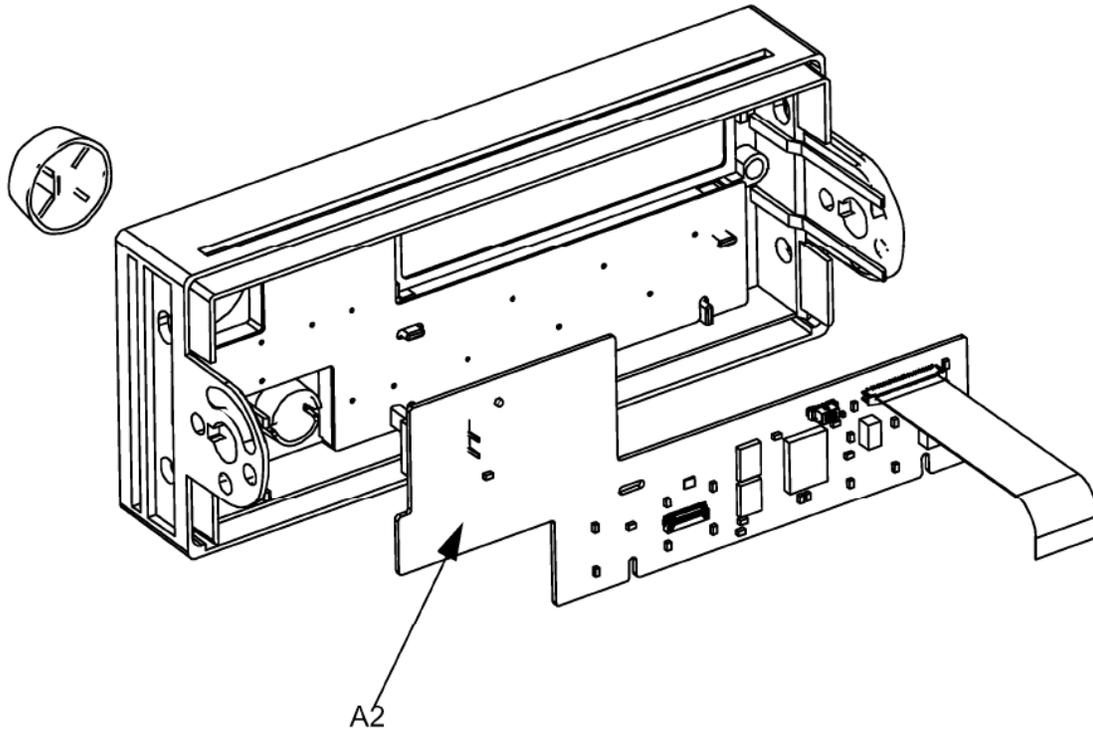
Mechanical encoders need to be replaced as they wear out with use, resulting in erratic knob behavior. Agilent has determined some 33220A encoders have been subject to early failure.

3. Pull to remove the knob. Lift out the keyboard PC board (A2 assembly).

4. Replace the following assemblies:
 - A2 front panel board, part number 33220-66512
 - Support plate, part number 33220-04112
