SN 34401A-13E

S E R V I C E N O T E

34401A 6 ½ Digit Digital Multimeter

**The Problem – Temperature drift out of accuracy specification on 3 Amp
DC/AC current range**

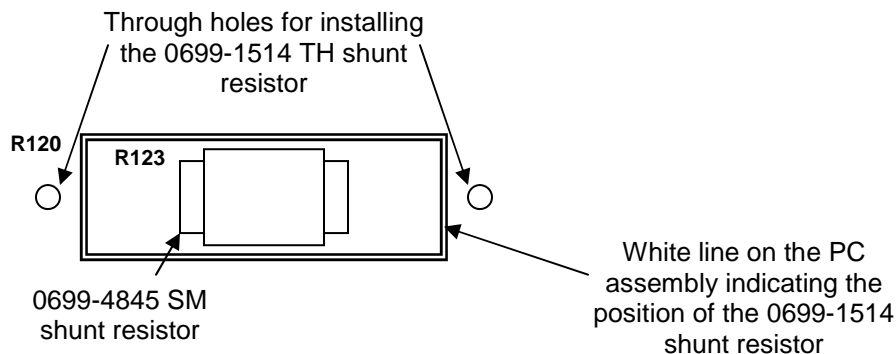
Layout diagram on the PC assembly

The 0699-4845 shunt resistors used on 34401A 3 Amp DC/AC current range may have a temperature coefficient which is higher than the required value. This will cause the voltage drop across the shunt resistor to drift out of specifications while measuring continuous current levels above 2 Amp (for example, >30 sec at 3 Amp). However, this measurement drift does not affect current measurements using the 10 mAmp, 100 mAmp, or 1 Amp current measurement ranges, nor will it affect 3 Amp DC/AC range measurements if they are not made continuously for >30 seconds.

The 0699-4845 shunt resistor should be removed and replaced by the through-hole shunt resistor 0699-1514. The following figure indicates the relative positions of the 0699-4845 shunt resistor and 0699-1514 shunt resistor. The 0699-4845 is an SMT component and should only be removed by a technician skilled in the repair of surface mounted components. Damage to the PC assembly can occur unless the proper tools are used to remove the shunt resistor. The PC assembly has undergone special washing to achieve High-SIR. Proper handling and reworking technique should be practice avoid contaminating the PC assembly which, could lead to performance related problems. The unit must be calibrated after replacing the 0699-4845 shunt resistor.
