34401A-16

# S E R V I C E N O T E

# 34401A Multimeter

<u>The problem</u>: The instrument may not show the correct voltage, when measuring a voltage in the range of -67 to -124 volts DC.

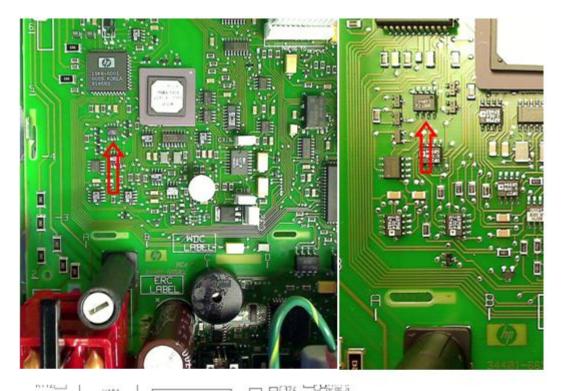
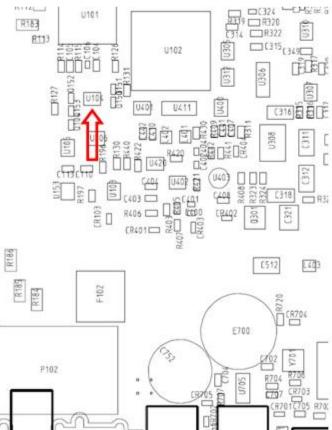
U104 should be removed and discarded. The picture below shows where U104 is located on the main board. The bottom of the pictures, are the back of the unit. You should replace U104 with part number 1826-8762. Standard SMT equipment and procedures should be used to prevent damaging the board. High Z processes need to be used as well to prevent degradation of the specifications. Exchange units are available if you are unsure of your capabilities in performing this repair. After the part has been changed the unit needs to be recalibrated.

1826-8762
 U104 OP Amp TI MPN(PA130UA)
 1
