34401A-17

# S E R V I C E N O T E

## 34401A - 6 ½ Digit Digital Multimeter

**The Problem – Temperature drift out of accuracy specification on 3 Amp DC/AC current range**

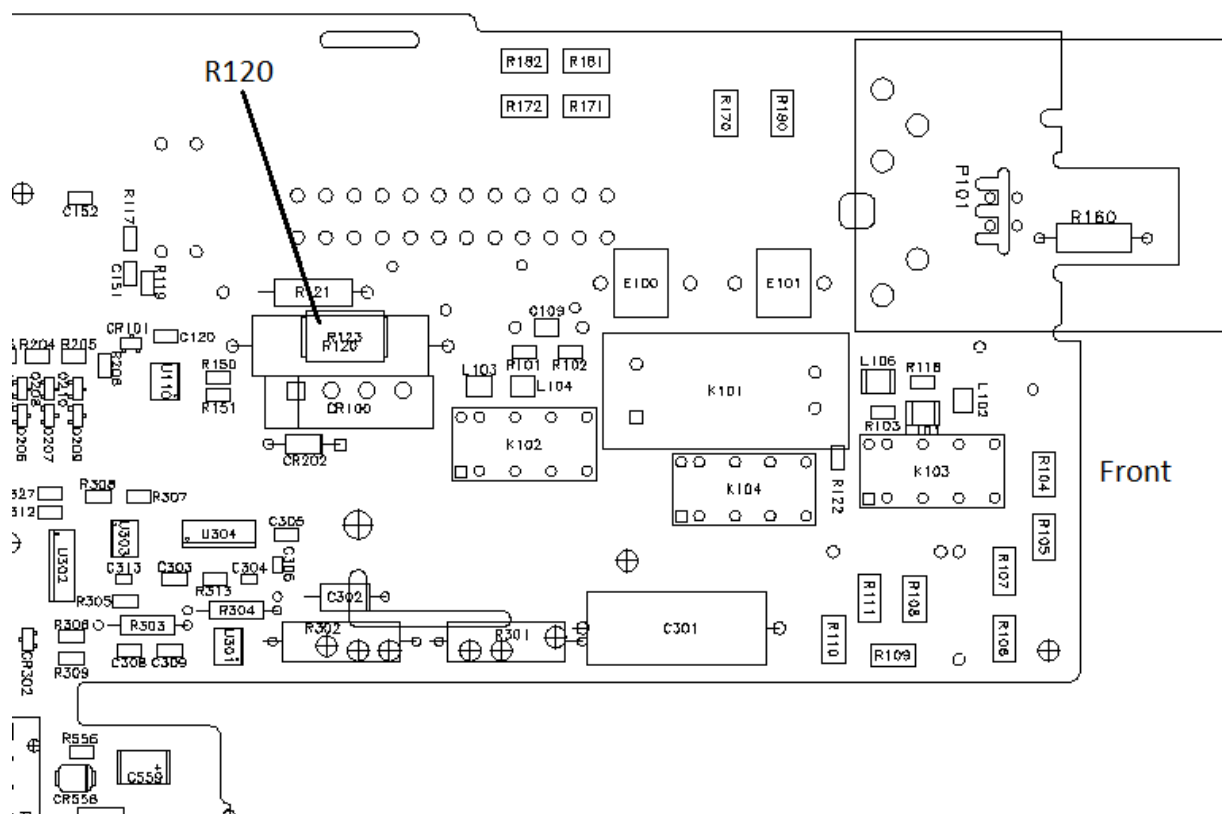
The 0699-1514 shunt resistors with date code 1107 used on 34401A 3 Amp DC/AC current range may have a temperature coefficient which is higher than the required value. This will cause the voltage drop across the shunt resistor to drift out of specifications while measuring continuous current levels above 2 Amp (for example, >30 sec at 3 Amp). However, this measurement drift does not affect current measurements using the 10 mAmp, 100 mAmp, or 1 Amp current measurement ranges, nor will it affect 3 Amp DC/AC range measurements if they are not made continuously for >30 seconds.

Refer to the 34401A component locator drawing on the next page. The old 0699-1514 shunt resistor should be removed and replaced by the new 0699-1514 resistor. The following figure indicates the relative position of the 0699-1514 shunt resistor. Damage to the PC assembly can occur unless the proper tools are used to remove the shunt resistor. The PC assembly has undergone special washing to achieve High-SIR. Proper handling and reworking technique should be practice avoid contaminating the PC assembly which, could lead to performance related problems. The unit must be calibrated after replacing the 0699-1514 shunt resistor.
