34401A-17A

**S E R V I C E**

**N O T E**

## 34401A - 6 ½ Digit Digital Multimeter

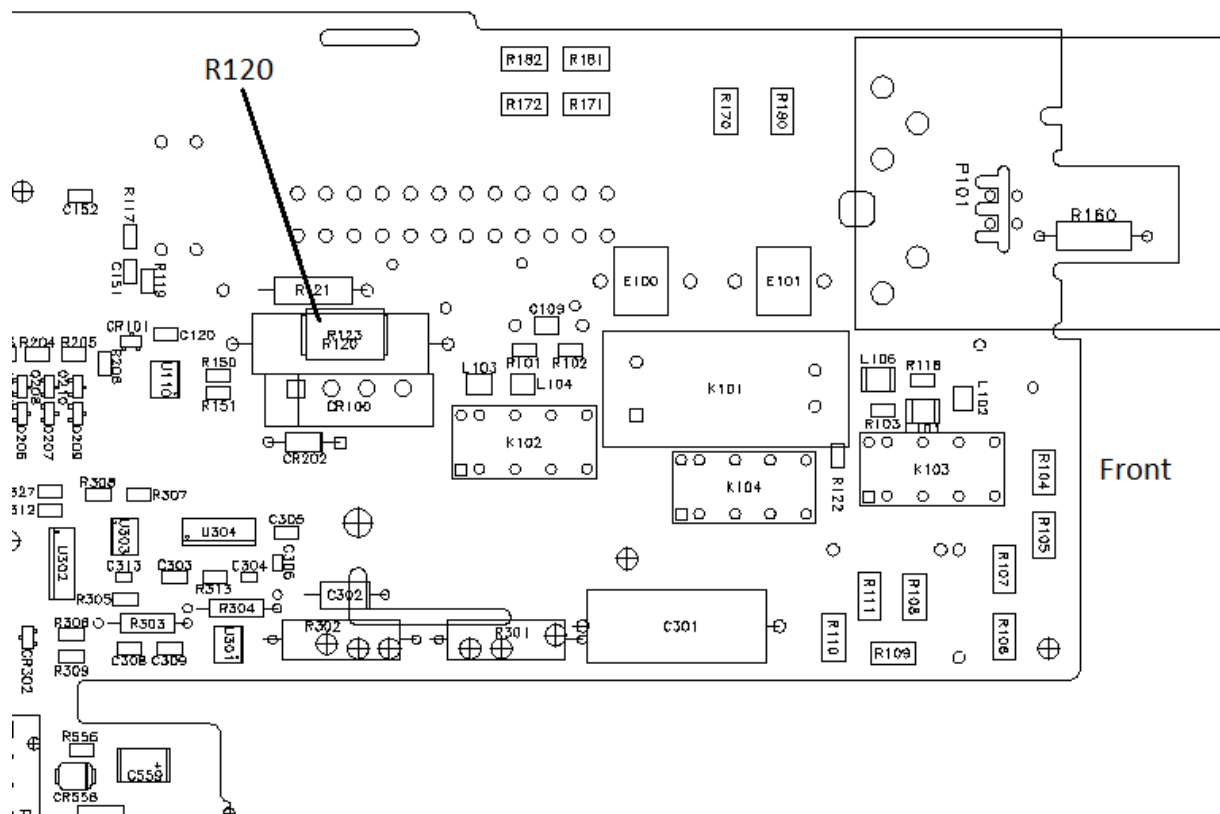
The 0699-1514 shunt resistors with date code 1107 used on 34401A 3 Amp DC/AC current range may have a temperature coefficient which is higher than the required value. This will cause the voltage drop across the shunt resistor to drift out of specifications while measuring continuous current levels above 2 Amp (for example, >30 sec at 3 Amp). However, this measurement drift does not affect current measurements using the 10 mAmp, 100 mAmp, or 1 Amp current measurement ranges, nor will it affect 3 Amp DC/AC range measurements if they are not made continuously for >30 seconds.

Refer to the 34401A component locator drawing on the next page. The old 0699-1514 shunt resistor should be removed and replaced by the new 0811-6669 resistor. The following figure indicates the relative position of the 0699-1514 shunt resistor. Damage to the PC assembly can occur unless the proper tools are used to remove the shunt resistor. The PC assembly has undergone special washing to achieve High-SIR. Proper handling and reworking technique should be practice avoid contaminating the PC assembly which, could lead to performance related problems. The unit must be calibrated after replacing the 0699-1514 shunt resistor.
