3458A-01C

S E R V I C E N O T E

3458A Multimeter

A/D Linearity Improvement

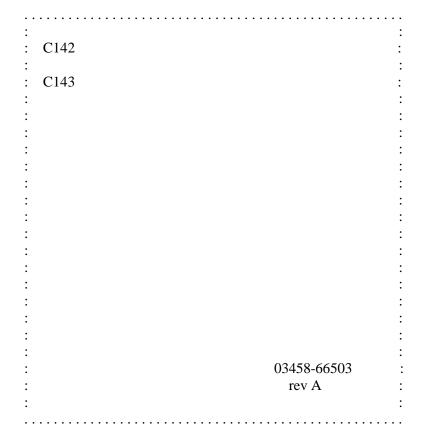
Component Locator Diagram for A3 Assembly (ERC < 2845)

Inspect all 3458A Multimeters with serial numbers < 2823A00700. If the A3 assembly (03458-66503, 03458-66513, or 03458-69503) has an ERC < 2845, then check to see if C142 and C143 have been updated to the 2.2 micro-farad capacitors (these parts are square parts with the leads coming out the bottom). The part is clearly labeled with 2.2 uf. If a 3458A needs updating then either do the steps listed as 1) or 2):

- 1) Replace C142 and C143 with Agilent Part Number 0160-0128. Then warm-up the 3458A for 3-hours, and perform ACAL ALL.
- 2) Replace the A3 PCA with a rebuilt PCA (03458-69503). Refer to the 3458A Miultimeter Assembly-Level Repair Manual for the removal/installation instructions. Following the up-grade, warm-up the 3458A for a minimum of 3-hours. Following the warm-up perform the following adjustments:
- --Front and Rear Terminal Offset Adjustments
- -- DC Gain Adjustments
- --Resistance and DC Current Adjustments
