SUPERSEDES
3570A-3

-hp- Model 3570A Network Analyzer

Serial Number: All

REPLACEMENT PARTS CHANGES

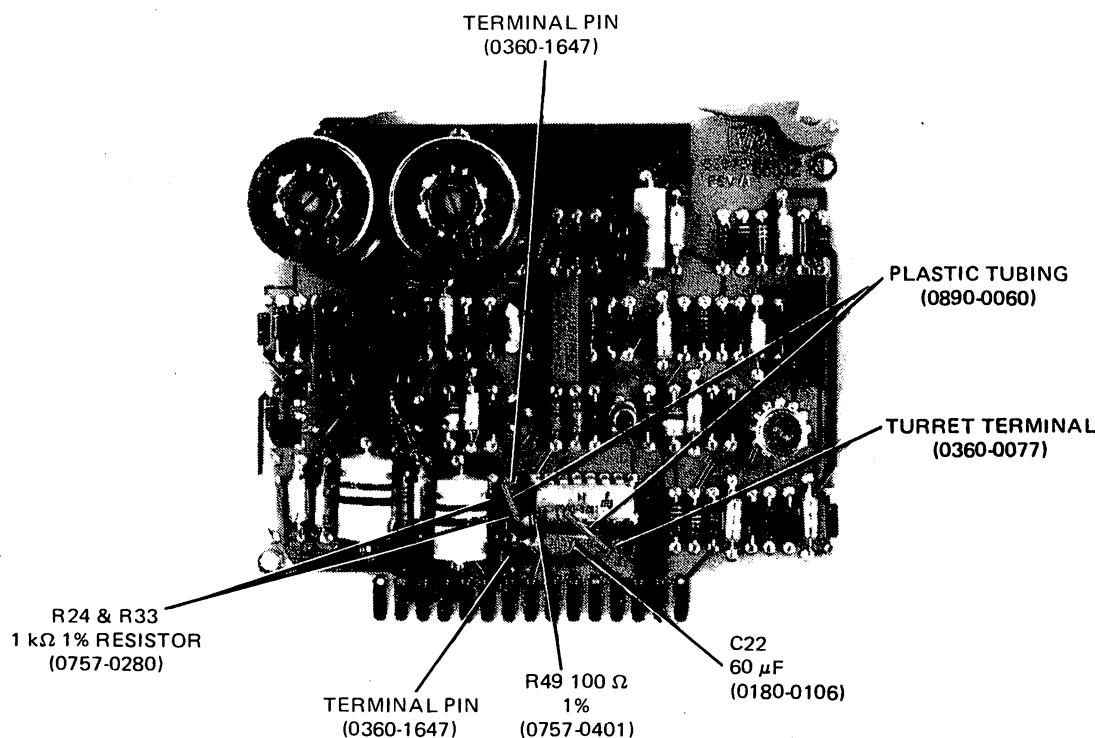
If you replace the old style A1/A7 Input Amplifiers of your 3570A with two new style input Amplifier Boards (03570-66551, 50 ohms, or 03570-66558, 75 ohms), you must modify the existing A2 and A18 Mixer/IF Amplifier Boards. Any Rev. B Mixer/IF Amplifier Board can be modified by simply changing A2/A18R24 and R33 from 75 ohm resistors to 1 kilohm 1% 1/8 watt metal film resistors (-hp- Part No. 0757-0280), and replacing A2/A18R49 (100 ohm 1% metal film resistor, -hp- Part No. 0757-0401). R49 would have been removed per the instructions of the previous paragraph and during a repair replacement of the Mixer/IF Amplifier. Revision A Mixer/IF Amplifier Boards must be modified more extensively.

Figure 1. Modified Mixer/IF Amplifier

1. A2/A18R24 should be changed from a 75 ohm resistor to a 1 kilohm 1% 1/8 watt metal film resistor (-hp- Part No. 0757-0280).
2. A2/A18R33 should be removed. Solder a terminal pin (-hp- Part No. 0360-1647) into each of the two holes used by R33 (short end of pin through the board).

3. Connect a 1 kilohm 1% 1/8 watt metal film resistor (-hp- Part No. 0757-0280) between the two terminal pins installed in Step 2.
4. Install a brass turret terminal (-hp- Part No. 0360-0077) approximately 1/4" directly below U2 pin 15. Use a number 51 (.0670") bit to make a hole for the turret. Flange out the bottom of the turret terminal so it is held firmly in the circuit board.

5. Solder a 60 μ F capacitor (-hp- Part No. 0180-0160) between the bottom terminal pin installed in Step 2 (the pin connected to pin 7 of the Mixer&IF Amplifier Board) and the terret terminal installed in Step 4. Cut off any excess lead.

6. Place plastic tubing (-hp- Part No. 0890-0060) on both ends of a 100 ohm 1/8 watt 1% metal film resistor (-hp- Part No. 0757-0401). Solder the resistor between the turret terminal installed in Step 4 and the upper terminal pin installed in Step 2.

7. All Rev. A Mixer/IF Amplifier Boards should now appear as in Figure 1. All Rev. B Mixer/IF Amplifier Boards should be modified as described previously.
