S E R V I C E N O T E

Agilent E4268A 120Hz/1kHz Capacitance Meter

Serial Numbers: JP1KF00101 / JP1KF00363

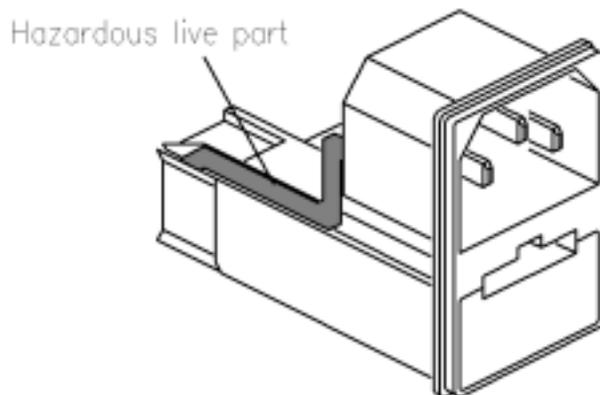
Figure 1. AC Line Connector

The AC inlet (P/N 1252-6951) has the potential to slip out of the instrument's rear panel slot if the AC power cord is forcefully pulled in a diagonal direction. When this happens, an exposed connection on the AC inlet module may touch the rear panel of the instrument and cause an electrical short if the AC power cord is still connected to the AC power outlet. See Figure 1.

In the worst case, there is also a possibility of an electric shock hazard to the user if the user completes a circuit between the instrument panel and another grounded connection while the AC power cord is still connected to the AC power outlet.

Solution 1. AC Inlet Still Intact.

- Remove the AC power cable from the AC power outlet and the product.
- Remove the top, bottom, and side covers.
- Seal the hot line terminal on the AC inlet with silicon paste (P/N 5183-4112).
- Reinforce the connection between the AC inlet and the rear panel with silicon paste.
- Perform Self Test to verify instrument operation.
