S E R V I C E N O T E

4284A Precision LCR Meter

Modification to prevent the 42841A Bias Current Source A4 board's fuses from blowing

DATE: December 1994

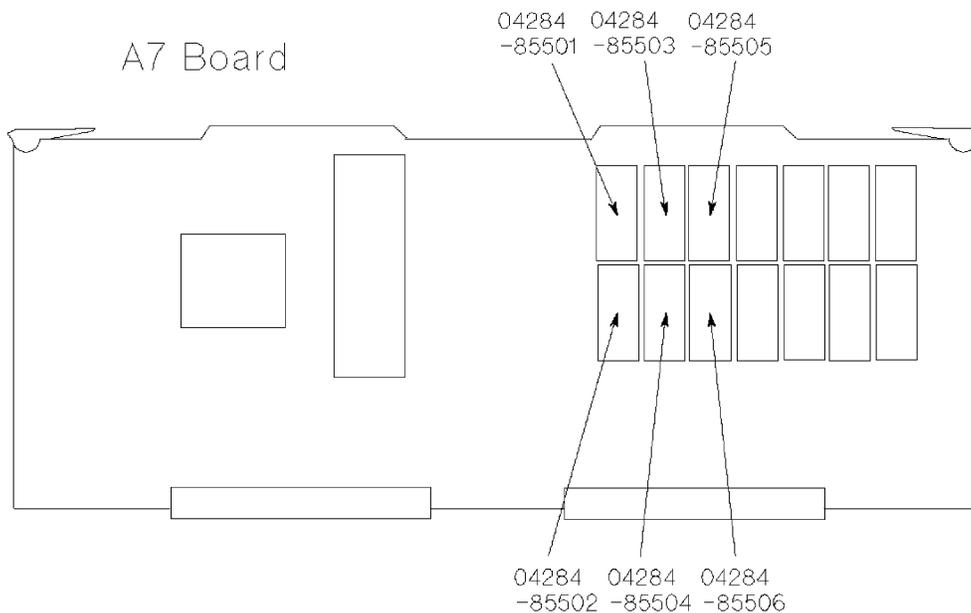
When the 4284A (firmware revision 1.11 and below) is used with the 42841A Bias Current Source, the 42841A fuses (A4F2, A4F3, A4F4, and A4F5) may sometimes blow because of a 4284A firmware bug. When A4F2/A4F3 blow, it causes there to be no bias current in the 1 A range, and when A4F4/A4F5 blow, it causes there to be no bias current in the 5 A range.

4284A ROM Replacement Procedure:

1. Remove the two feet located on the top of the rear panel to remove the top cover.
2. Remove the shield plate which doesn't have the warning message.
3. Remove the A7 digital control board, which has the black and violet board extractor.
4. Replace the ROMs with the new ROMS.
5. Reinstall the A7 board.
6. Turn the 4284A ON to confirm that the firmware version is 01.20. (The firmware version is displayed on the lower left side of the LCD at the start of the turn on process).
7. Replace the shield plate, the top cover, and the two feet.
