**4294A-02A-S**

# **S E R V I C E N O T E**

## **Agilent 4294A Precision Impedance Analyzer**

### **POSSIBLE ELECTRIC SHOCK HAZARD**

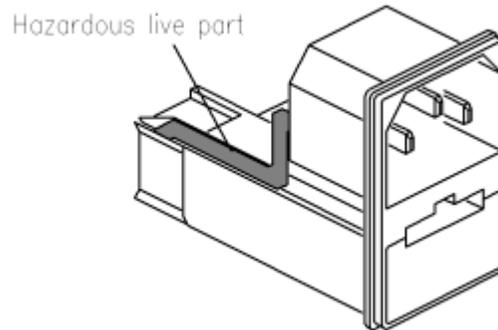
**Figure 1. AC Inlet Connector**

The AC inlet (P/N 1252-6951) has the potential to slip out of the instrument's rear panel slot if the AC power cord is forcefully pulled in a diagonal direction. When this happens, an exposed connection on the AC inlet module may touch the rear panel of the instrument and cause an electrical short if the AC power cord is still connected to the AC power outlet. See Figure 1.

In the worst case, there is also a possibility of an electric shock hazard to the user if the user completes a circuit between the instrument panel and another grounded connection while the AC power cord is still connected to the AC power outlet.

Since the required silicon seal P/N: 5183-4112 is obsolete, please proceed with "Solution2" by changing the whole rear panel assembly.

- Remove the AC power cable from the AC power outlet and the product.
- Remove the top, bottom, and side covers.
- Replace the rear panel assembly with P/N 04294-00213.
- Install the new fuse P/N 2110-1303.
- Perform Self Test to verify instrument operation.
