**4349B-05**

# S E R V I C E N O T E

## 4349B 4-Channel High Resistance Meter

### **Remedy for OVLD display due to incomplete soldering of capacitor on A1 board**

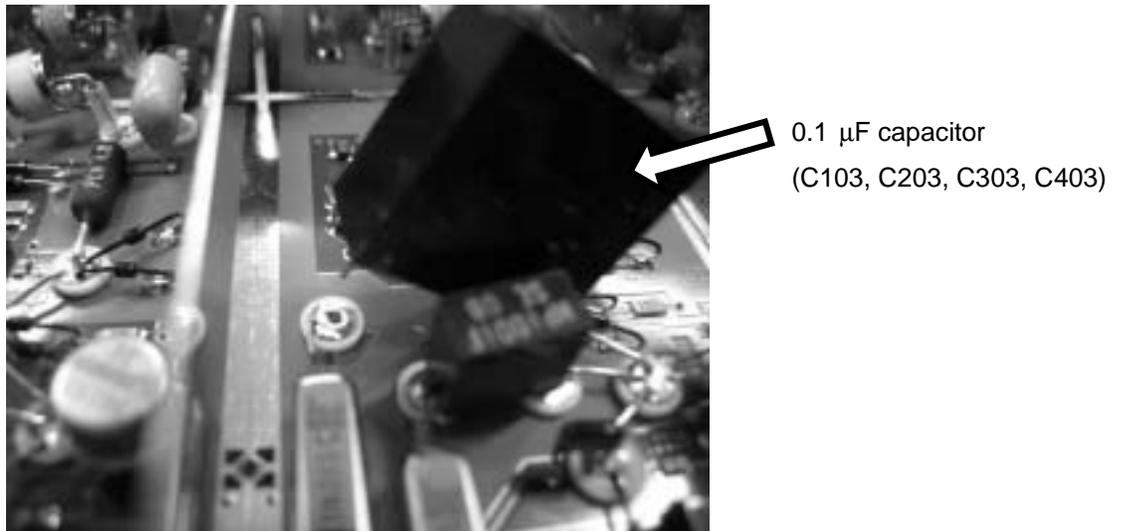
These 4349B units have possibility that one or some of 0.1  $\mu\text{F}$  capacitors C103, C203, C303 and C403 on the A1 board assembly is not firmly soldered to a multi-terminal on the board. If the capacitor lead is not completely soldered, the integrator at input stage malfunctions.

(See Figure 1 for an example of capacitor, which was easily pulled out with this check.)

Figure 1. Example of capacitor which was easily pulled out with the check.

When the 4349B exhibits the aforementioned symptom, check the capacitors C103, C203, C303 and C403 on the A1 board for defective soldering. Try to pull up the capacitor located in the faulty measurement channel. If the capacitor lead is pulled out or not firmly soldered, replace the A1 board with new one.

Note: Re-soldering the capacitor should be avoided because the capacitor lead may not be easily soldered. In some cases, the length of capacitor lead may be too short.
