S E R V I C E N O T E

SUPERSEDES: 438A-14

HP 438A Power Meter

**Modification to Eliminate Loose Reference Oscillator
N-type connectors**

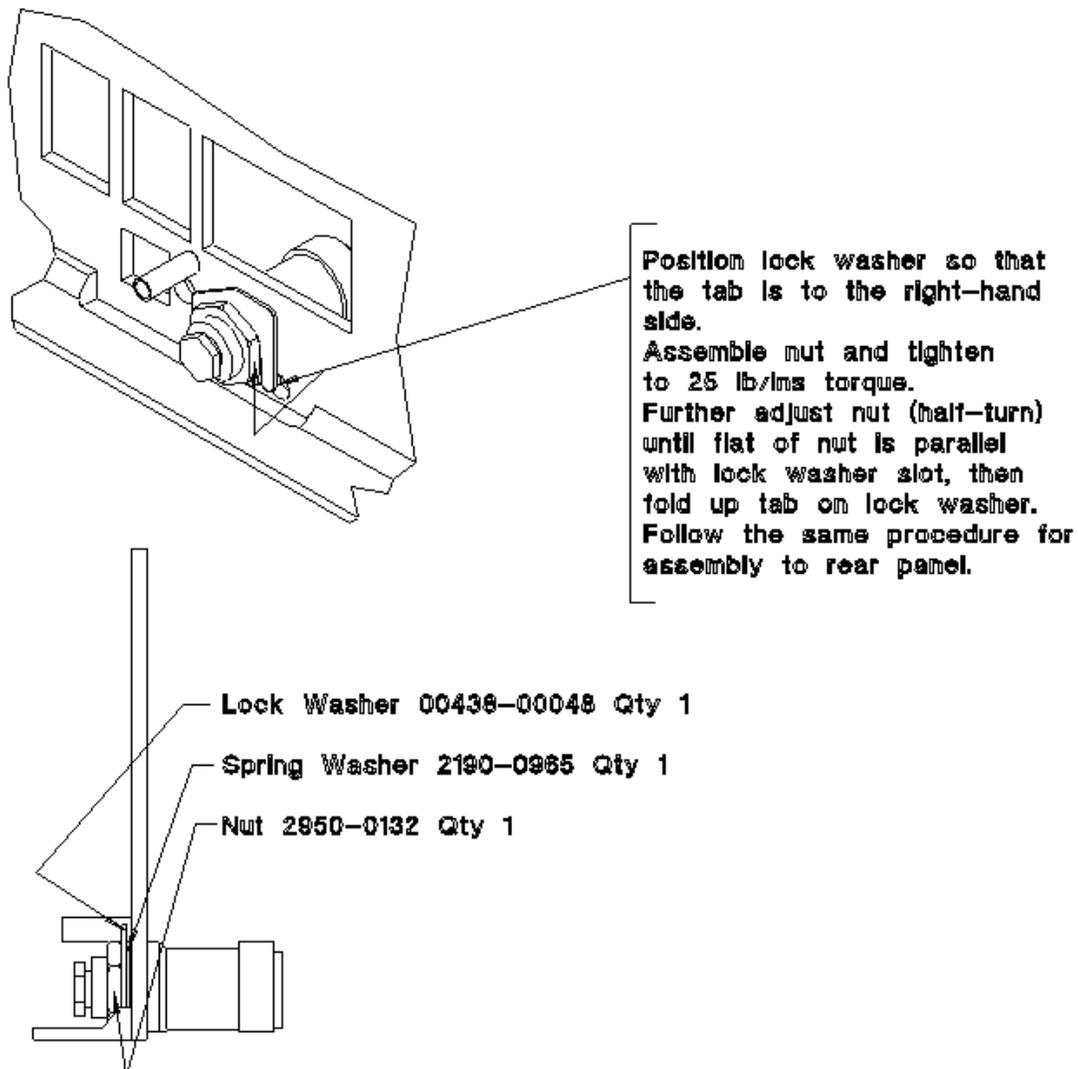
Multiple connections of power sensors to the Reference Oscillator, together with the weight of the sensor, have been causing lateral movement on the connector which has distorted the mounting hole on the front panel. This has in turn allowed the retaining nut to rotate backwards and make the connector even looser. Tightening the nut has fixed the problem in the past but the problem has re-occurred in some instances because the front panel hole distortion still exists.

A new fixing mechanism has been introduced which includes a spring washer and a lock washer. If the hole distortion occurs these two washers ensure that the nut remains under tension and cannot rotate. The connector therefore does not come loose. The instrument will need to be stripped down to give access to the rear of the Reference Oscillator connector on the front or rear panel. See Figure 1. for instructions on how to put on the new fixing hardware.
