S E R V I C E N O T E

Agilent 4396B RF Network/Spectrum Analyzer

Serial Numbers: JP1KE00101 / JP1KE00865

DATE: September 2000

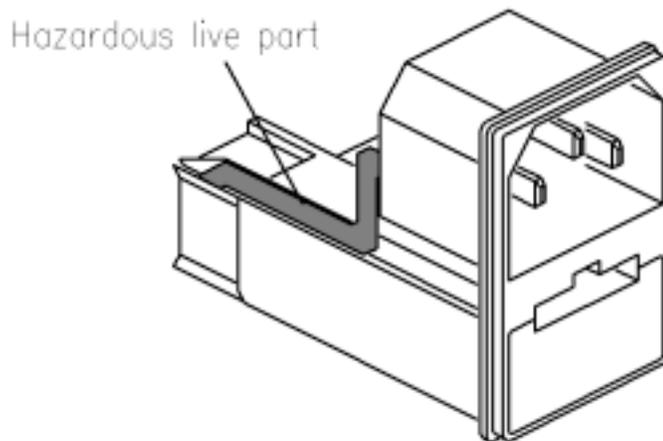
The AC inlet (P/N 1252-6951) has the potential to slip out of the instrument's rear panel slot if the AC power cord is forcefully pulled in a diagonal direction. When this happens, an exposed connection on the AC inlet module may touch the rear panel of the instrument and cause an electrical short if the AC power cord is still connected to the AC power outlet. See Figure 1.

Figure 1. AC Inlet Connector

In the worst case, there is also a possibility of an electric shock hazard to the user if the user completes a circuit between the instrument panel and another grounded connection while the AC power cord is still connected to the AC power outlet.

Solution 1. AC Inlet Still Intact.

- Remove the AC power cable from the AC power outlet and the product.
- Remove the top, bottom, and side covers.
- Seal the hot line terminal on the AC inlet with silicon paste (P/N 5183-4112).
- Reinforce the connection between the AC inlet and the rear panel with silicon paste.
- Perform Self Test to verify instrument operation.

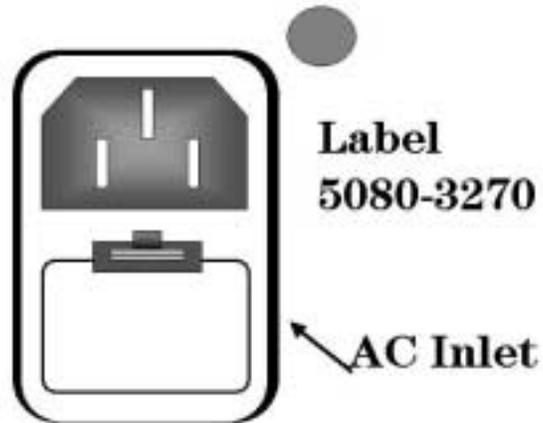
Fig. 2

Figure 2. Repair Completed Label

After completing the above instructions, stick the label (P/N 5080-3270) next to the AC Inlet on the rear panel as a mark that this repair has been completed. See Figure 2.
