S E R V I C E N O T E

4957A Protocol Analyzer

PC Assy/04957-66503/66504/66505/66506/U30

Modification to Stop Monitoring and/or Simulating

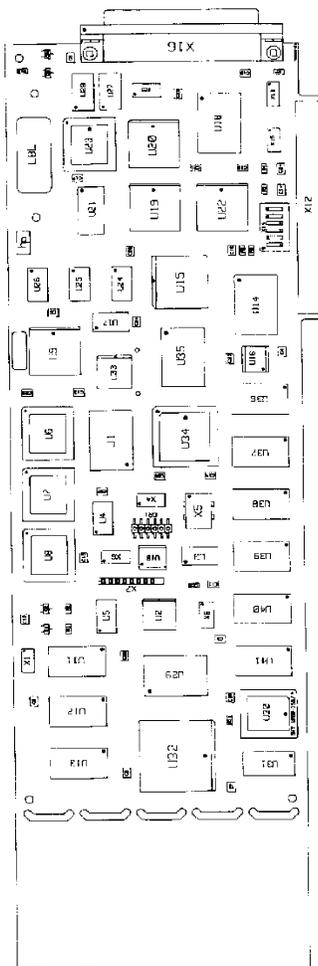
Fig. 1

The 4957PC has a problem working with the 18281A ISDN Basic Rate Interface. The problem occurs when using the 4957PC/18281A in a monitor or simulate run mode. The monitoring or simulating can be started, but can not be stopped by pressing the EXIT key. The only method of stopping the monitoring or simulating process is by cycling the power to the card.

4957PC Card
04957-66503/4/5/6

The ROM, U30, has been reprogrammed to fix this run mode problem. Using Figure #1, remove ROM U30, located in the lower left corner of the board, from its socket. The present part number will be either 04957-19007 or 04957-19015. Place the new ROM, p/n 04957-19034, in the socket. Place the PC card into a computer and run the HPTools application. At the top level menu of the 4957PC, press <MORE> and enter the Self Test menu. Run the self test loop to verify the operations of the card.
