5DX-62-S

S E R V I C E N O T E

5DX Series I, II, 2L and 3 systems

POSSIBLE X-ray Emission HAZARD

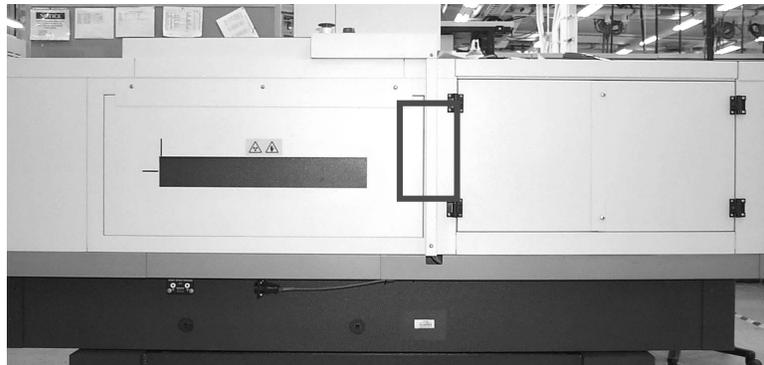
Figure 1: Right side of system

On the inside of the system near the outer barrier panels, there may be a rivet that in certain panel applications gets hit by the stage. Over time, the rivet is moved back and forth by the stage and can create an enlarged hole in the lead shielding of the cabinet. The rivet will eventually break off due to metal fatigue, and this could allow an X-ray emission above the Agilent specification.

Inspect the inside of the cabinet in the areas marked in red. Inspect the same areas of the cabinet for Series I and Series II Systems with loaders.

If a damaged or missing rivet is found in this area, perform a local X-ray Safety Test on the area. If the emission levels are above the Agilent specification, the system should be shut down according to the process in the X-ray Safety Test Report.

Order the Rivet Repair Consumables Kit (N7200-60008) and the Rivet Repair Tool Kit (N7200-69011) from GTLS and charge to warranty citing 5DX Service Note 62-S. Repair the rivet according to the provided procedure at an agreed upon time. After the kit is installed, complete a local X-ray Safety Test and document the repair and emission levels on the appropriate report. Charge labor to warranty as well.
