5DX-81B

S E R V I C E N O T E

5DX Series 2L, 3 and 5000 Systems

5DX Digital I/O Inspection Instructions for potentially PCA shorts

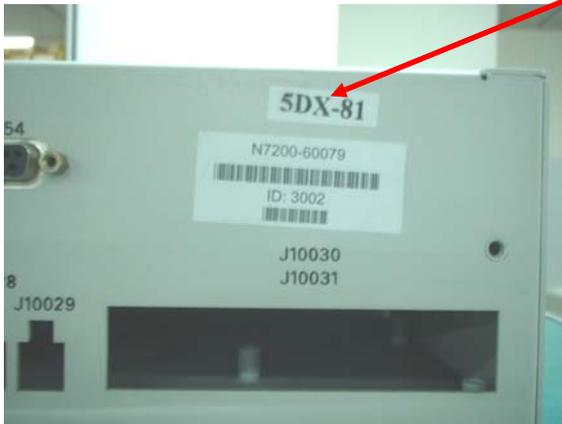
Photo 1

If the DGIO have either one of the following labels as shown in Photos 1 and 2 the Digital I/O has already been inspected.

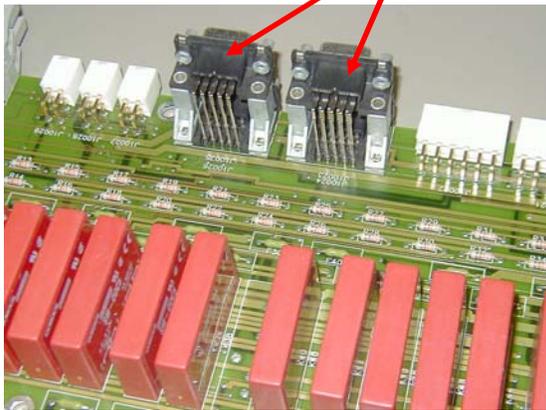
Once the panel cover has been removed, visually inspect the DB9 connectors in the back of the Digital I/O box (Connectors J10025 –J10028). See Photo 4 and Photo 5

Photo 4 (Good DB9 Connectors)

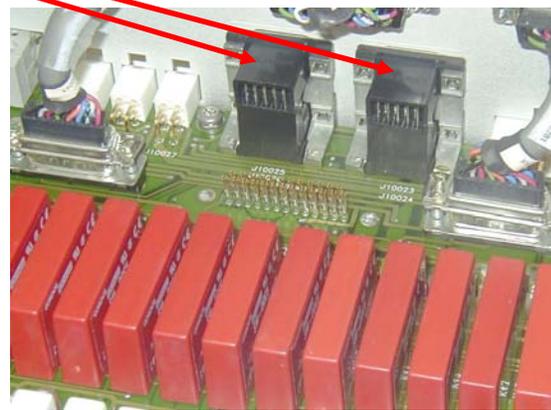
Recent problems in the field have been discovered related to the 5DX Digital I/O. We have traced this back to a different vendor manufacturing the E7200-66529 Digital I/O PCA. The vendor used a different type of stacked DB connector than the PCA was originally designed for. This newer connector, when mounted, has the potential to short out several of the trace vias underneath the connector. There are two problems that can occur:

1. This short can affect the Right outer Panel Clear Sensor. The sensor will not change state when shorted. This leads to panel handling errors and unexpected panel handling behavior (Panel will sometimes unload internally).
2. This short can affect the Rear SMEMA TR1 LED causing it to be stuck in the on state.

Photo 5
(Defective DB9 Connectors if no Kapton tape underneath)

Any N7200-60079 and N7200-69079 (Digital I/Os) with the black AMP DB9 connectors Photo 6 and without Kapton tape underneath are defective and should be replaced by Agilent Qualified Personnel. The defective material should be returned to SPD.

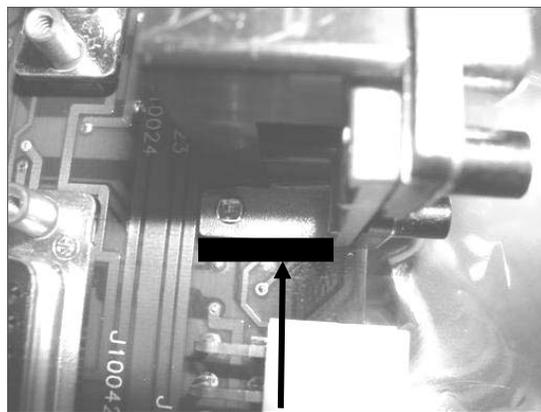
Note: Photo 7 shows the factory fix. The factory has added Kapton tape underneath the black connectors.
