66309B-08

# S E R V I C E N O T E

## 66309B - MOBILE COMMUNICATION DC SOURCE, DUAL-OUTPUT 15V/3A,12V/1.5A. GPIB

**Power-On Self test Errors, Auto reboot, Blank display. No output Communication errors. No communication when using the GPIB Interface.**

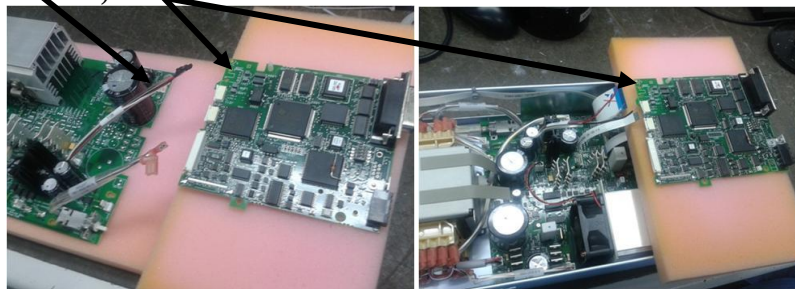
The cable P/N 5080-2452 coming from the control board should be disconnected for the mail connector (circuit reference) "J206" which is soldered on the interface board.

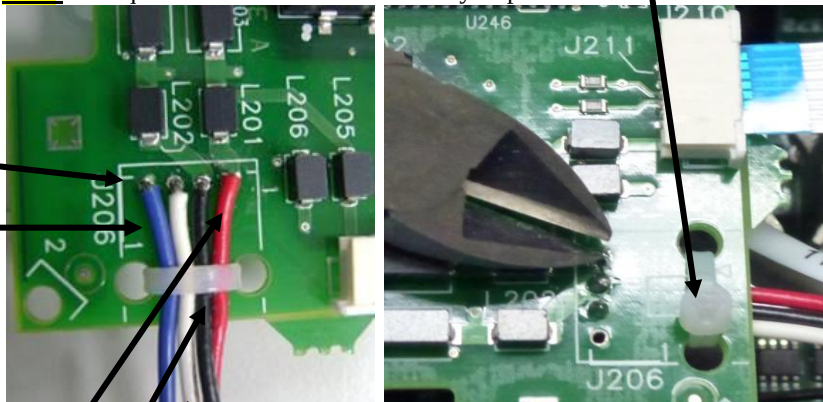
**Note** the sequence of the cable wires is very important!

1. Cold solder joints top and bottom of the assembly
2. Good solder fillets on the top and bottom of the assembly
3. Insure that all of the wire strands are in the holes provided and there are no shorts of solder or wire strands between each wire when soldered into the “A2” GPIB interface assembly.
4. Trim the lead make sure they are not over cut and no excessive leads are left.
5. Make sure that the instrument is clean of solder and wire strands and loose wires.
6. A Wide Nylon cable tie is required as shown to support the wires after the up-grade has been completed. Cut the excess Nylon of as shown.

The **Red** wire is soldered in the main control board (reference E320) and should be soldered into pin #1 or the square pad of “J206” on the “A2” interface assembly.

The **Black** wire is soldered in the main control board (reference E324) wire should be soldered into pin #2 of “J206” on the “A2” interface assembly. .

The White wire is soldered in the main control board (reference E321) should be soldered into pin #3 of “J206” on the “A2” interface assembly.
