66309D-07

# S E R V I C E N O T E

## 66309D - MOBILE COMMUNICATION DC SOURCE, DUAL-OUTPUT 15V/3A,12V/1.5A. GPIB

**Power-On Self test Errors, Auto reboot, Blank display. No output Communication errors. No communication when using the GPIB Interface.**

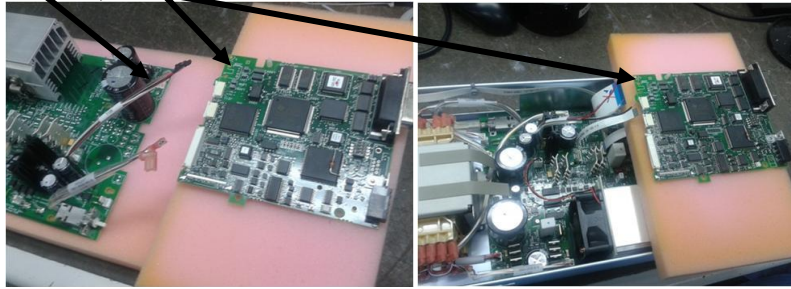
The cable P/N 5080-2452 coming from the control board should be disconnected for the mail connector (circuit reference) "J206" which is soldered on the interface board.
