66319B-08

# S E R V I C E N O T E

## 66319B - MOBILE COMMUNICATION DC SOURCE, DUAL-OUTPUT 15V/3A,12V/1.5A. GPIB

Serial Numbers: MY43003910 – MY43004590    SG43003910 – SG43004590

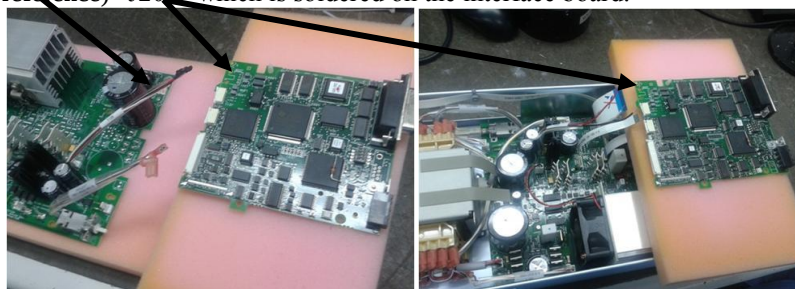
The instrument will exhibit the defects described above when the primary 5 volts drops below the design limits described. Poor crimping of the female connectors on the bias cable is the cause of the problem. The pictures below show in detail the female connectors having the problem.

The cable P/N 5080-2452 coming from the control board should be disconnected for the mail connector (circuit reference) "J206" which is soldered on the interface board.
