66319D-08

# S E R V I C E N O T E

## 66319D - MOBILE COMMUNICATION DUAL-OUTPUT DC SOURCE, WITH BATTERY EMULATION, DVM. GPIB.

Power-On Self test Errors, Auto reboot, Blank display. No output Communication errors.  
No communication when using the GPIB Interface.

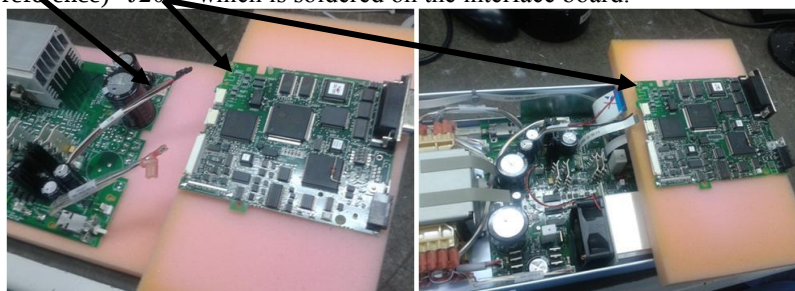
The cable P/N 5080-2452 coming from the control board should be disconnected for the mail connector (circuit reference) "J206" which is soldered on the interface board.

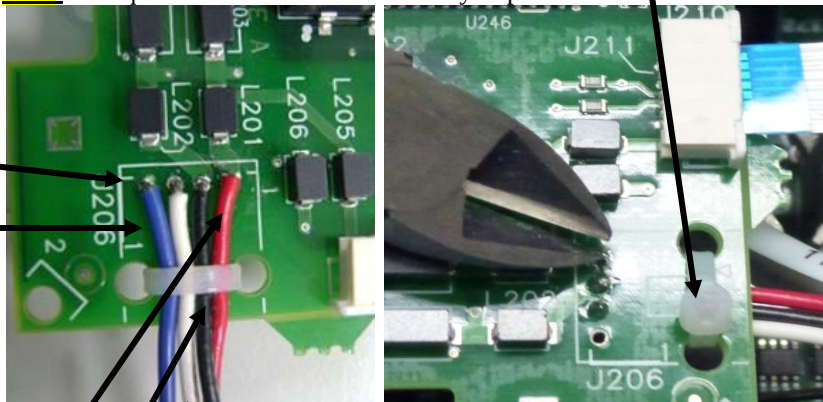
**Note** the sequence of the cable wires is very important!

1. Cold solder joints top and bottom of the assembly
2. Good solder fillets on the top and bottom of the assembly
3. Insure that all of the wire strands are in the holes provided and there are no shorts of solder or wire strands between each wire when soldered into the “A2” GPIB interface assembly.
4. Trim the lead make sure they are not over cut and no excessive leads are left.
5. Make sure that the instrument is clean of solder and wire strands and loose wires.
6. A Wide Nylon cable tie is required as shown to support the wires after the up-grade has been completed. Cut the excess Nylon of as shown.

The **Red** wire is soldered in the main control board (reference E320) and should be soldered into pin #1 or the square pad of “J206” on the “A2” interface assembly.

The **Black** wire is soldered in the main control board (reference E324) wire should be soldered into pin #2 of “J206” on the “A2” interface assembly. .

The White wire is soldered in the main control board (reference E321) should be soldered into pin #3 of “J206” on the “A2” interface assembly.

The **Blue** wire is required for the models shown below **ONLY**. This **Blue** wire comes from the connector on the battery emulation board P/N 5064-0131 circuit reference J001 Pin 12, the **Blue** should be soldered into pin # 4 of “J206” for the models listed below only. All other **66300X Mobile Comm DC Sources** only require 3 wires.
