6672A-10

S E R V I C E N O T E

**6672A - DC POWER SUPPLY, 0-20 V, 0-100 A, 2000 W.
GPIB CONTROLLED**

The four filter capacitors circuit reference (C416-C419) on the A4 AC input board starts leaking electrolyte

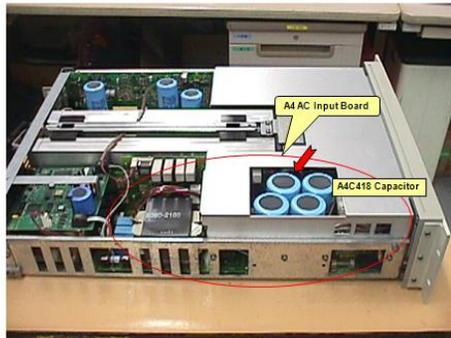
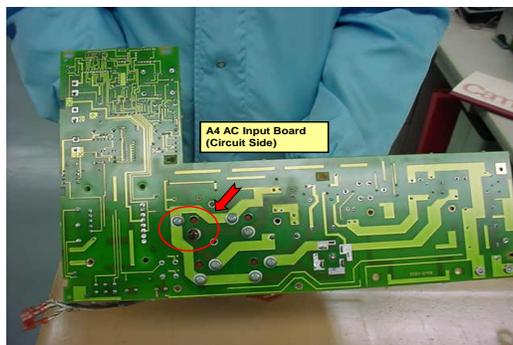
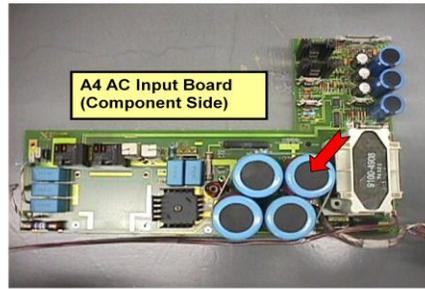
The four filter capacitors circuit reference (C416-C419) on the A4 AC input board starts leaking electrolyte - not through the pressure valve in the bottom as one would expect but through one of the terminal screw bushings.”

The screw P/N 2680-0217 length currently being used was not considered and the length was overlooked. The screw length is 0.375 inches long. We have found that the screw can be 0.055 inches too long and may bottom out causing the tapped hole in the header of the capacitor to become cracked or become broken.

When this happens the electrolyte will slowly leak out over time, and cause the defect described. This situation is even worse due to the capacitor is mounted with the header face down. If the capacitor was mounted header face up a cracked or broken header would not have caused this problem, the electrolyte could not leak out.

1. All affected models and tested assemblies WIP (Work In Process), FGI (Finished Goods Inventory) at SPO (Support Parts Organization) & AMC (Asian Manufacturing Center) has been inspected for capacitors with damaged headers due to the incorrect screw
2. When this repair is being done all of the hardware described above should be replaced (It is NOT recommended that any of the hardware be reused)
3. The following figures can be used when doing the repair.
4. Inspect the assembly as described below.
5. The last figure will aid in the reassembly of the hardware and the capacitors.
