6674A-11

S E R V I C E N O T E

**6674A - DC POWER SUPPLY, 0-60 V, 0-35 A, 2100 W.
GPIB. CONTROLLED**

Serial Numbers: MY41000101/ MY41002602 SG41000101/ SG41000573

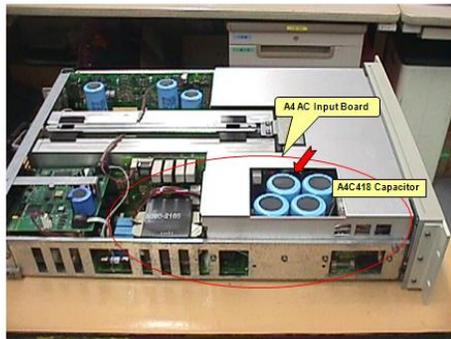
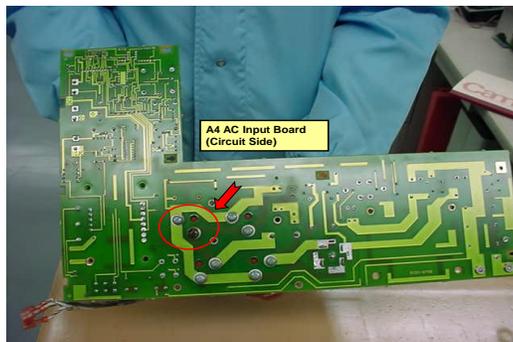
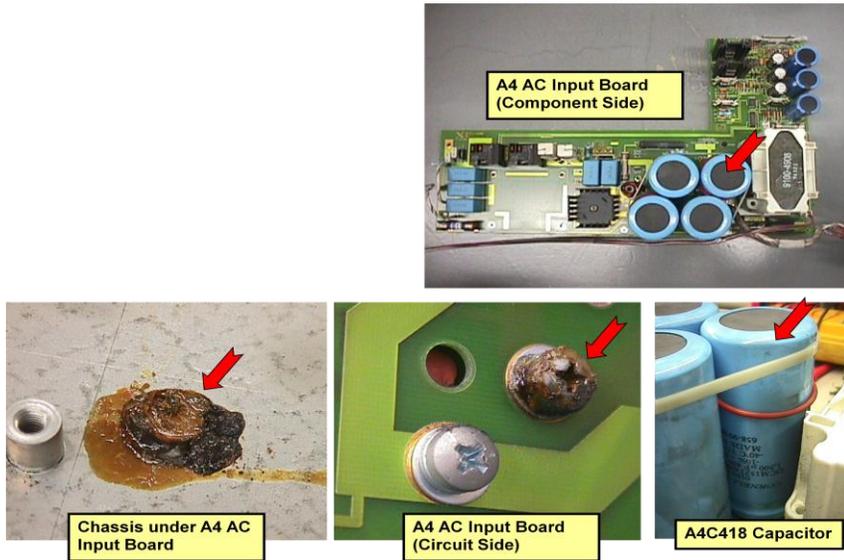
The four filter capacitors circuit reference (C416-C419) on the A4 AC input board starts leaking electrolyte - not through the pressure valve in the bottom as one would expect but through one of the terminal screw bushings.”

The screw P/N 2680-0217 length currently being used was not considered and the length was overlooked. The screw length is 0.375 inches long. We have found that the screw can be 0.055 inches too long and may bottom out causing the tapped hole in the header of the capacitor to become cracked or become broken.

When this happens the electrolyte will slowly leak out over time, and cause the defect described. This situation is even worse due to the capacitor is mounted with the header face down. If the capacitor was mounted header face up a cracked or broken header would not have caused this problem, the electrolyte could not leak out.

1. All affected models and tested assemblies WIP (Work In Process), FGI (Finished Goods Inventory) at SPO (Support Parts Organization) & AMC (Asian Manufacturing Center) has been inspected for capacitors with damaged headers due to the incorrect screw
2. When this repair is being done all of the hardware described above should be replaced (It is NOT recommended that any of the hardware be reused)
3. The following figures can be used when doing the repair.
4. Inspect the assembly as described below.
5. The last figure will aid in the reassembly of the hardware and the capacitors.
