81134A-01A

S E R V I C E N O T E

Supersedes:
81134A-01

81134A- High Speed Pulse Generator

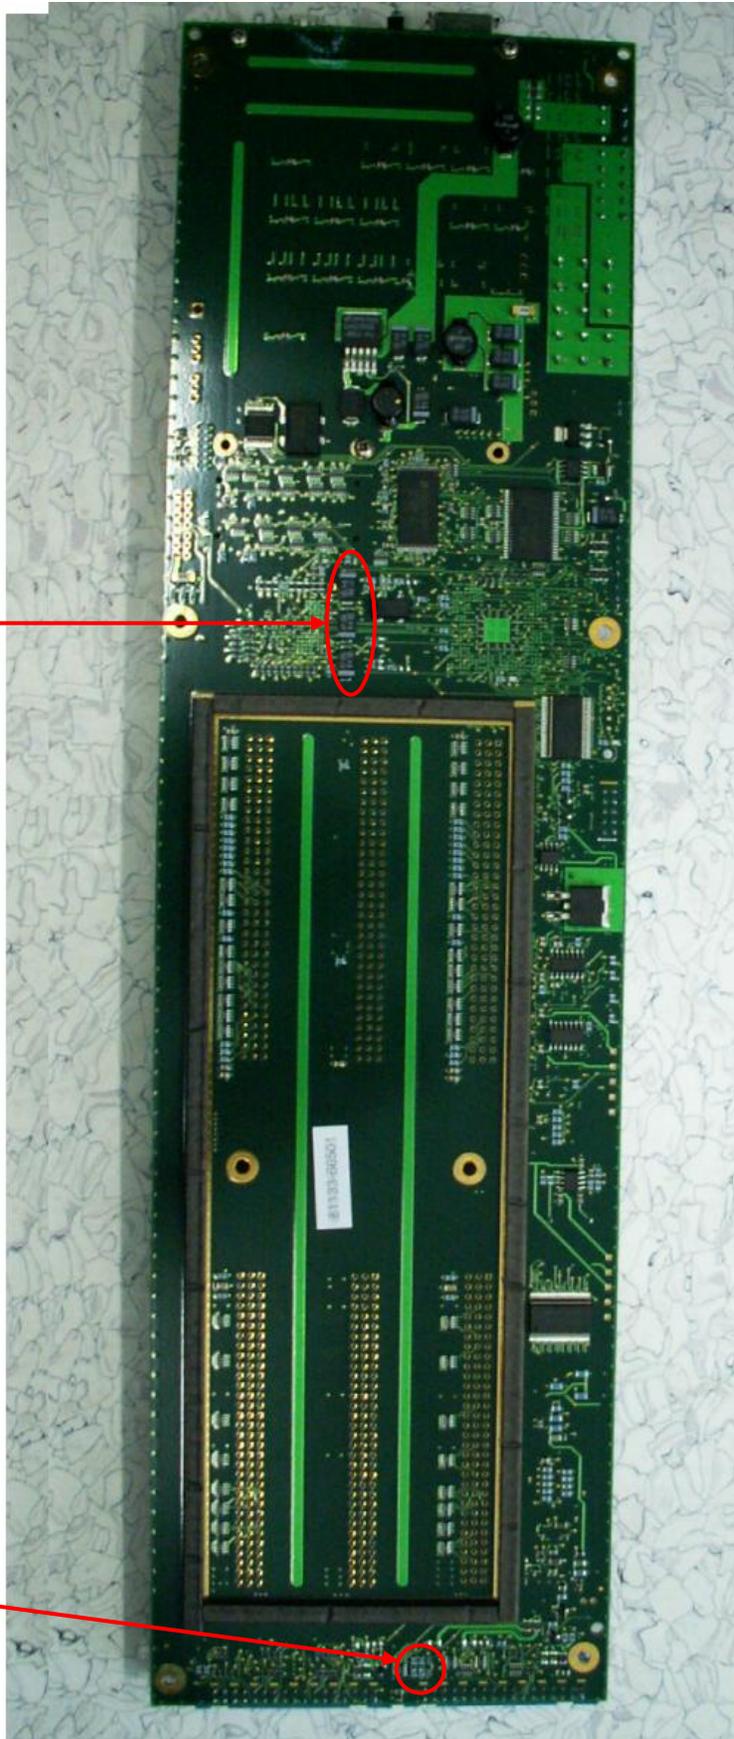
MOTHERBOARD
BACK SIDE VIEW

Three polarized tantalum capacitors on the motherboard are connected with the wrong polarity. The polarized tantalum capacitors are normally more sensitive than others, so they tend to fail after some months. Due to this, wrong voltages were delivered to the front panel board which in turn affected the display.

Polarized Capacitors

Extra Resistors

The preventive maintenance to avoid flickering display failures requires removing the 3 capacitors shown in the following picture. And replacing them with new capacitors (part number 0180-4758) while mounting them with the correct polarity.

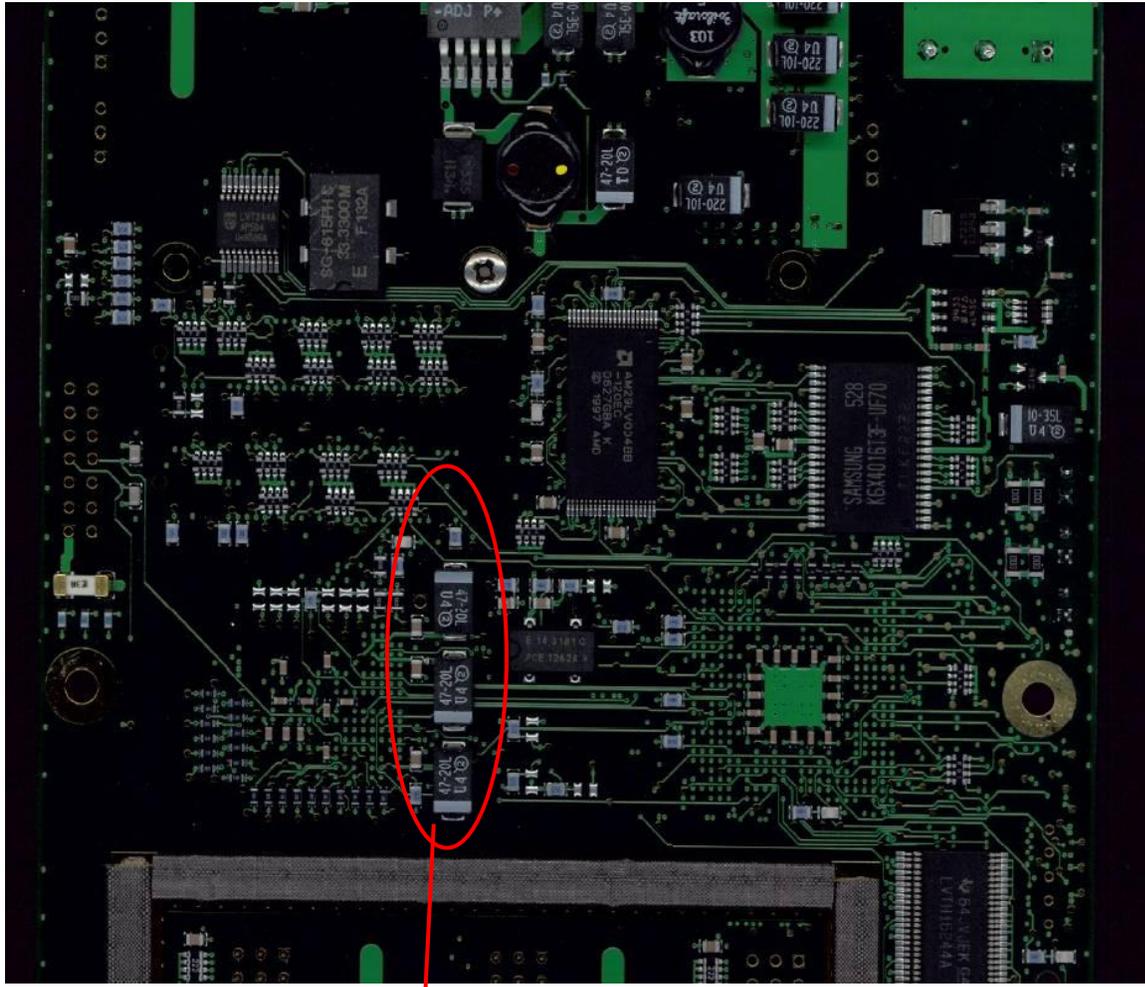
CLOSE UP VIEW WHERE THE CAPACITORS ARE LOCATED

Capacitors mounted with the wrong polarity. The positive side is shown with the white/grey stripe. These 3 capacitors need to be removed.

The capacitors are best removed using hot air. The new capacitors need to be mounted using standard soldering equipment.

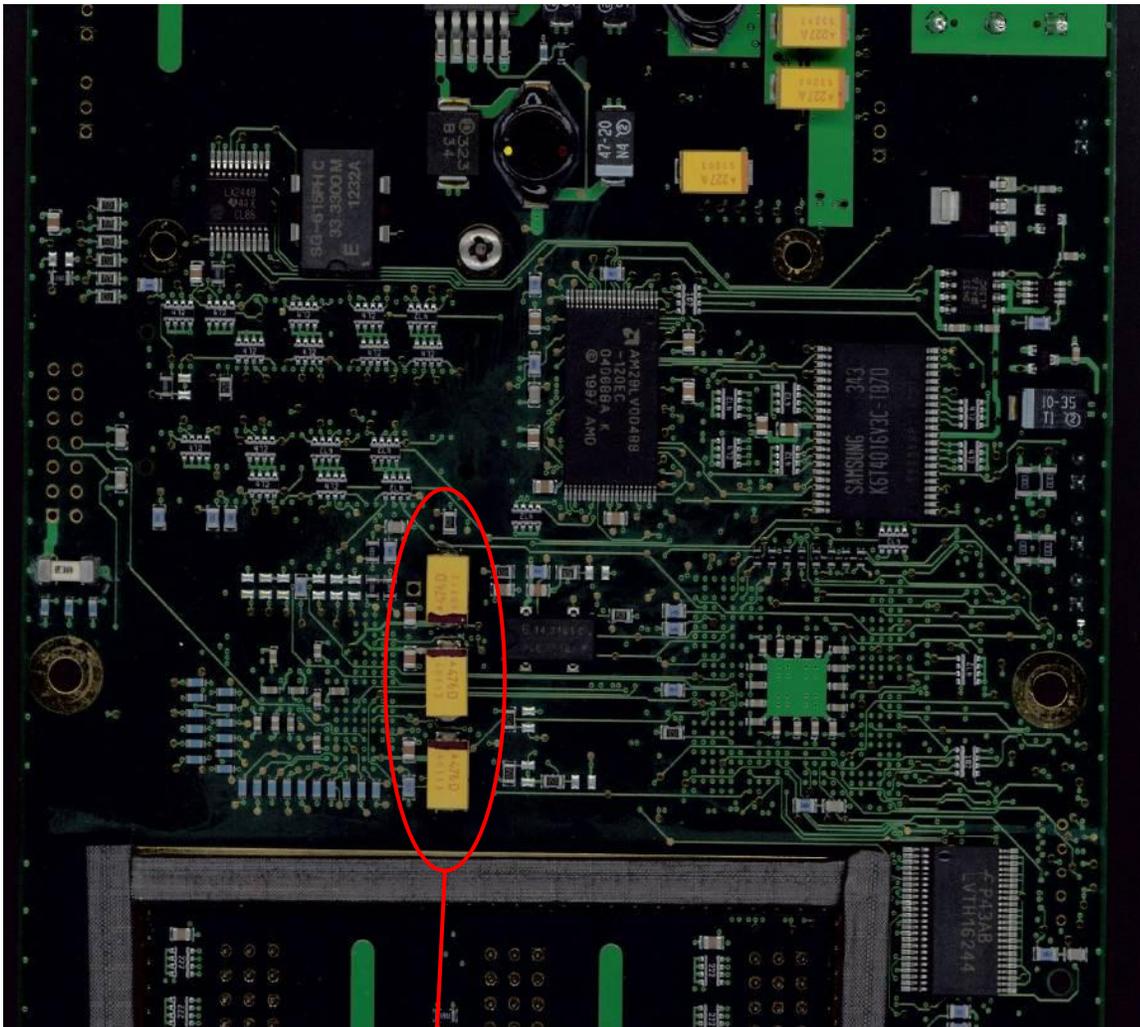
CLOSE UP VIEW WHERE THE CAPACITORS ARE LOCATED

This photo shows the capacitors mounted with the right polarity. The positive side is shown with the black stripe. The colors might vary.

By applying new capacitors and mounting them with the right polarity failures can be prevented for the future.

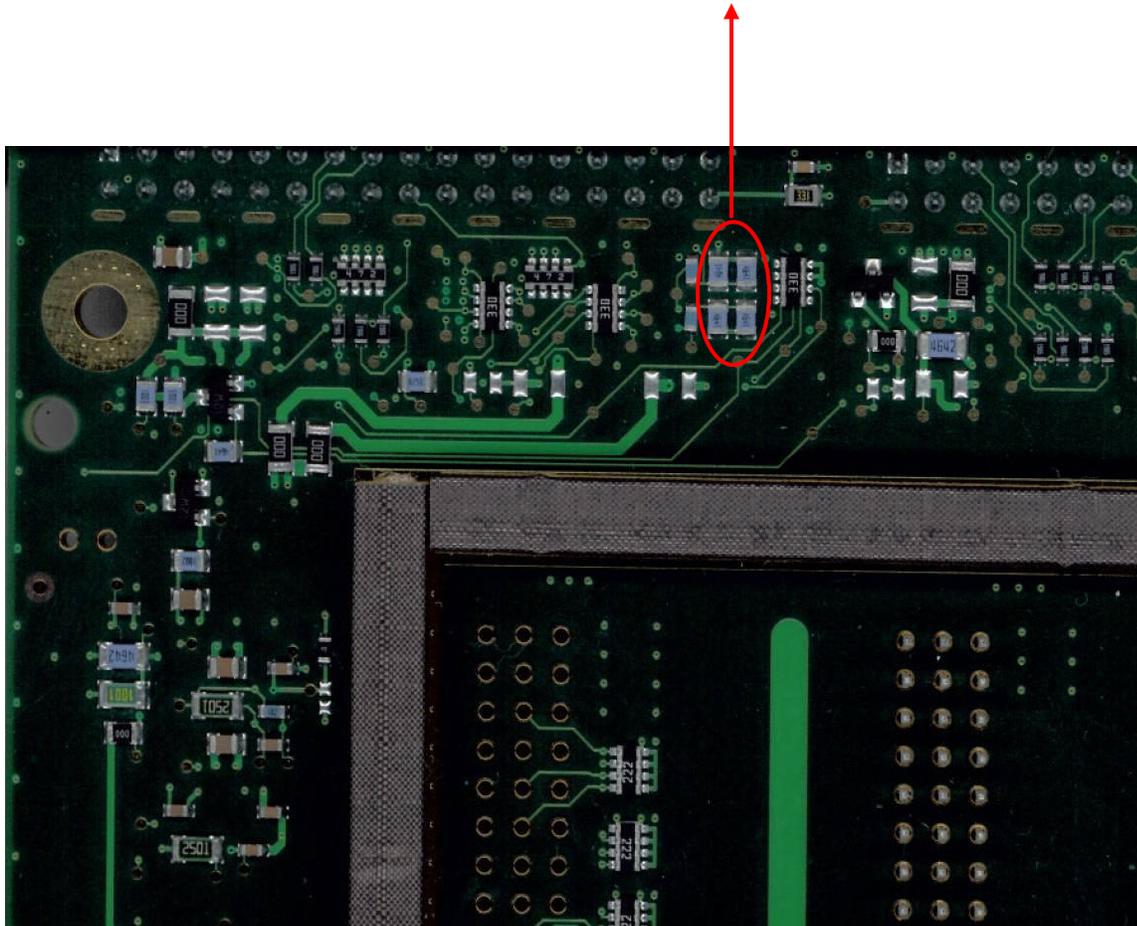
The rotary encoder (APN 0960-1055) has failed in some cases due to incorrect pull up resistance of the encoder. The pull-up resistance of this encoder as specified by the manufacturer is minimum 2.2 K Ohms. According the schematic of the front panel in the 81134A, the pull-up resistance used was 1.5 K Ohms. The lesser resistance value had possibly led to the flow of more currents into the encoder and had degraded the performance of it over a period of time.

Resistors to be removed (The colours can be different)

By removing a few parallel resistors the resistance can be increased, preventing failures of the rotary encoder in the future.

For the preventive maintenance of the know problem the following 4 resistors need to be removed. They are best removed using hot air.

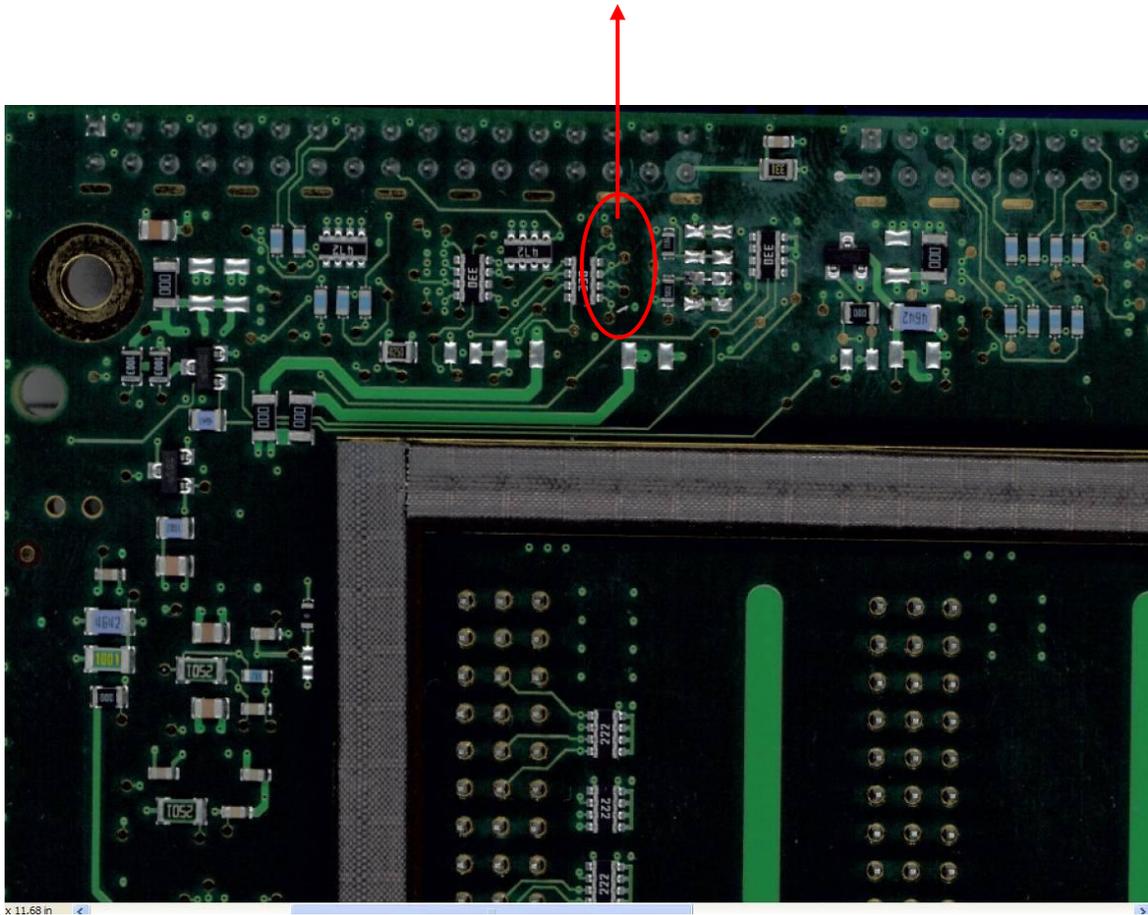
CLOSE UP VIEW – THE RESISTORS ARE REMOVED

The place where the 4 resistors are removed
