81150A-11

Modification Recommended Service Note

81150A - 1- or 2-channel 120 MHz Pulse-/Function-/Arbitrary Generator

Potential issue with duplicate MAC address

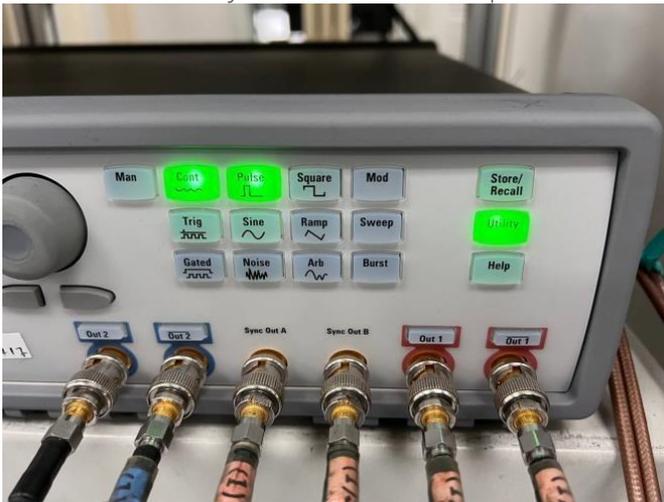
1. Click Utility button at the front panel

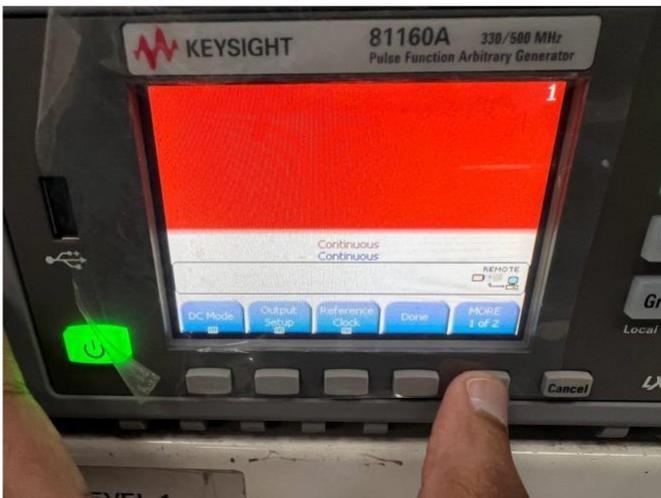
2. Press button more 1 of 2

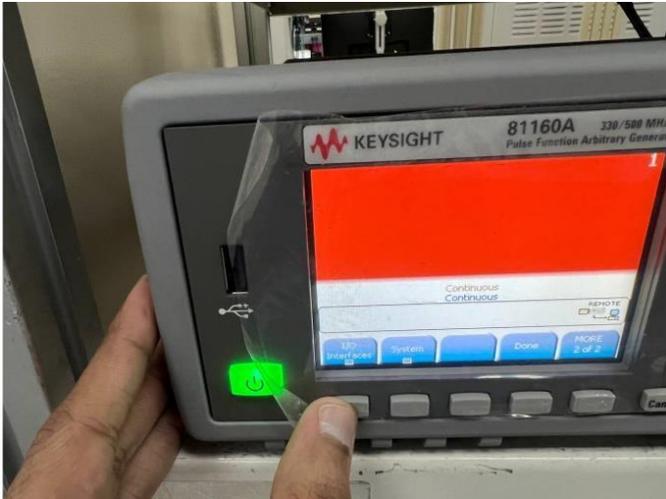
3. Press button I/O interfaces

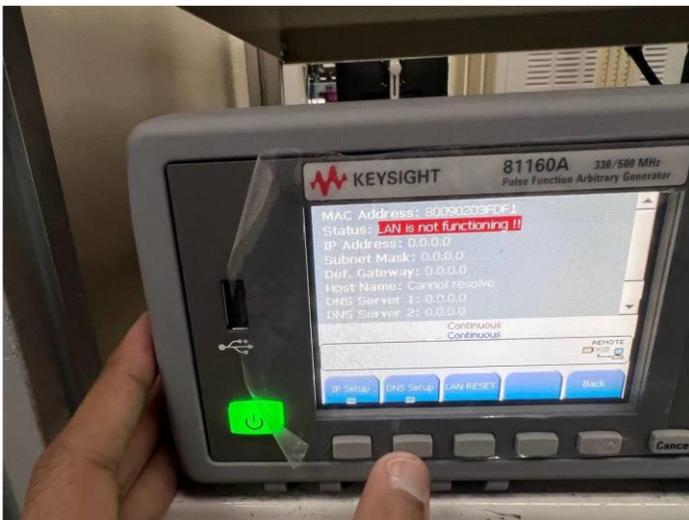
4. Press LAN button to reach LAN interface

All units which are carry MAC Address “80 09 02 03 FD FF” are affected. Please send the units back to Keysight for repair with reference information to this service note.

Product must be returned to the factory for service note installation.
