8494A-02

Modification Recommended Service Note

8494A – Manual Step Attenuator

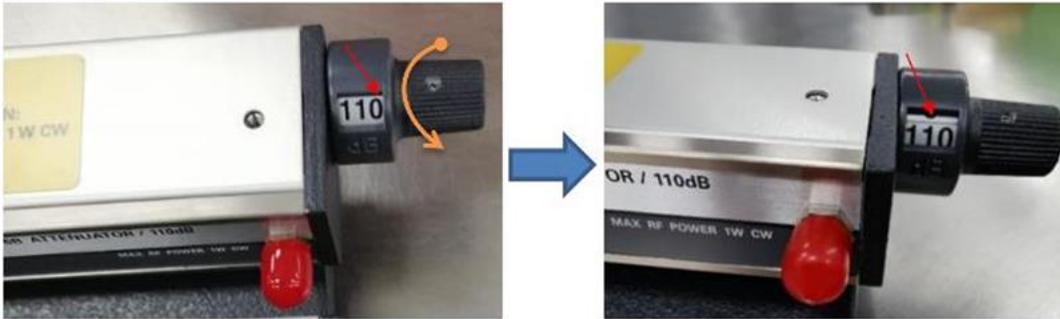
The identified batch of step attenuator's rotating knob may become loose when the user applies an extended force to turn the knob beyond the maximum attenuation value. This will cause the attenuation value to be located outside of the indicator window and may create confusion on the actual attenuation value.

The attenuation knob was not securely tightened to the internal shaft, causing it to turn further. This is due to an insufficient torque that was applied to tighten the set screw during assembly at the factory.

This issue can be fixed by re-tightening the screws on the rotating knob.
