S E R V I C E N O T E

8566A-16

HP 8566A AND 8566B SPECTRUM ANALYZER

REPLACEMENT RF ATTENUATOR RETROFIT KIT WITH CALIBRATION PROM

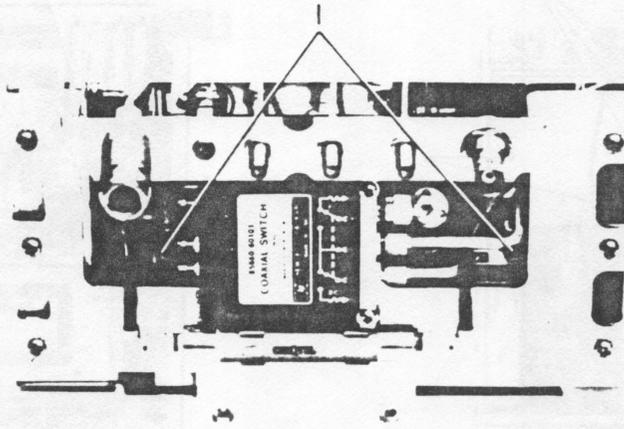
Figure 5. HP 85660A/B RF Attenuator Connections

Overtightening of A6 RF Module semi-rigid cables can cause significant HP 8566A/B Frequency Response degradation.

- e. Carefully align both A6A2 RF Attenuator SMA connectors with semi-rigid cables (I), Figure 5, and tighten cables using 6 in-lbs. of torque.
- f. Tighten remaining ends of both semi-rigid cables using 10 in-lbs. of torque.

- j. Carefully align both A6A2 RF Attenuator SMA connectors with semi-rigid cable (I), Figure 5 and tighten cables using 6 in-lbs. or torque.
 - k. Tighten remaining ends of both semi-rigid cables using 10 in-lbs. of torque.

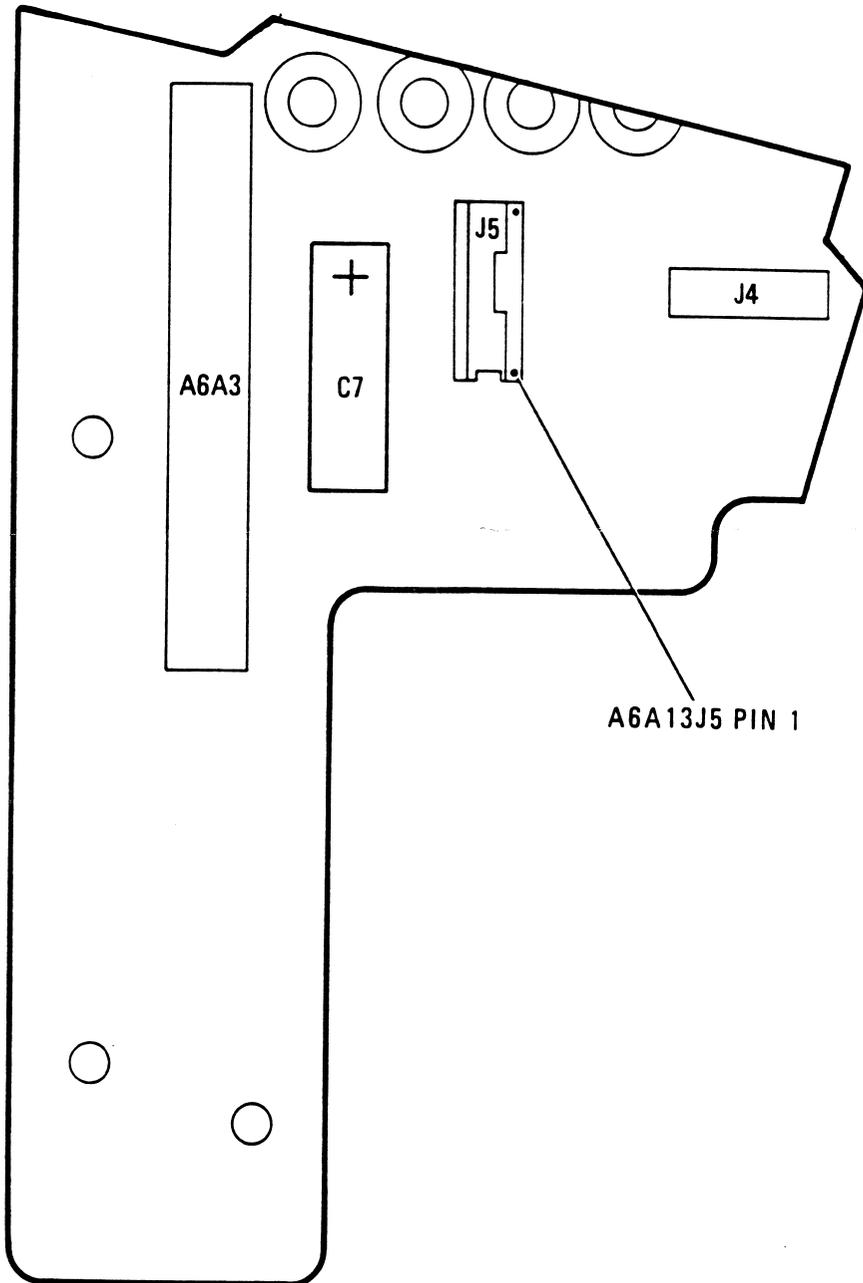
Figure 10. A6A13J5 RF Attenuator Cable Socket, Partial Component Locations

Permanent damage to new A6A2 RF Attenuator circuitry can result if A6A2W1 RF Attenuator Ribbon Cable is incorrectly plugged into DIP socket A6A13J5 on RF Module Motherboard Assembly (plug either misaligned or backwards in socket).

- i. Noting proper plug orientation, plug new A6A2W1 RF Attenuator Ribbon Cable into DIP socket A6A13J5 on RF Module Motherboard (Figure 10). Cable will route towards

A6A3 Last Converter Assembly (away from center of RF Section chassis) when correctly installed with pin 1 aligned with corresponding A6A13J5 pin 1 position.

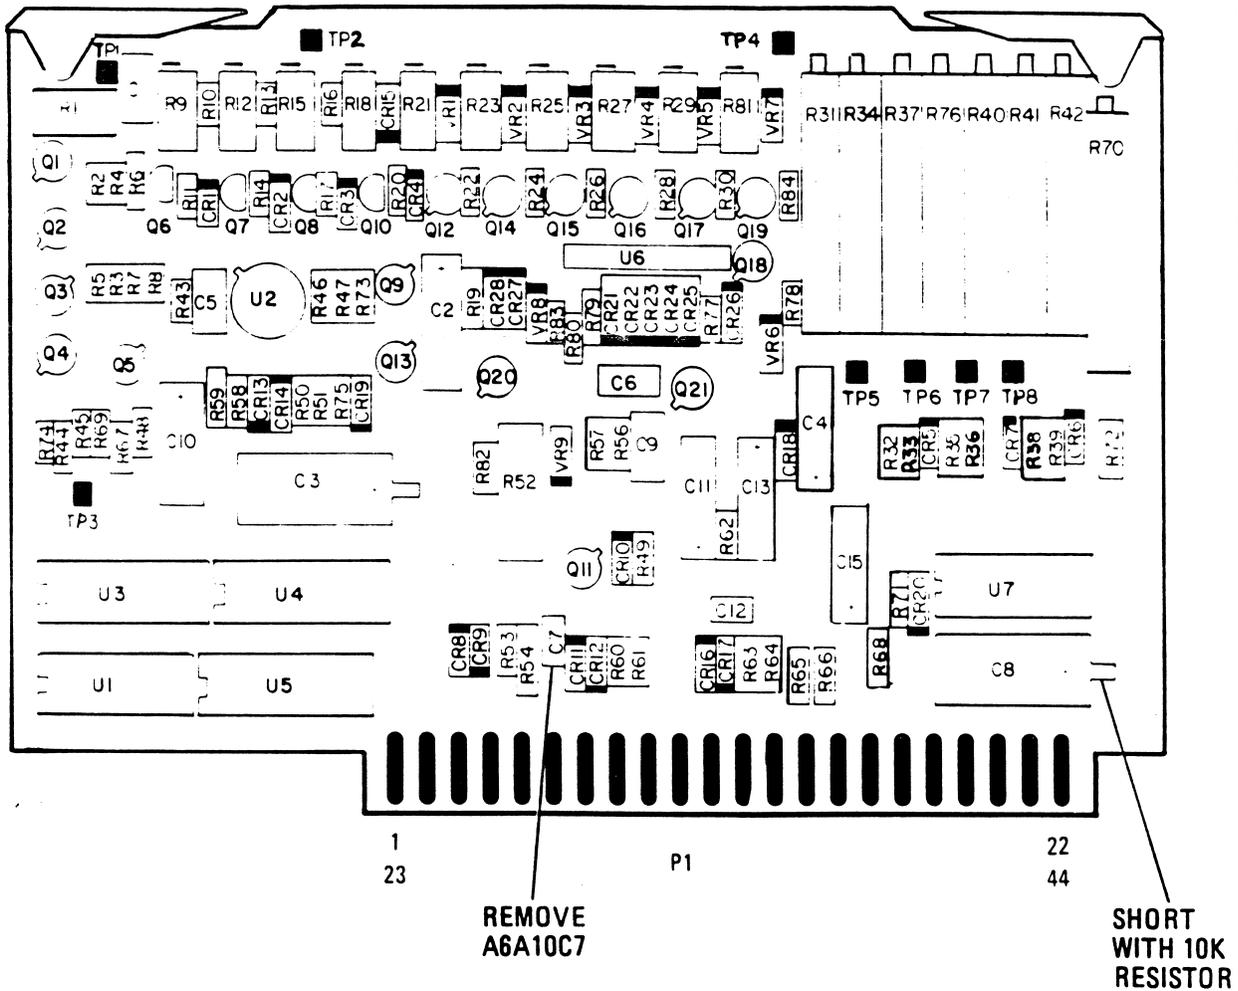
Figure 11. A6A10 Miscellaneous Bias/Relay Driver, Component Locations

- l. Replace A6A9 Phase Lock Assembly in RF Section.
 - m. As shown in Figure 11, remove and discard capacitor A6A10C7 (HP Part Number 0160-3879, CAPACITOR-FXD .01 uF 100 VDC CER) from A6A10 Miscellaneous Bias/Relay Driver Assembly.

- b. Remove A6A10 Miscellaneous Bias/Relay Driver Assembly from RF Section. Using 10K resistor included in RF Attenuator Retrofit Kit, momentarily short leads of capacitor A6A10C8 (Figure 11) to drain off residual +22 Vdc charge before setting assembly aside.

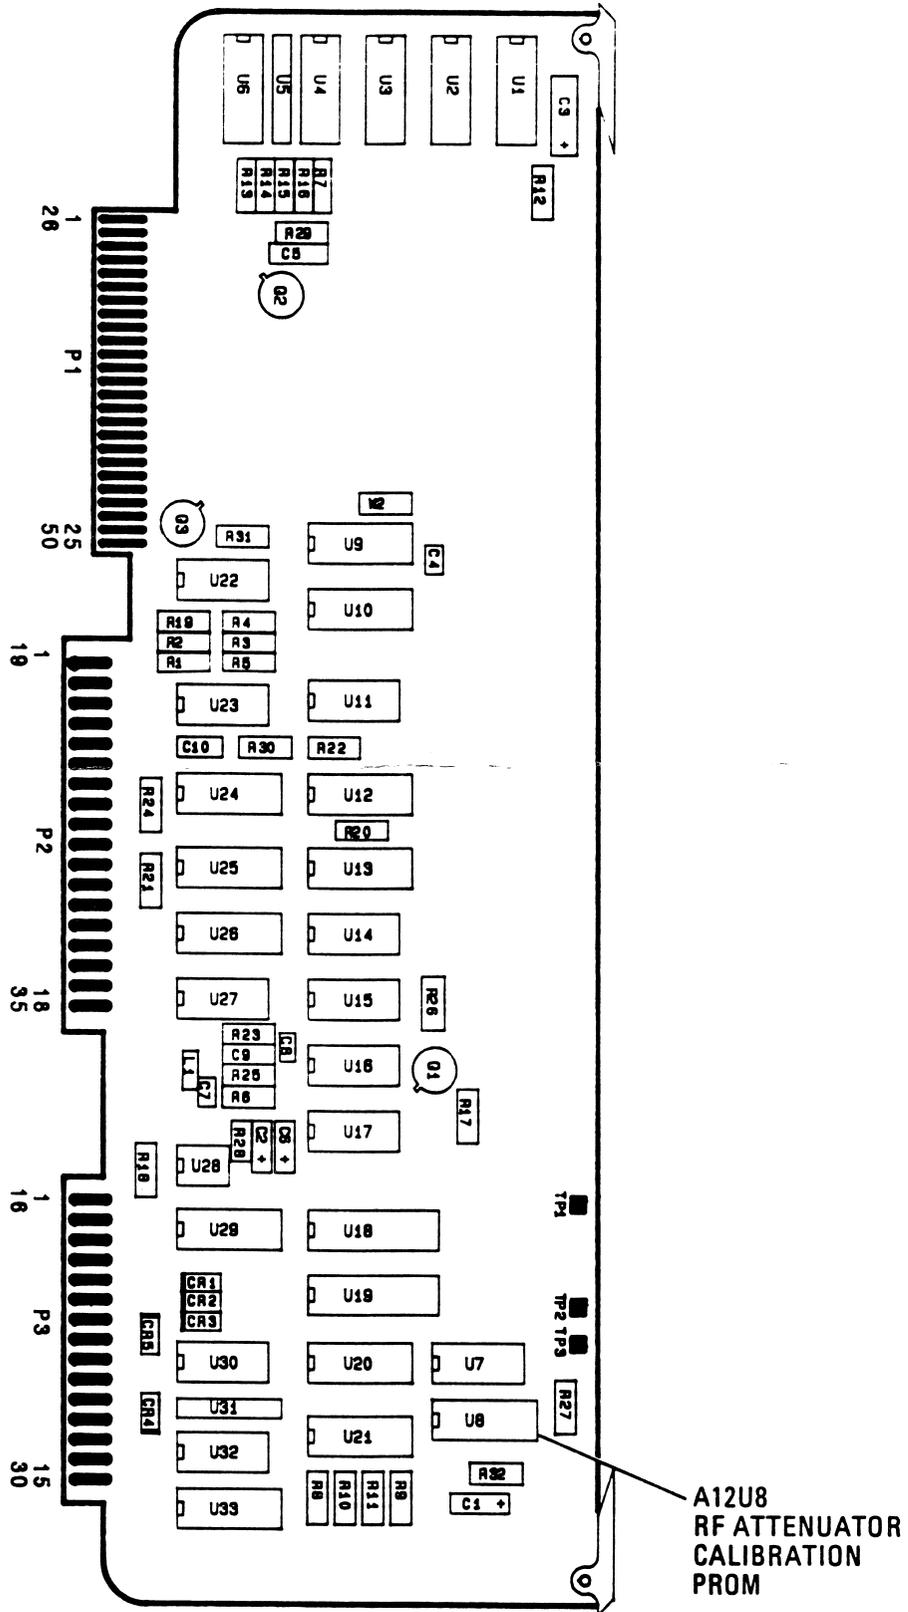
Figure 14. A12 Front-Panel Interface, Component Locations

Permanent damage to new RF Attenuator Calibration PROM A12U8 could result if it is improperly installed in the 16-pin DIP socket of A12 Front Panel Interface Assembly (which would destroy calibration data for A6A2 RF Attenuator).

19. Carefully install new RF Attenuator Calibration PROM A12U8 into 16-pin DIP socket on A12 Front Panel Interface Assembly Figure 14.
20. Replace A12 Front Panel Interface into A23 RF Motherboard circuit board position designated by red circuit board guide.
