P R O D U C T I O N M E M O

INSTRUMENT: 8568A SPECTRUM ANALYZER

SUBJECT: KEYBOARD SWITCH FAILURES
(FLYING SPRING SYNDROME)

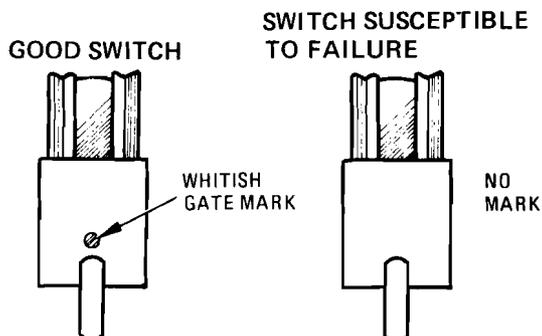
Figure 1. Pushbutton Front-Panel Switch, HP P/N 5060-9436

Not all switches are susceptible to the "fly-away spring" failure. Switches that have a "gate mark" (from the mold) that appears on the red body as a small whitish dot about in the center of the surface opposite the spring (see Figure 1) do not exhibit the "fly-away spring" failure.

8568A Spectrum Analyzers shipped after December 10, 1981 may have good switches that do not have a "gate mark". Therefore, the above criteria can be used to identify bad switches ONLY in 8568A Spectrum Analyzers that were shipped on or before December 10, 1981. (Serial Numbers 2118A01500 through 2140A01700 for the 85680A; 2112A02340 through 2134A02750 for the 85662A.)

Rebuilt (Blue-Stripe) keyboards have been set up for the RF Section and IF-Display Section; 85680-60141 and 85662-60129 respectively. The rebuilt keyboards include all key caps and all front-panel LEDs. For 85680A RF Sections with serial numbers 2118A01500 through 2140A01700, and 85662A IF-Display Sections with serial numbers 2112A02340 through 2134A02750, follow **PROCEDURE** in this Production Memo. For instruments that do not fall within the above designated serial number ranges, but appear to exhibit the "fly-away spring" failure, contact the 8568A Product Support Engineer before beginning repair.

DO NOT REPLACE KEYBOARDS UNLESS AT LEAST ONE SWITCH HAS FAILED and the failure mode is a "fly-away spring". If one or more switches have failed in this manner, replace both the RF Section Keyboard and the IF-Display Section Keyboard.
