S E R V I C E N O T E

HP 8590D Option R13 Spectrum Analyzer

Counter-Lock Assembly modification to improve marker count stability under certain conditions.

Page 2 SERVICE NOTE 8590D-02

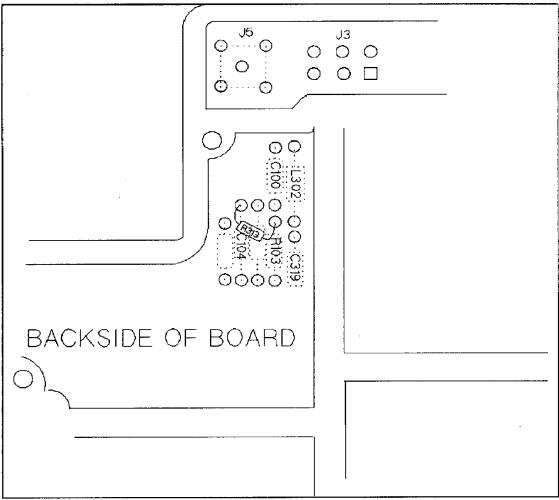
Figure 1. A25 Counter-Lock Assembly

Instruments which have the A25 Counter Lock Assembly with HP P/N 08591-60053 or 08591-60061 may experience non-stable marker count readings. These non-stable counts are a problem while using marker count on AM modulated signals in wide Resolution BW's. When counting AM modulated signals (like the visual carrier of a TV signal) we have un-wanted modulation (15.7KHz sync rate) on the VIDEO_IF signal being combined with the COUNTER 21.4MHz input signal.

Add a high-pass filter circuit (corner freq of 1.4MHz) to the COUNT IF1(Block M) circuit which blocks the unwanted low frequency modulation signal and allows the 21.4MHz to pass through with very little loss.

- 2. Remove the screw securing the two halves of the casting. Separate the casting halves and place the assembly bottom side up on the work surface.
- 3. Refer to Figure 1. for the location of R103 and remove R103. Install C321 in place of R103 but do not solder at this time. Install R313 as shown in Figure 1. One lead will share a hole with C321 (just installed). The other lead will share a hole with C104 as shown.
- 4. Apply the label (08591-60073) over the old board number.
- 5. Apply a label (08591-60073) onto the rear panel for future reference.
