**86100A-02A**

# S E R V I C E N O T E

## 86100A Digital Communications Analyzer

### **Intermittent or slow floppy disk reads**

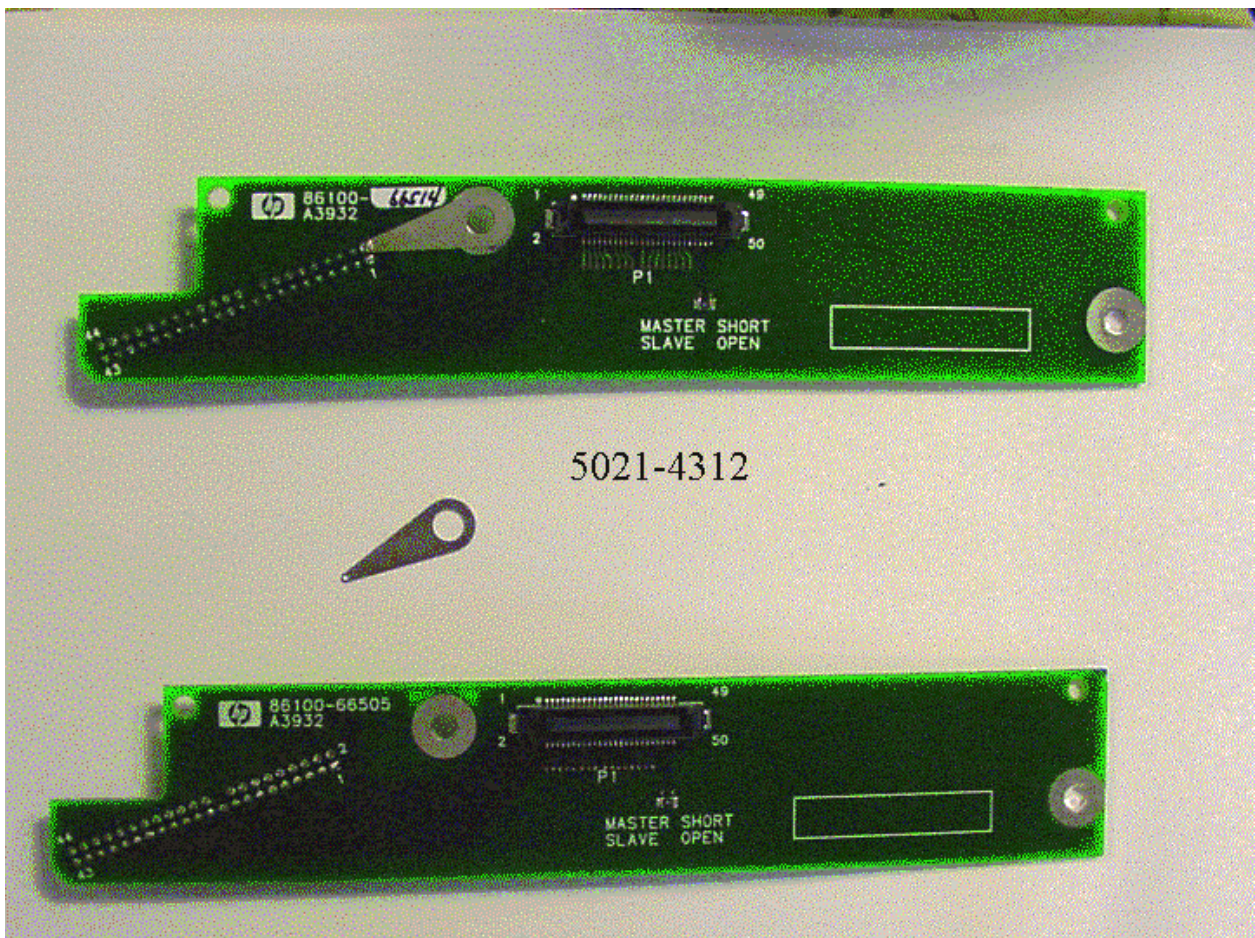
Poor grounding in original design causes intermittent read problems. New assembly, 86100-66515 no longer available.

Modify 86100-66505 LS 120 Adapter by adding 5021-4312 ground clip between pin 2 of 44 pin connector and adjacent screw hole. Solder to pin2 so that hole is concentric with screw hole. Re-label assembly 86100-66514. See attached figure.
