86100C-12

S E R V I C E N O T E

86100C Digital Communications Analyzer Mainframe

Motherboard board mounting modification improves product reliability related to boot up issues.

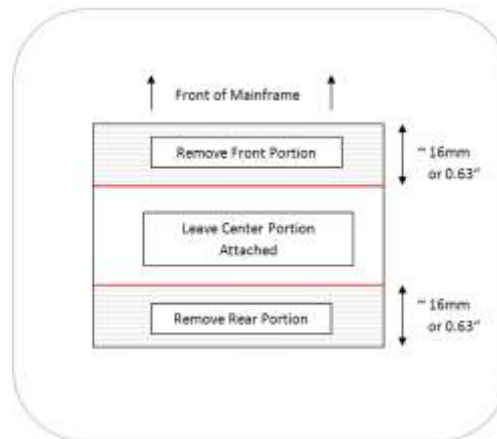
Foam mounted underneath the microprocessor board to prevent vibration during shipment may flex the board more than desired on some units, resulting in intermittent power-on failures. Modifying the foam as described reduces the flex and improves reliability.

Modify the foam as described below. The modification will remove roughly half of the foam, equally from the front and rear, leaving a strip in the center.

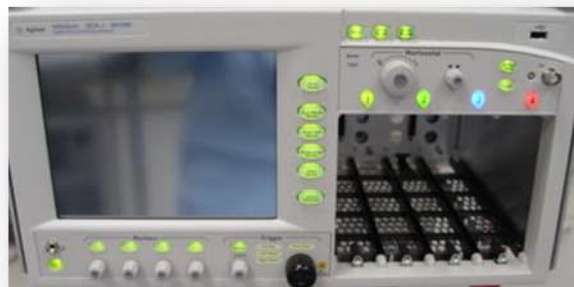
The most common symptom is a boot up error as shown here. The mainframe will come to the point where all LEDs are lighted but will not progress through the boot sequence.

This can be either a hard failure or very intermittent.
