86130A-07

S E R V I C E N O T E

86130A BitAlyzer Error Performance Analyzer

Intermittent “Whitescreen” display on instrument startup.

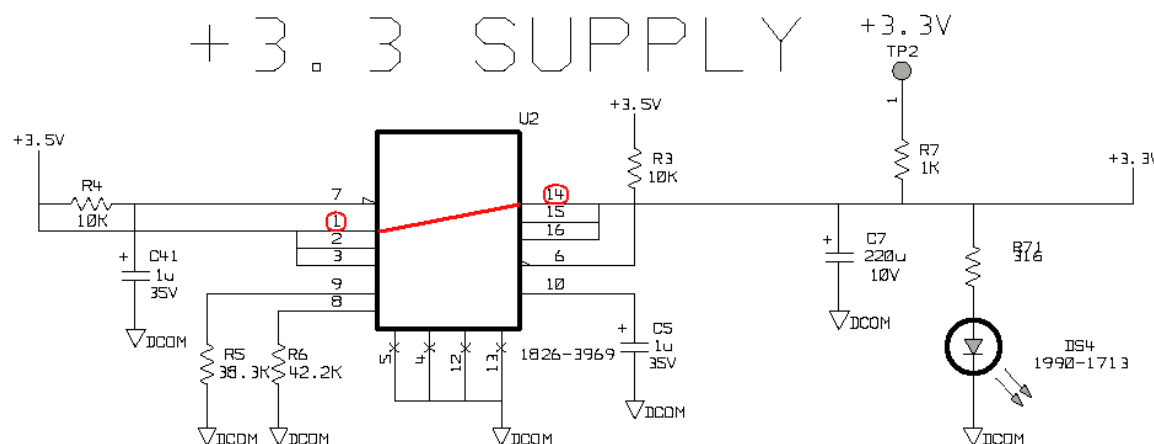
On boot-up only, the 86130A instrument display may intermittently appear “white” and will not display any graphics. This can be caused by U2 (+3.3V HotSwap Power Manager PN1826-3969) on the A1A2 Power Distribution Assy (86130-60001 RevA) interrupting the 3.3V supply if transient current exceeds its set limit. It has been determined that the 3.3V breaker to the A5A1 CPU Board is not required since it is not capable of drawing more than 4A of current (per the CPU vendor). On an average unit it never exceeds 3A.

Solution/Action:**MOD #4 POWER DISTRIBUTION BOARD****(1) Removal of U2****(2) Jumper PIN#1 to PIN#14 (20-gauge wire)**

- 4) Remove the instrument cover and locate the A1A2 86130-60001 Power-Dist. Assembly.
 - 5) Using side-cutters carefully (as to **not** dislodge PCB traces) cut each of the 14 legs on U2 (Agilent PN1826-3969, MFG PN UCC3918) Hot-Swap Manager integrated circuit.

- 6) Using a soldering iron, carefully remove the remaining legs from the printed-circuit-board assembly.
 - 7) Clean any excess solder off of the remaining fourteen pads of U2.

- 8) Using a #20-gauge wire, bridge the PIN#1-to-PIN#14 pad. Leave no excess wire over the ends of the two pads!
- NOTE: USE THIS SPECIFIC WIRE SIZE !**

- 9) Solder the wire on either end to the two pads.
 - 10) Test this MOD by reinserting the power-plug and powering the BERT to the “powered-on” state.
 - 11) If the instrument powers on and the display comes on then the modification verification was successful. Attach a “MOD 4” label between “Connector P4 and the Lambda DC-DC convertor module”.
