86130A-09

SERVICE NOTE

86130A BitAlyzer Error Performance Analyzer

Install Teflon insulating sheets in A2 (PG Assy) / A3 (ED Assy) slots.

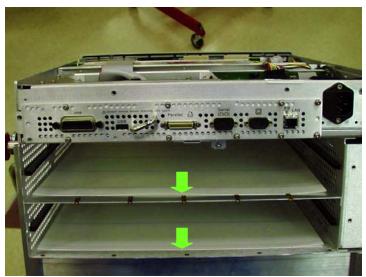
Due to metal on metal contact, it is possible to create small aluminum filings when installing A2 (PG Assembly) or A3 (ED Assembly) into the 86130A mainframe. Although the filings have never been positively identified as root cause for any failures, there exists the potential that they could cause an internal short in the instrument, causing a failure.

Figure 1 – location of Teflon insulating sheets in A2/A3 slots.

Add Teflon insulating sheets to the bottom surfaces of the A2 and A3 mainframe slots to prevent metal on metal contact between the tray assemblies and the mainframe. Install the insulators only if the instrument is opened and the A2/A3 assemblies are removed.

- 1. Clean the slot mainframe surface with an alcohol wetted anti-static cloth to remove any foreign particles from the slot surface.
- 2. Install the white Teflon sheets as shown in Figure 1.
