**86130A-11**

# S E R V I C E N O T E

## 86130A BitAlyzer Error Performance Analyzer

**Audio Circuit Modification if 86130A speaker stops working.**

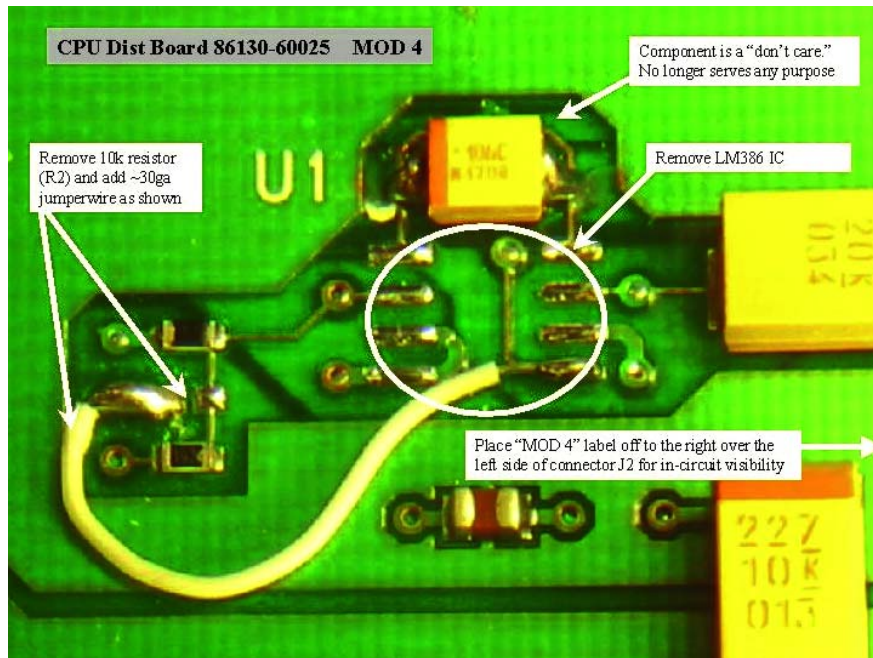
**Figure 1** – Location of modifications on A5A3 CPU Distribution Board 86130-60025

The LM386 audio amp on the A5A3 CPU Distribution Assembly is prone to latching per the IC manufacturer. In addition, it was found that the circuit driving this amp could exasperate the problem due to small changes in load conditions as a result of part-part variability (hence, only some instruments experience this condition).

**Step 1** – Modify A5A3 CPU Distribution Assembly 86130-60025 – refer to Figure 1 below.

- a. Remove R2 10K Resistor.
- b. Remove LM386 IC.
- c. Add 30ga jumper as shown.
- d. Affix MOD4 label to assembly.
