## S E R V I C E N O T E

## **HP 8751A Network Analyzer**

# Modification to prevent the HP 8751A from hanging up when being controlled by a controller.

Page 2 SERVICE NOTE 8751A-14

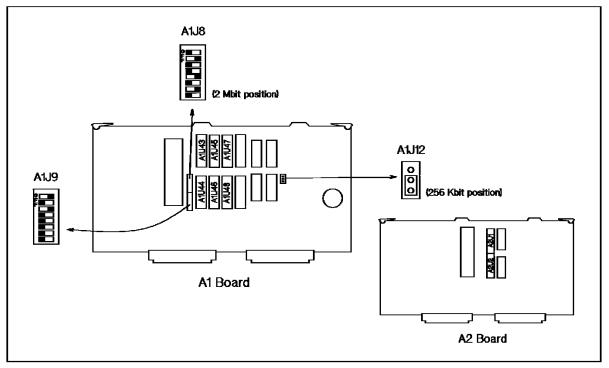
Figure 1. A1 and A2 Boards

The HP 8751A may hang up or reset, when the 8751A repeats the same measurement under the computer-controlled circumstances. Check if this service note can be applied to your case, refer to the following situation list (you must have ALL the situations listed below):

- 1. The HP 8751A is controlled by an external controller through the HP-IB interface.
- 2. The HP 8751A repeats the same measurement.
- 3. The HP 8751A hangs up and resets after several hours or several days.
- 4. This symptom happens regularly.

It is fixed from the firmware Rev.4.02. Replace ROMs on the A1 and A2 boards with Rev.4.02 ROMs.

- a. Remove only the A1 board.
  - b. Replace the ROMs of the A1 board with Rev.4.02 ROMs. Table 1 and Figure 1 show the ROM locations.
- 4. If the revision is "Rev.3.xx" and below,

- a. Remove the A1 and A2 boards.
  - b. Replace the ROMs of the A1 and A2 boards with Rev.4.02 ROMs. The ROM locations are shown in Table 1, Table 2 and Figure 1.

- c. The Figure 1 shows the jumper and bit switch settings for Rev.4.02. In case of any difference, replace RAMs and change the switch settings with referring the Modification Note (P/N 08751-90034).
