**B1500A-01**

**S E R V I C E N O T E**

**B1500A Semiconductor Device Analyzer**

**Mouse cursor moves to edge against operator move to another location**

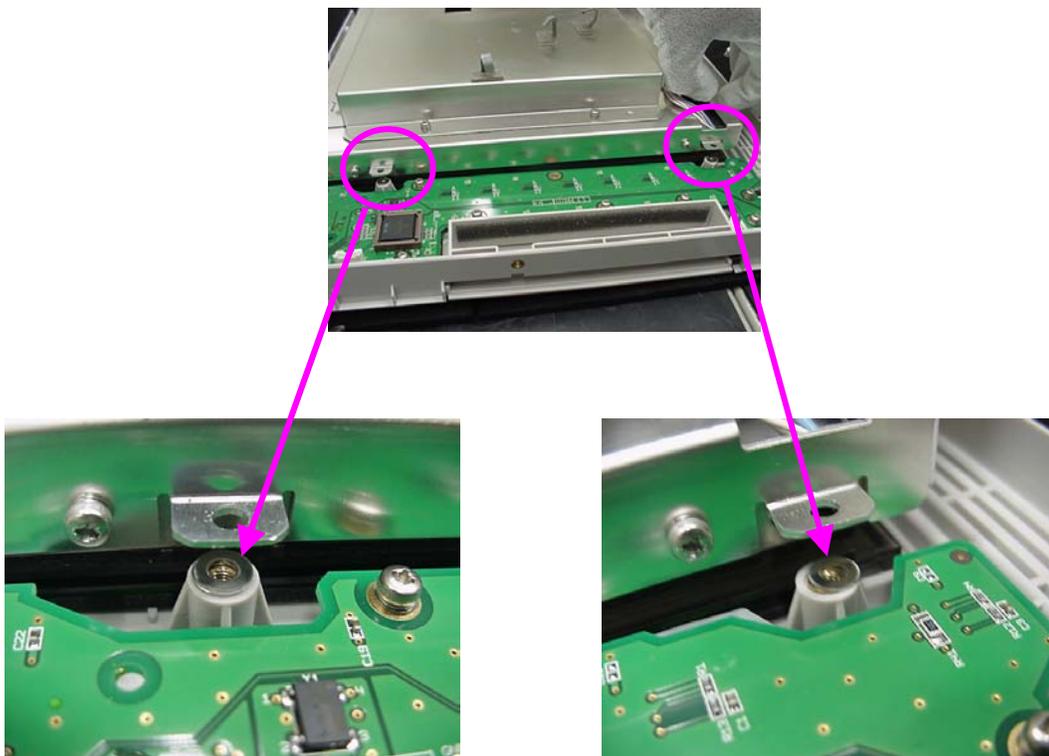
The front frame bezel cover pushes LCD touch panel. This situation cause mouse cursor to jump to the certain edge even if operator (end user) move mouse cursor to another location.

Check which corner the mouse cursor jump to. Remove LCD assy fixing screw, and insert 3050-0891 washer between LCD fix hole and screw housing on bezel only for the corner that cause this problem. For the worst case, you may need to insert washers in three corners. How many screw will be needed is depends on the situation.

Please be carefully to prevent from dusts into the LCD panel.

After insert washers, please don't forget to confirm to check mouse cursor performance, and diagnosis for Front Panel.
