CX1101A-01

# Modification Available Performance Enhancement Service Note

## CX1101A Current Sensor, Single Channel, +/- 40 V, 100 MHz, 40 nA - 1 A

Serial Numbers: MY56160101 / MY56160318

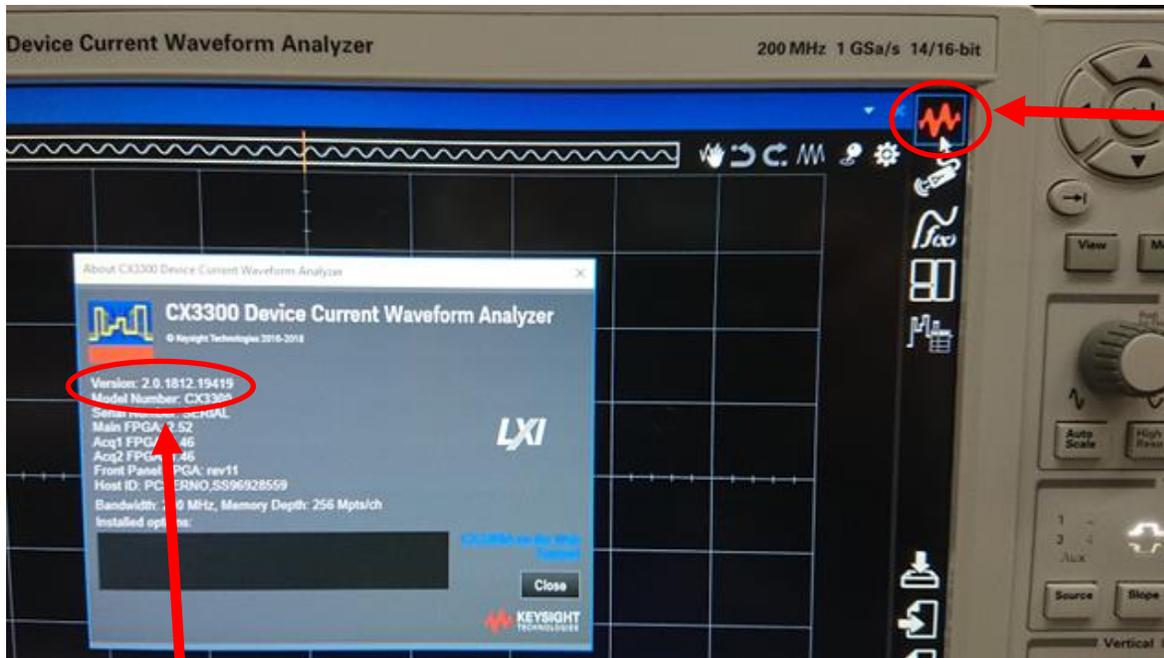
Firmware revision

How to confirm the CX3322A/CX3324A firmware revision.

- Click the Keysight logo icon and confirm the firmware revision in the pop-up window.

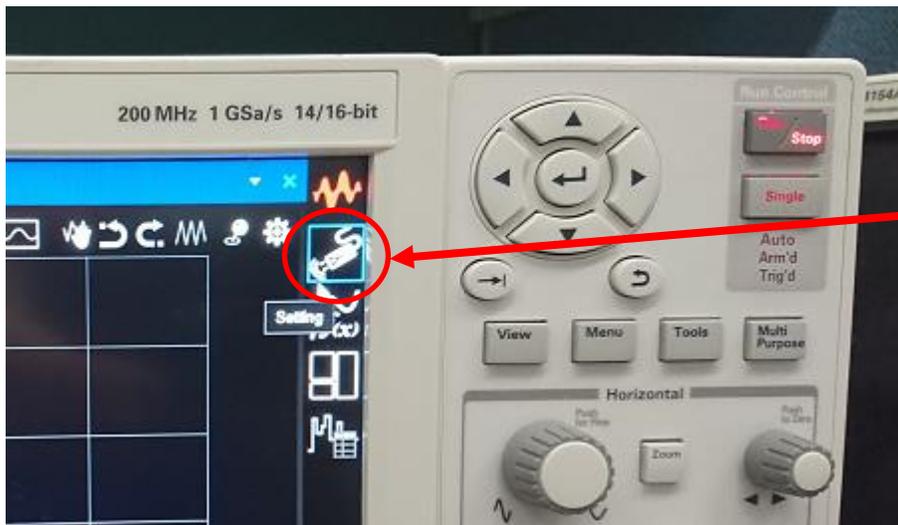
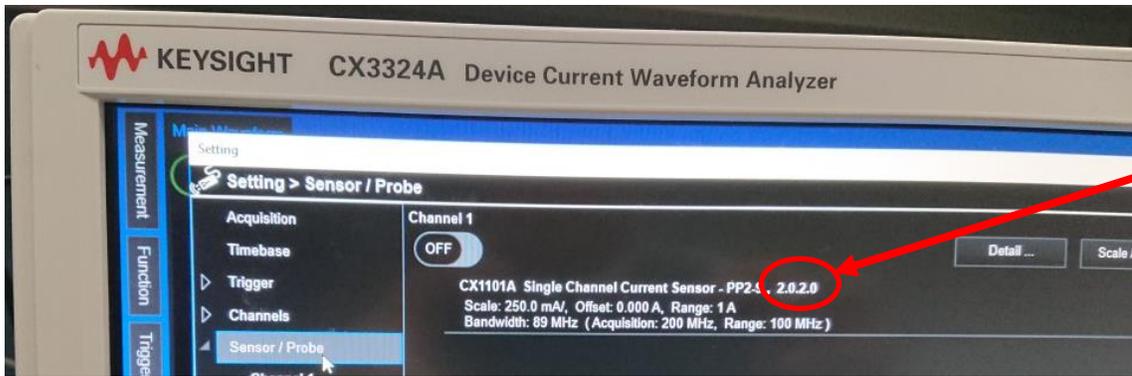
Sensor Revision

How to check CX1101A sensor revision.

- Click "Sensor" icon on CX3322A/CX3324A display. And in the pop-up window, there is a sensor revision information.

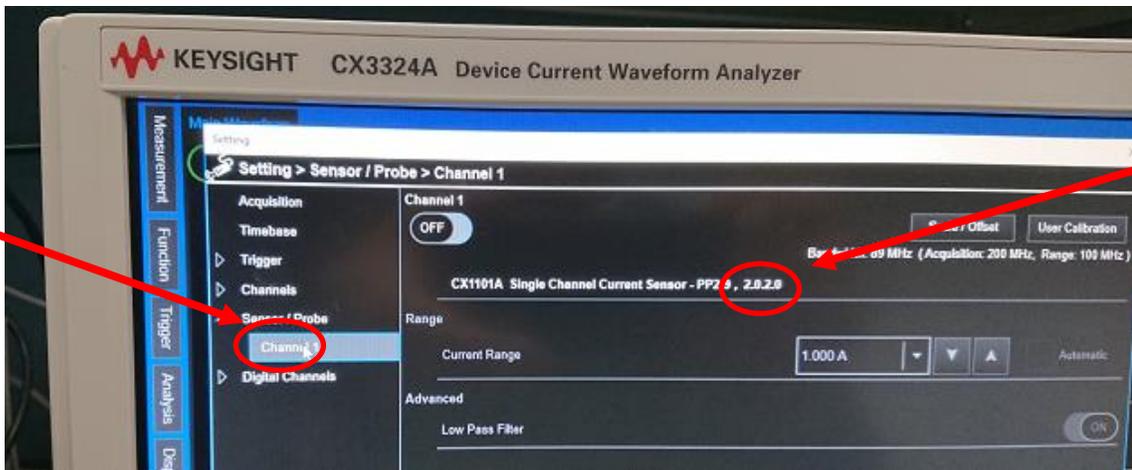
Sensor Revision

NOTE: If not displayed, click on "Channel 1" in the "Sensor/Probe" section to get the below. This explains the case when CX1101A is connected to Channel 1 port.
