# DSO9064A-03

## S E R V I C E N O T E

### DSO9064A Oscilloscope: 600MHz, 4 analog channels

Serial Numbers: MY0000001-MY52250100, SG00000001-SG52250100

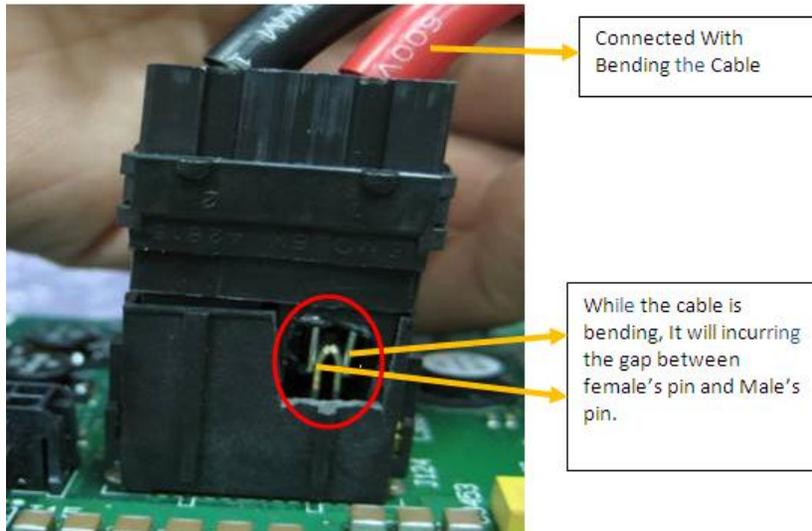
Figure #1.

Many customers are experiencing Random Shutdowns. This make them want to have Service Note - 02A completed. The problem is with service note -02A, this isn't the only possible cause for the symptom consequently not resolving their problems. This issue has been determined to be a connection problem with the J124 connector on the acquisition assembly and the 12 volt power cable. See figure #1.

Replace the 12 Volt Bulk power cable to the longer version 54904-61631 eliminating the connector tilt increasing the surface tension. See Figure #2. Clean and inspect the connection J124 on the acquisition board. If the J124 is pitted then replace the acquisition board. Use contact cleaner or alcohol.
