## DSO9104A-04

**S E R V I C E N O T E**Supersedes:  
None**DSO9104A Oscilloscope: 1 GHz, 4 analog channels**

Serial Numbers: MY0000001-MY52250100, SG00000001-SG52250100

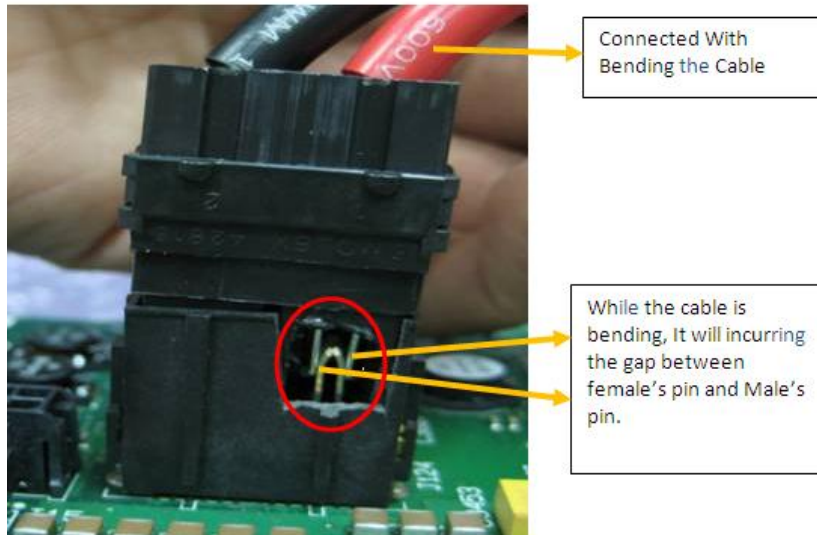
Figure #1.

Many customers are experiencing Random Shutdowns. This make them want to have Service Note - 02A completed. The problem is with service note -02A, this isn't the only possible cause for the symptom consequently not resolving their problems. This issue has been determined to be a connection problem with the J124 connector on the acquisition assembly and the 12 volt power cable. See figure #1.

Replace the 12 Volt Bulk power cable to the longer version 54904-61631 eliminating the connector tilt increasing the surface tension. See Figure #2. Clean and inspect the connection J124 on the acquisition board. If the J124 is pitted then replace the acquisition board. Use contact cleaner or alcohol.
