DSOS254A-03A

# Modification Recommended Service Note

## DSOS254A – DSO Infiniium S Series 2.5GHz 4 channel

**The Problem** – Under certain circumstances a PLL2 error may occur on the S-series products.

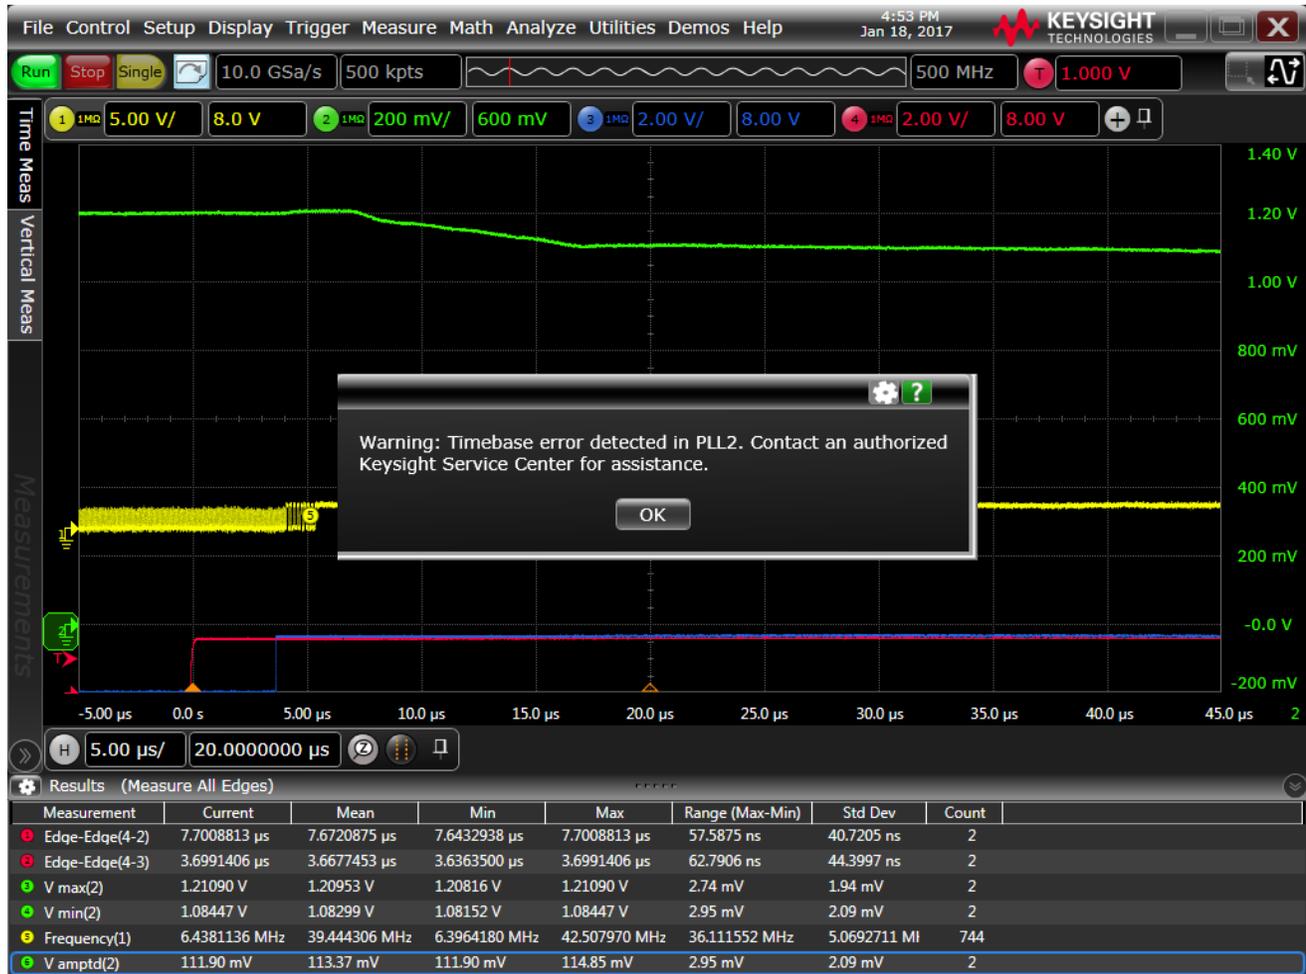
On the old acquisition board, 54911-66501/69501, a PLL2 error message sometimes occurs. The error message appears on the screen as below:

There is a new acquisition board available for the S-series scopes (54911-69511); any repairs associated with the older 54911-69501 needs to be replaced with 54911-69511.

1. Replace the acquisition board with the 54911-69511.
2. Save the Serial Numbers of the replaced and the new Acquisition Boards in Siebel. Please, follow this procedure:

3. Return the failed 54911-69501 acquisition board to the factory..
